## STRUCTURAL INSPECTION

4131 Durness Way  
Houston TX 77025

OCTOBER 14, 2020

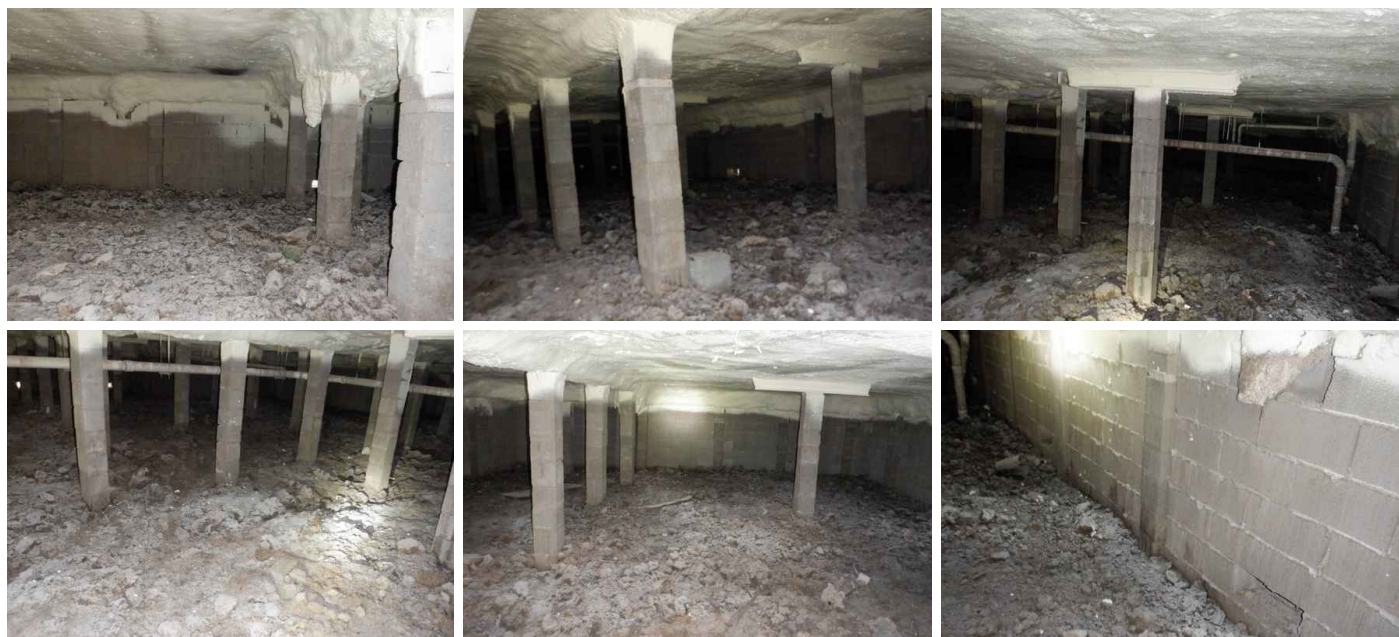
The foundation was a block and beam type foundation, with individual support piers (blocks) and wood beams spanning between the piers at the crawlspace under the house.

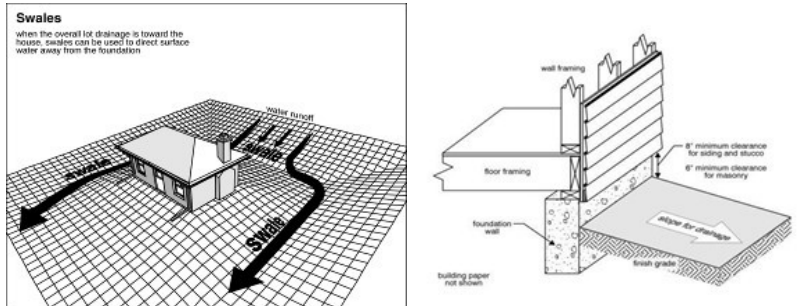
The perimeter drainage around the property appeared to generally be adequate. It could not be determined with certainty if water would pool at any localized low areas around the property. Further investigation with the homeowner is recommended to determine if there are any drainage problems or water that ponds on the property after a rain.

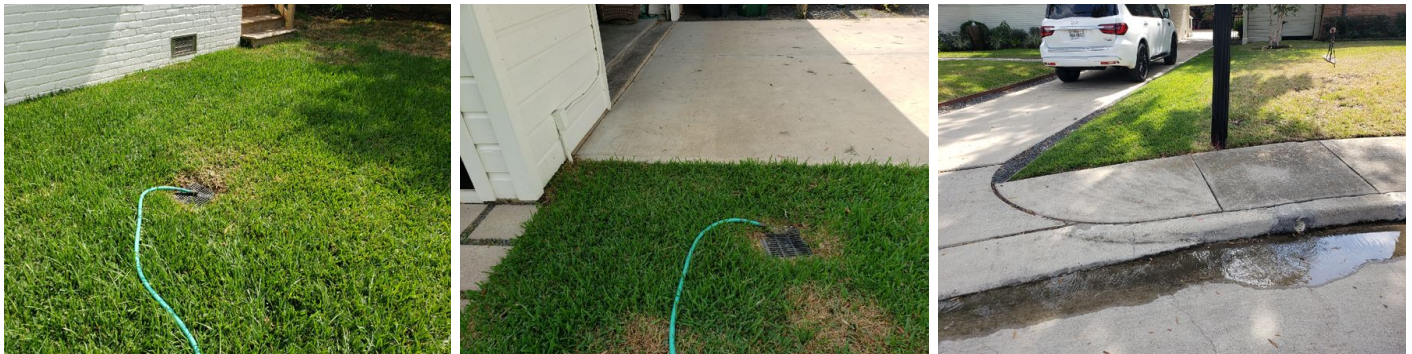
The underground drainage system at the rear of the house was checked by running water into the drain for approximately 15 minutes, and the system was observed to be draining properly to the street.

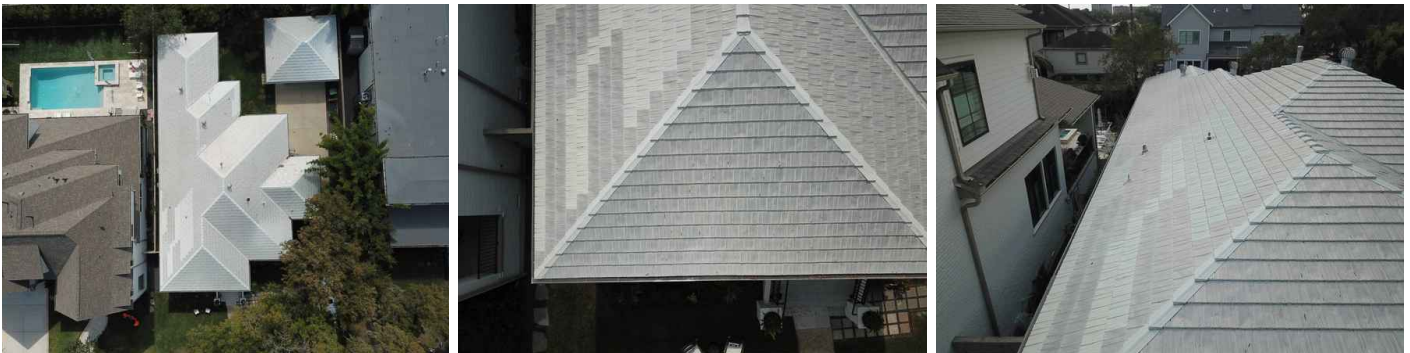
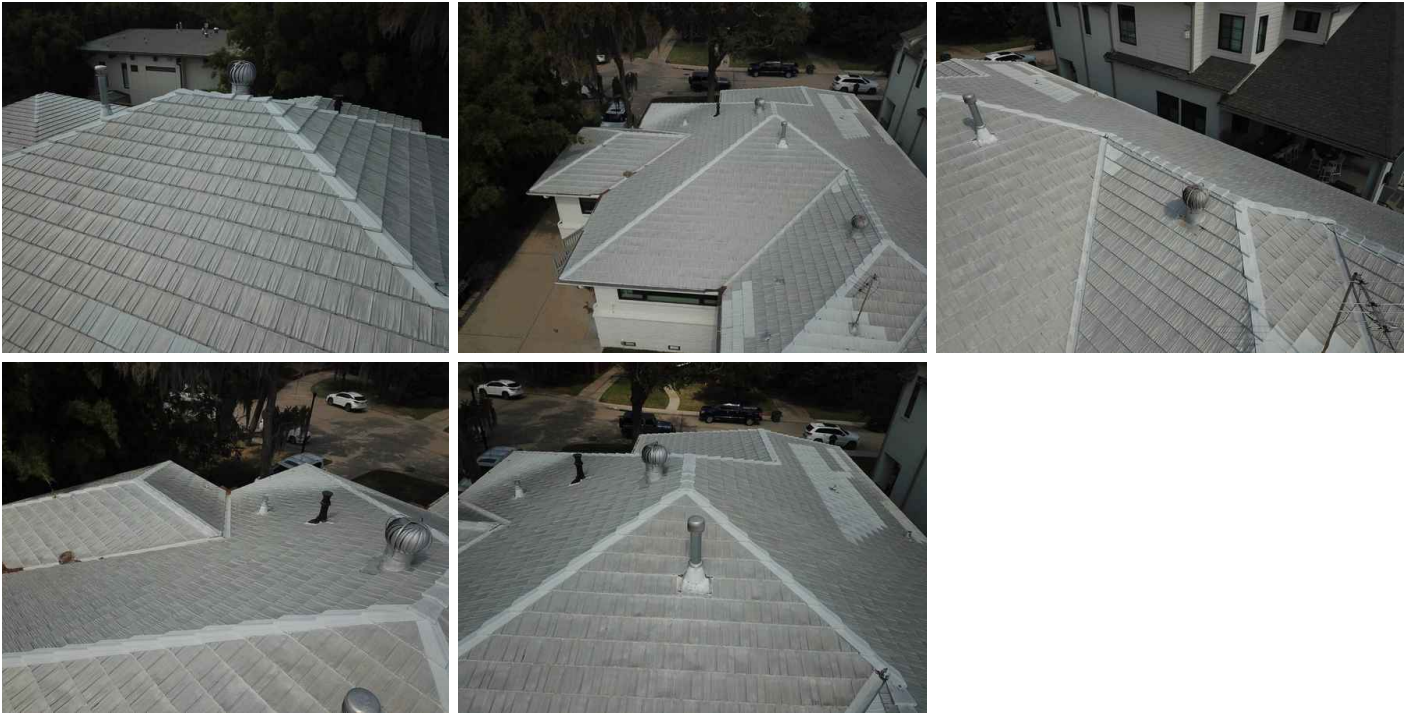
Due to the aluminum shingles on the roof, the roof was not viewed from its surface due to safety concerns, but was viewed from photographs taken by a drone.

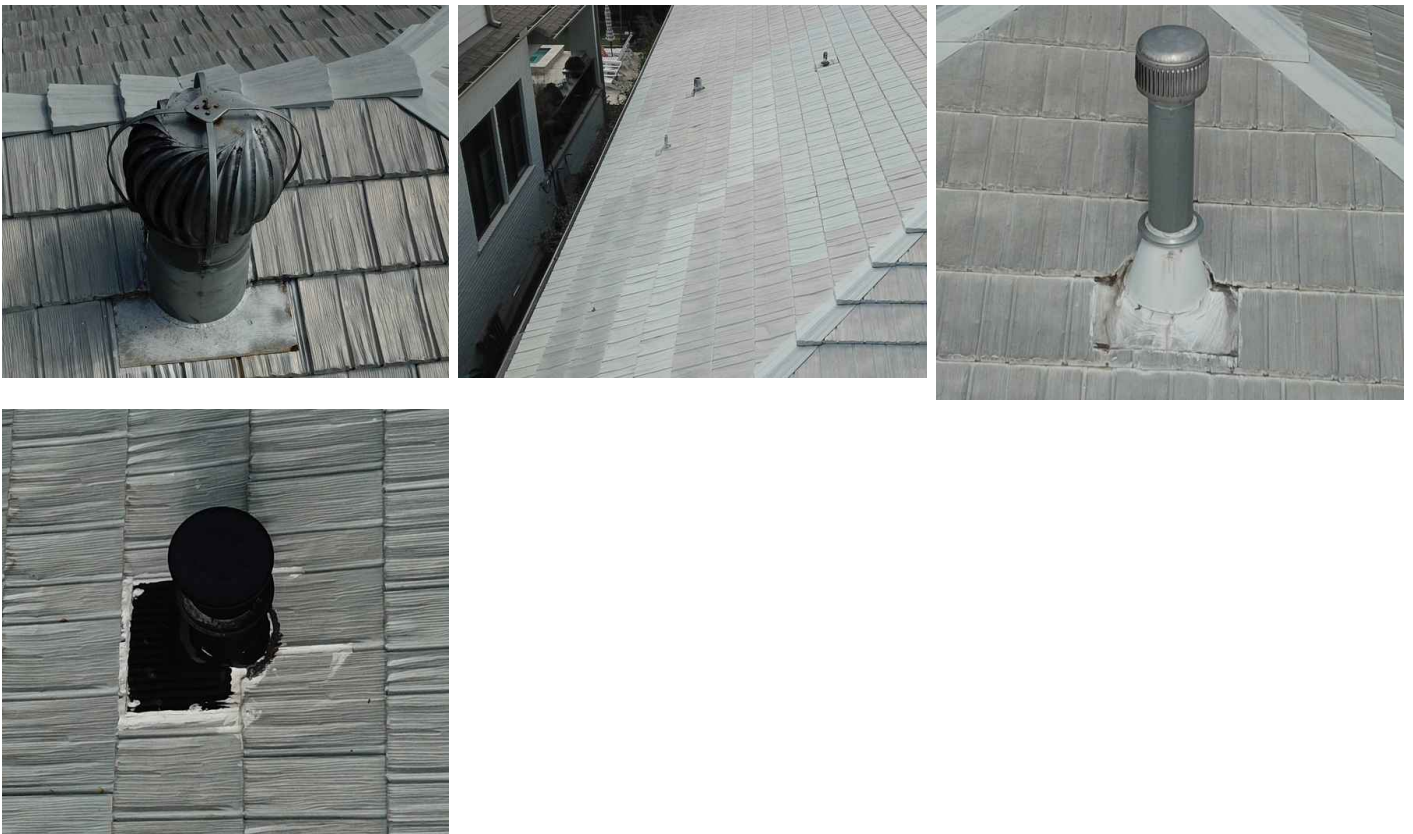
### Roof Details: Good sealant details

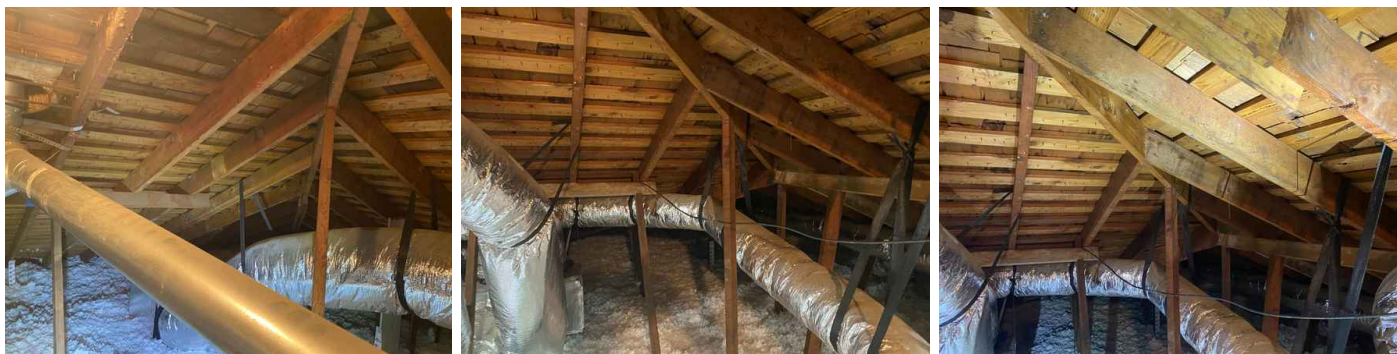
The attic space was viewed only from the areas determined by the inspector to be safely accessible from the access walkway.

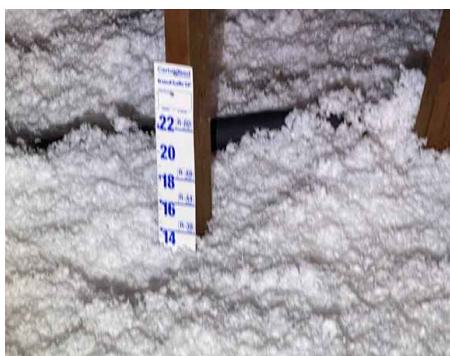
The insulation in the attic was average for the age of the house. The blown-in insulation appeared to be approximately 12" thick, which would be an R30 energy rating. It is pointed out that the insulation requirements according to the latest standard for new houses in this area is an R38 energy rating.

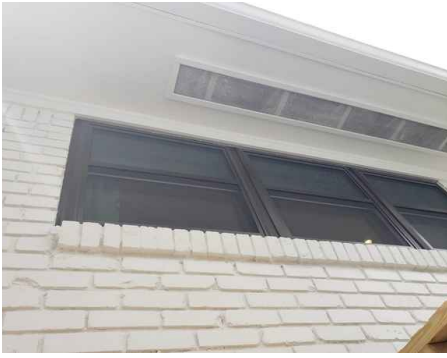
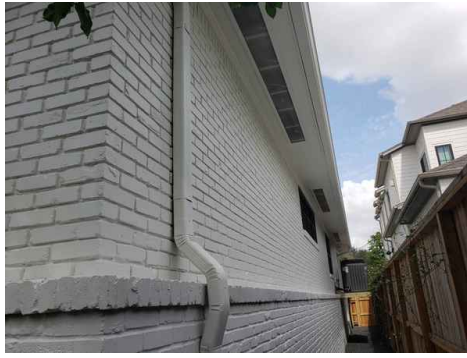
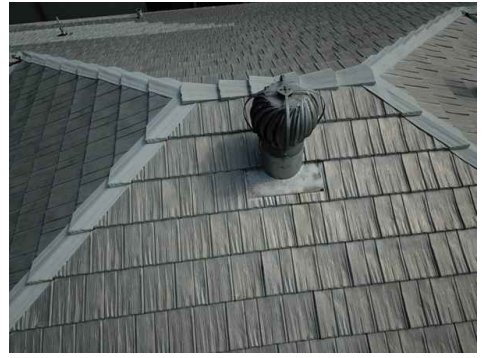
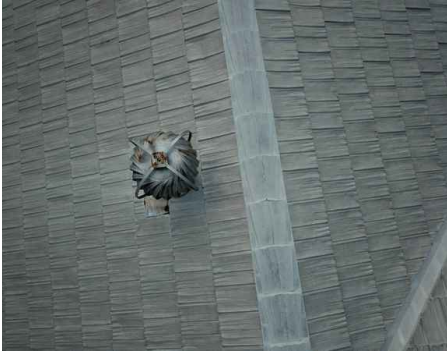
The ventilation for the attic included whirlybird vents in the roof and screened vents in the soffits.

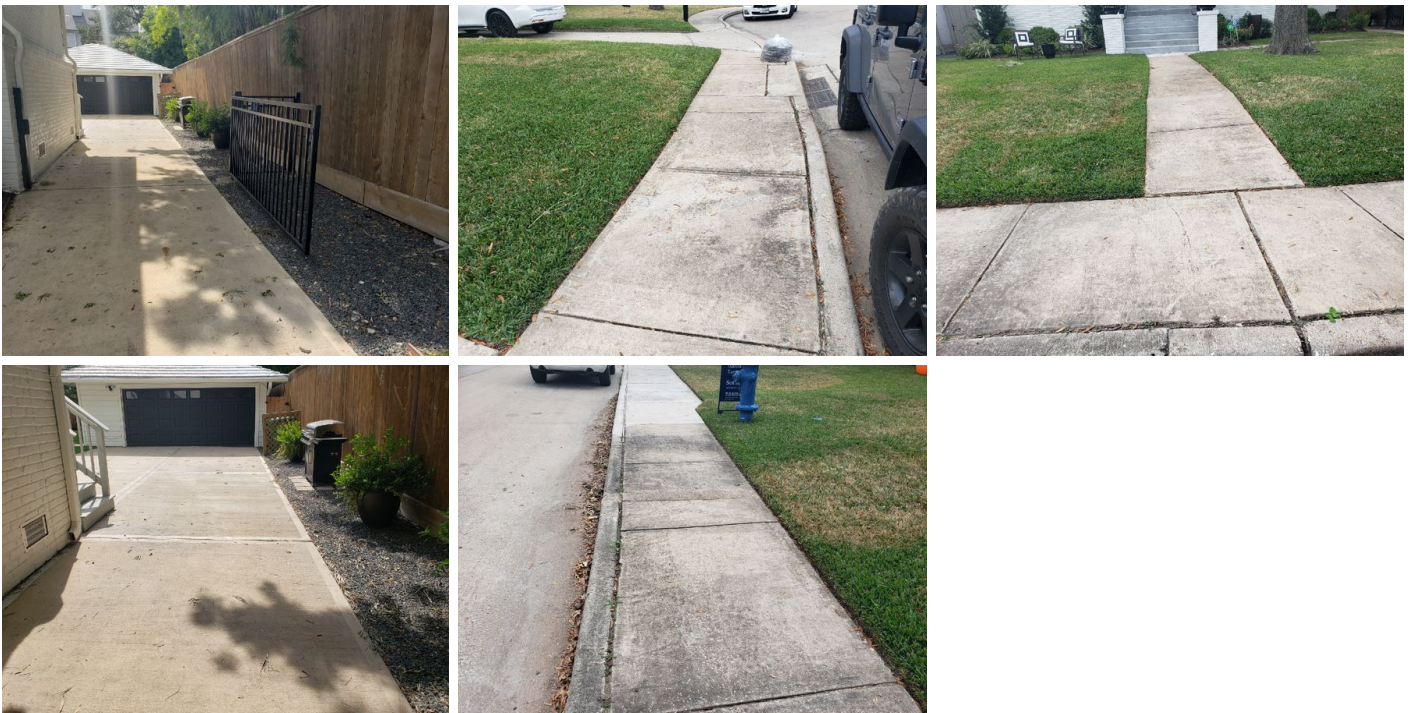
The flatwork concrete listed above was in generally good condition at the time of the inspection with no significant repairs needed. Note that there may be some small cracks in the concrete, but in the opinion of the inspector, the concrete is still functional.

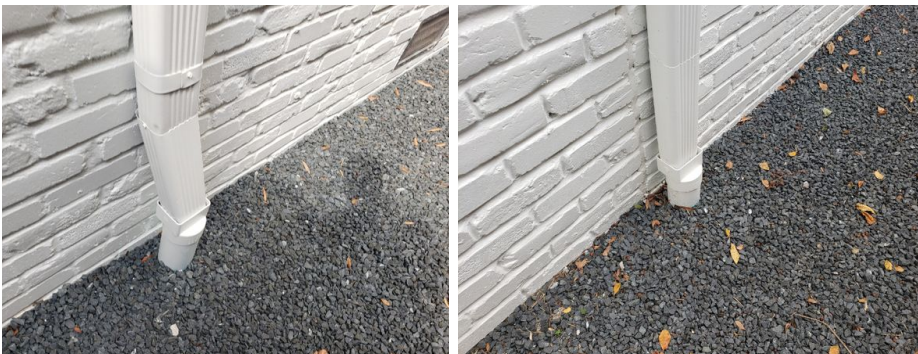
The downspouts were connected to an underground drainage system, which was not checked for performance and/or adequacy.

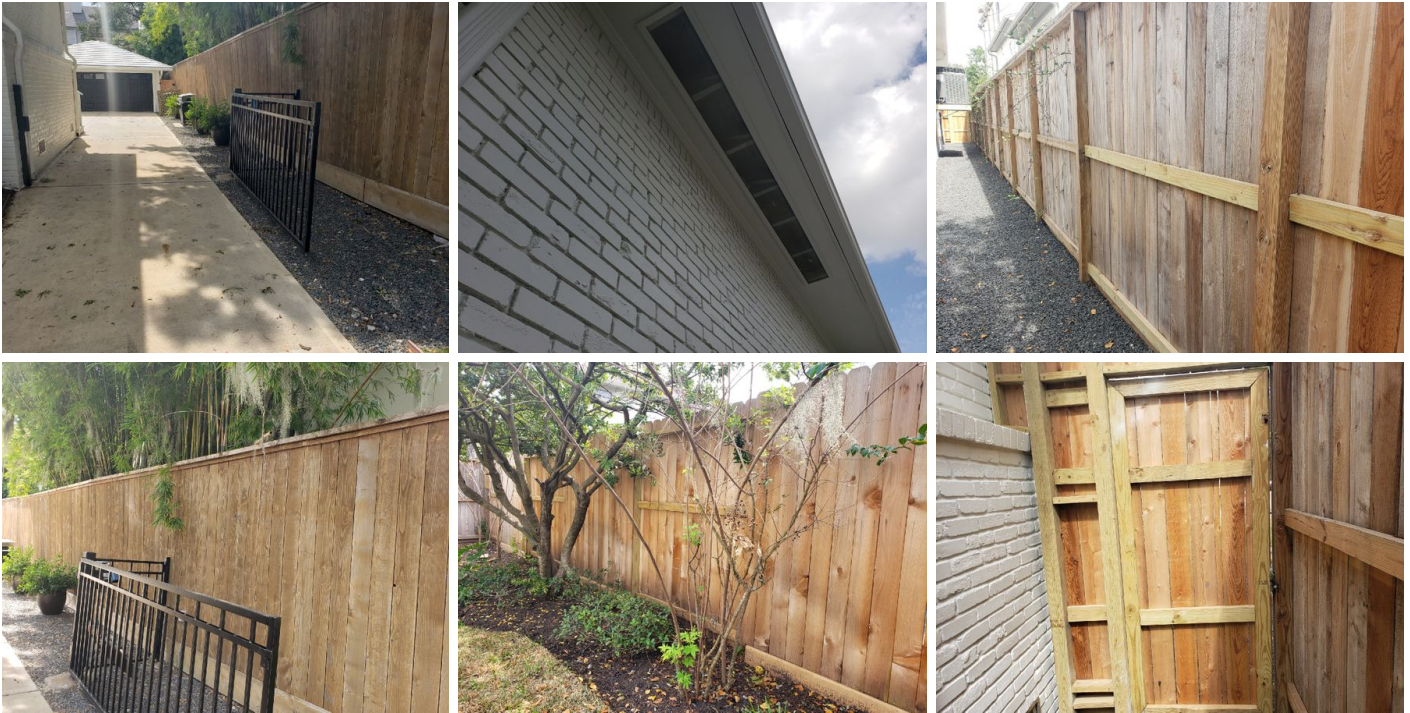
The gates and fences were in generally good condition at the time of the inspection and no repairs were observed to be needed.

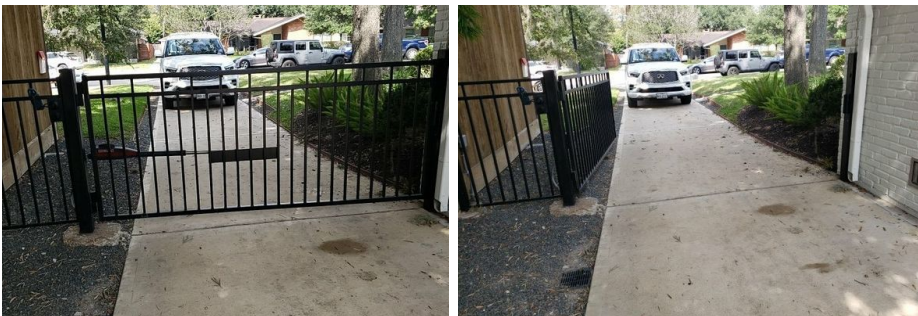
The electric gate was functional at the time of the inspection, and appeared to open and close properly with no repairs needed.

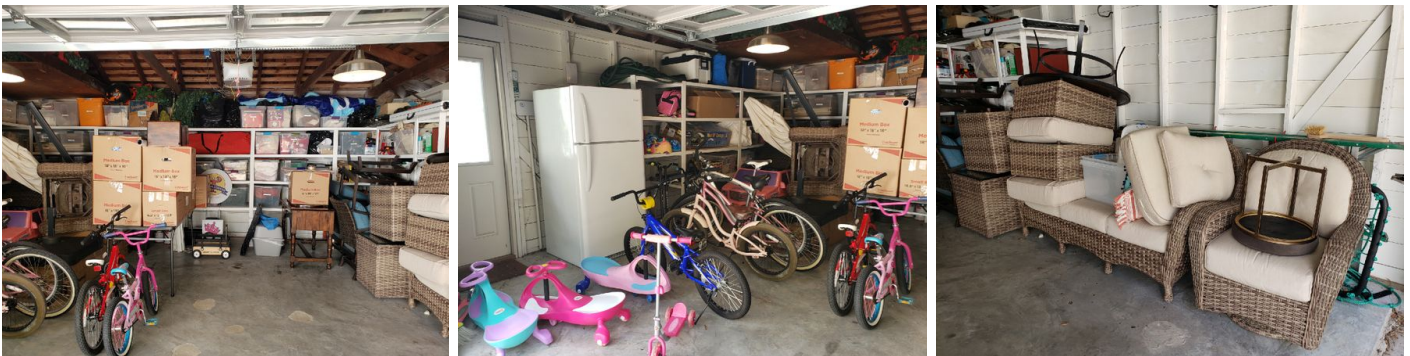
The garage had stored items in the garage, and access was limited inside the garage. We did not move any item in the garage, and not all of the garage was viewed at the time of the inspection.
