PROPERTY INSPECTION REPORT FORM

Mackinley Tatom <i>Name of Client</i>	04/29/2022 <i>Date of Inspection</i>
15340 Gorham Drive , Houston, TX 77084 <i>Address of Inspected Property</i>	
Tim Carpenter <i>Name of Inspector</i>	#23947 <i>TREC License #</i>
<i>Name of Sponsor (if applicable)</i>	<i>TREC License #</i>

Home Inspection Report

PROPERTY INSPECTED:
15340 Gorham Drive
Houston, TX 77084

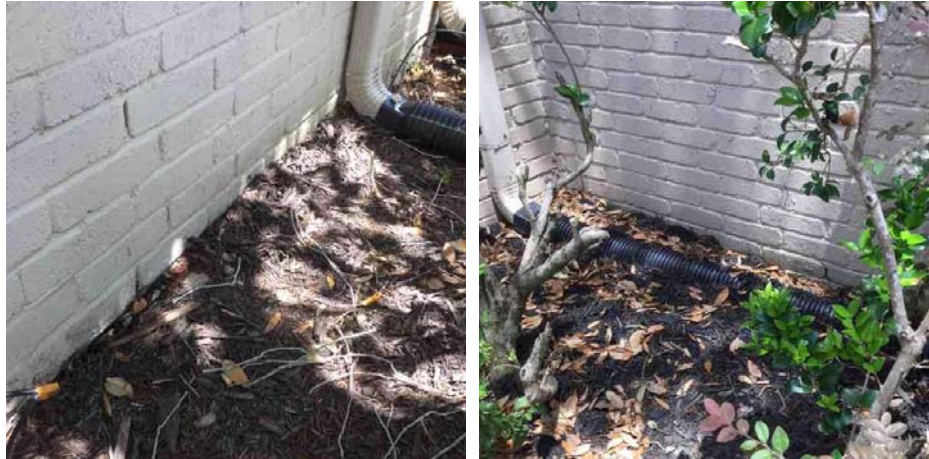
- **Spalling noted. Recommend repair and reparging to reduce further deterioration.**

- Some portions of the foundation were visually concealed from view and could not be inspected.

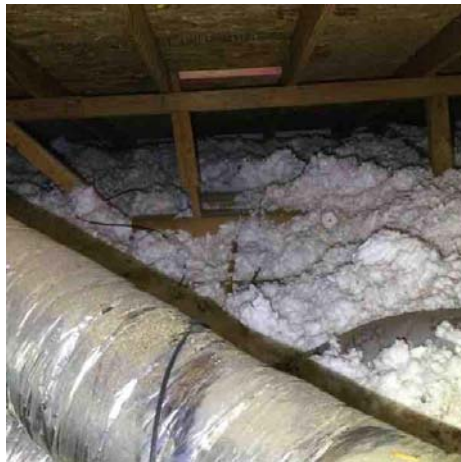
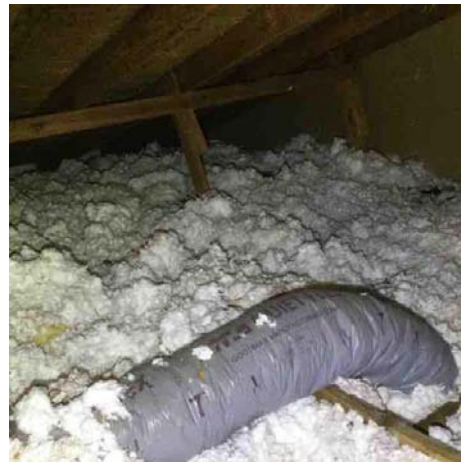
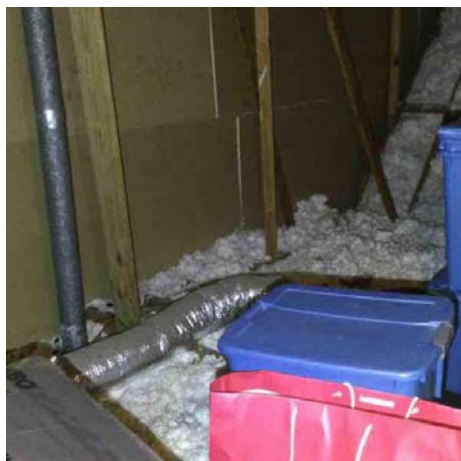
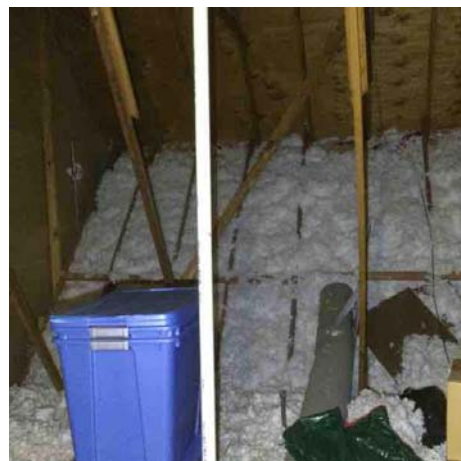
- For reference only.

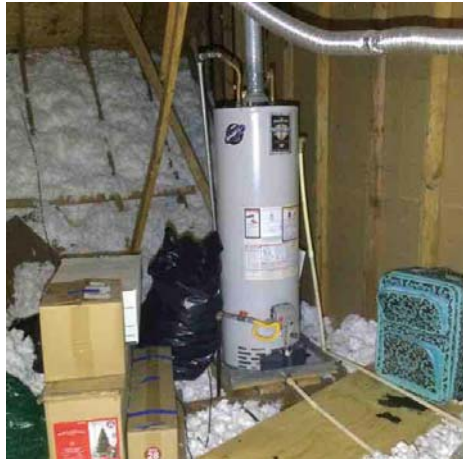
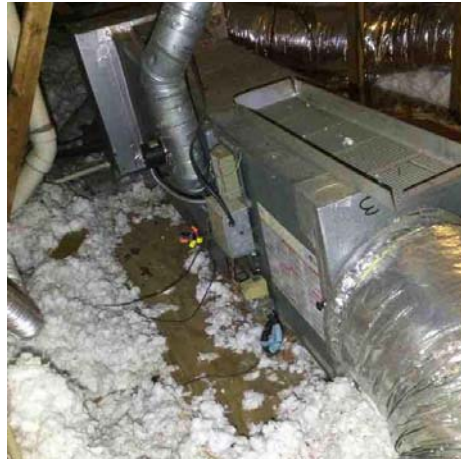
• Outside light in attic was observed which indicates openings in the roof material. Water heater flue.

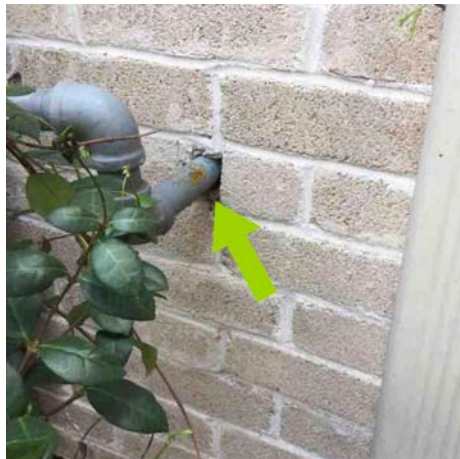
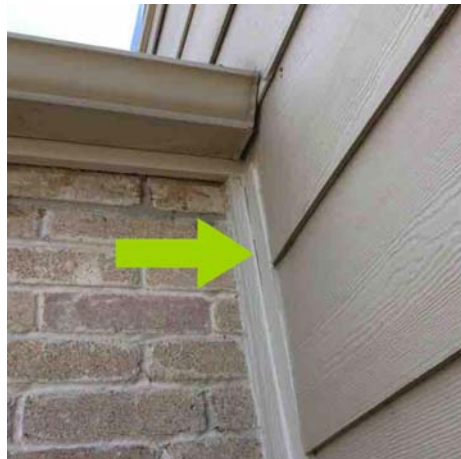
Repaired

• Exterior walls show typical minor settling cracks, no other visual indications of structural movement were noted at the time of the inspection. Re-point mortar area(s) and seal as necessary to reduce unwanted moisture intrusions and promote good weather seal.

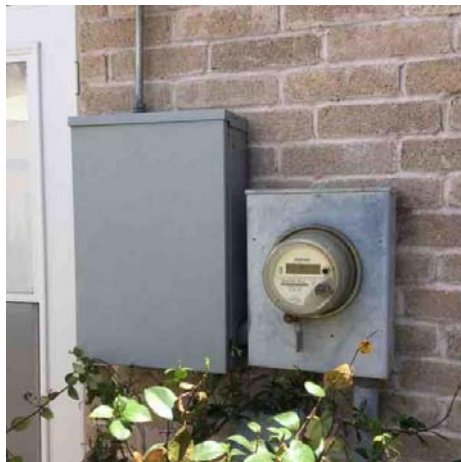
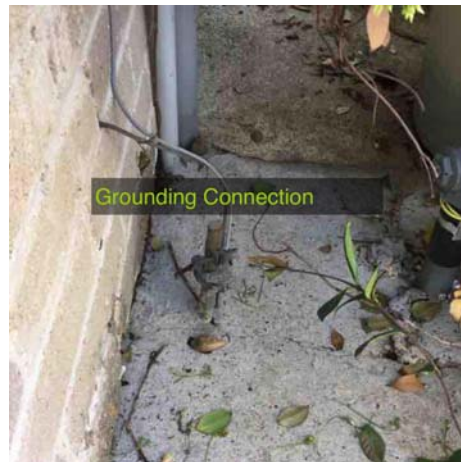
- Main distribution panel is 100 amp service; underground, 120/240 volt, aluminum leads and uses breakers. All bondings and groundings were not visible and could not be verified.

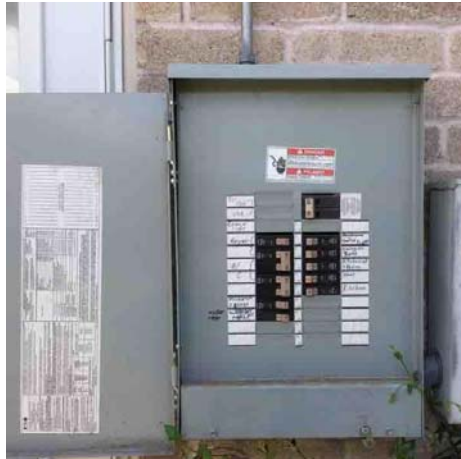
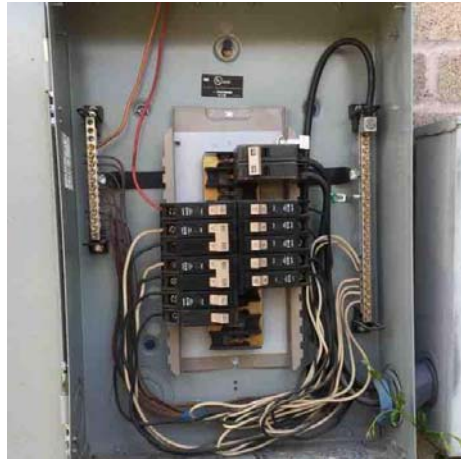
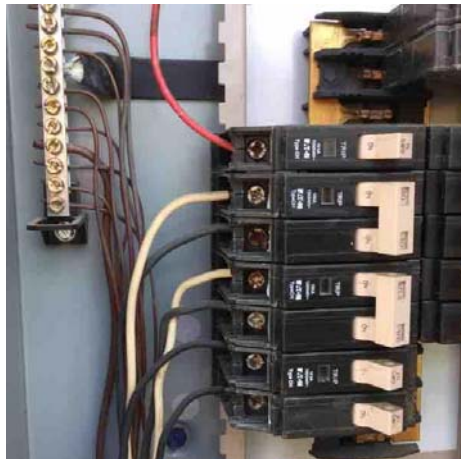
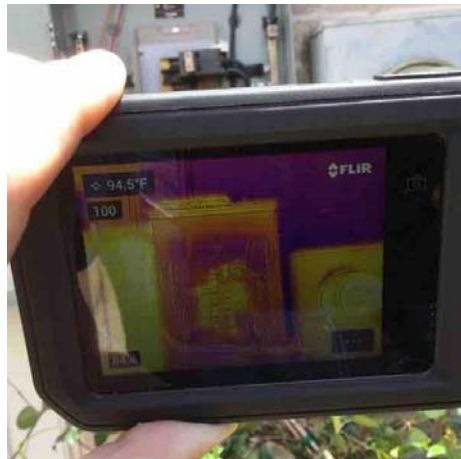
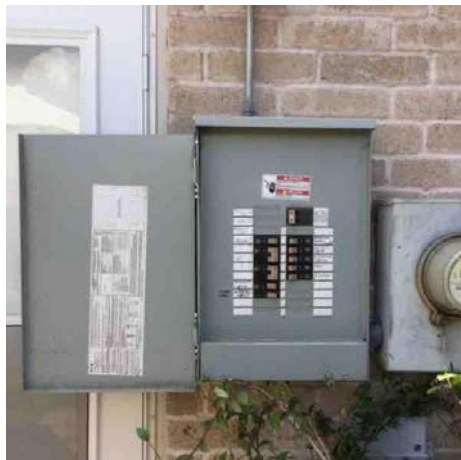
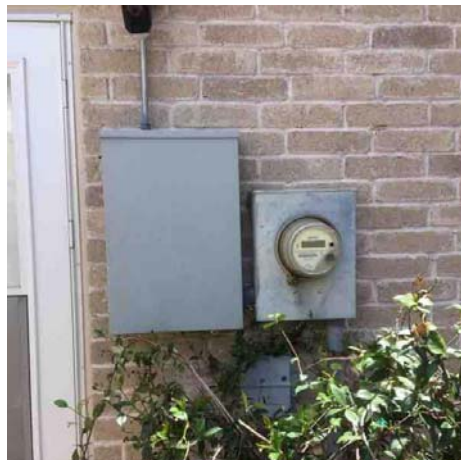
Repaired

- Improper use of a pipe clamp was observed securing ground wire to ground rod (see photo). Recommend replacement of pipe clamp with a proper "Acorn" type clamp.
- White wires to 240 volt appliances were not marked as "hot" in the distribution panel. Wire should be marked with black electrical tape to indicate purpose.
- Electrical panel is missing strain relief grommets. Install grommets to properly protect the wires for safety.

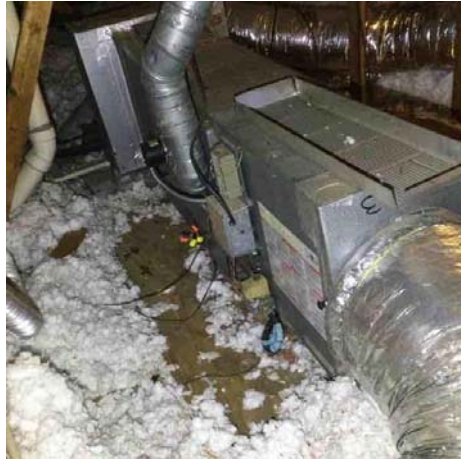
- Heating system was run for more than 30 minutes. System met accepted standard differentials of 35 to 50 degrees between supply and return registers. Reading ranged between 37 - 40 degrees.

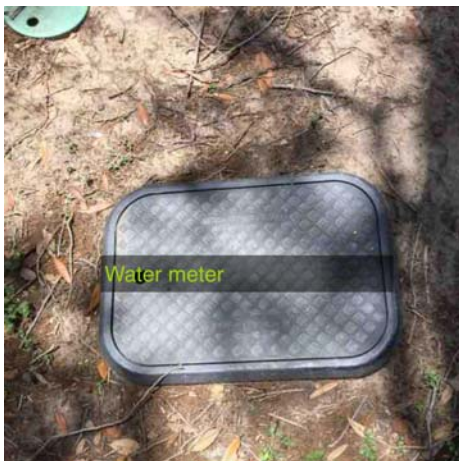
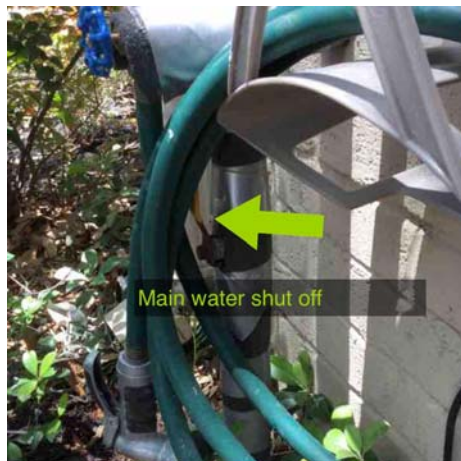
- Main water shut off is located at the exterior front.

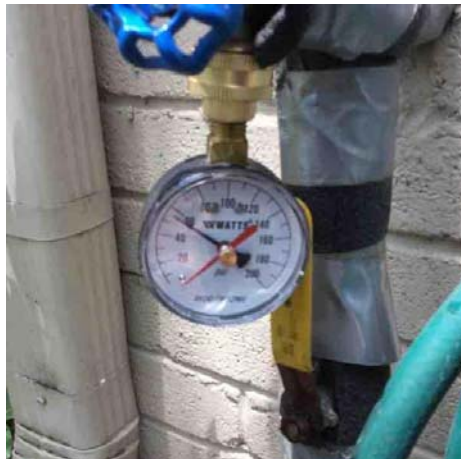
- Galvanized water lines noted in home for the main water supply. These lines can corrode and clog over time reducing or stopping water flow/pressure. While visual evidence at the time of the inspection notes the system is functioning within normal parameters, consider upgrading to PEX pipe to reduce possible failure in lines and related issues.

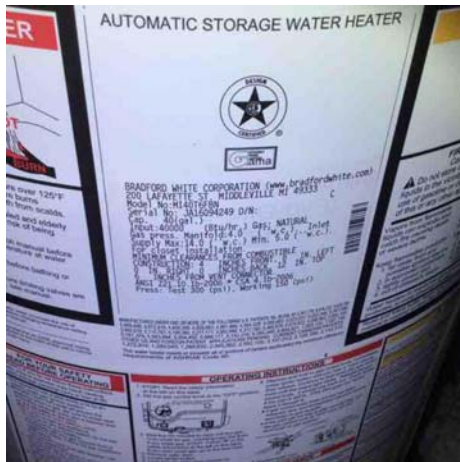
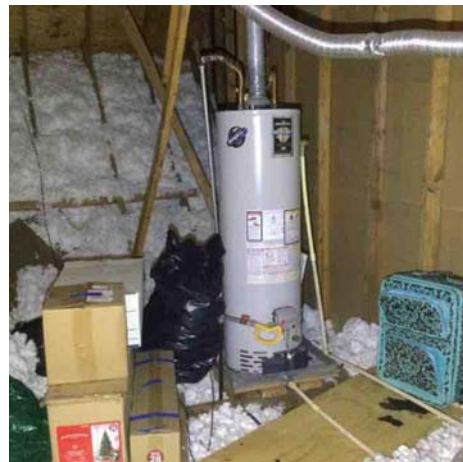
C. Water Heating Equipment
Energy Sources: Natural gas
Capacity: 40 gallon
Comments:
 • 2012.

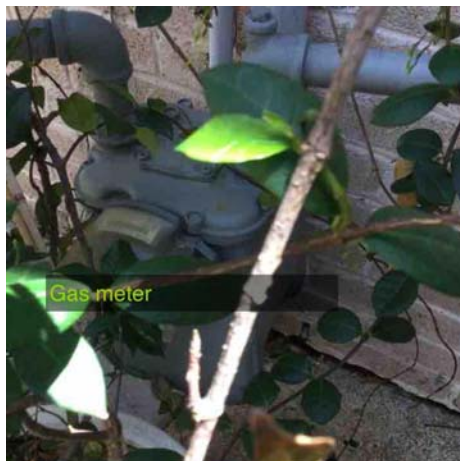
E. Gas Distribution Systems and Gas Appliances
Location of gas meter: Back of house
Comments:
 • Gas meter is located at the exterior back.

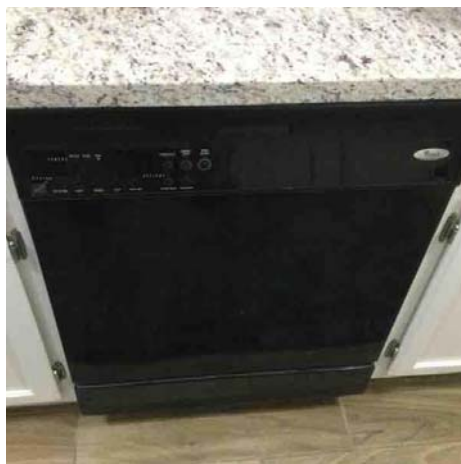
- "Dishwasher was operated in normal mode, run through a complete, normal cycle. Function and operation appear to be normal. Lower access panel not removed. At the time of the inspection the dishwasher did not leak. Care should be taken the first time the dishwasher is run after a period of inactivity because seals tend to dry out and can leak at first. If this happens dry the area inside the unit where the leak is occurring and then re-start the dishwasher. Also be sure to follow the manufactures recommendation for type of soap and amount as this can be the cause of leaking. If it continues to leak repair is required."

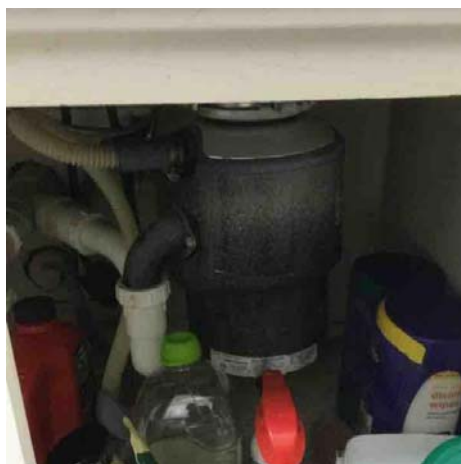
- Functioned properly at the time of inspection.

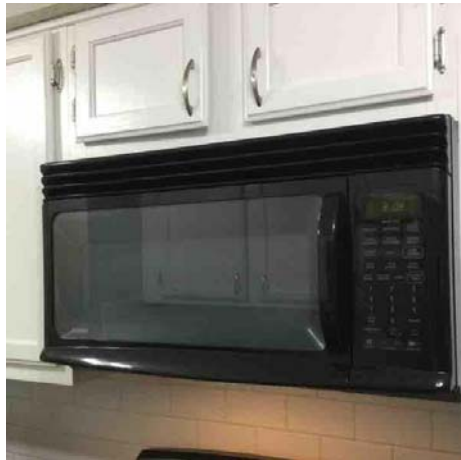
- Microwave exhaust vent noted, exhaust fan and light appear to be functioning as intended at the time of the inspection, clean and service filter on a regular basis. Unit terminates (in the home/outside the structure).

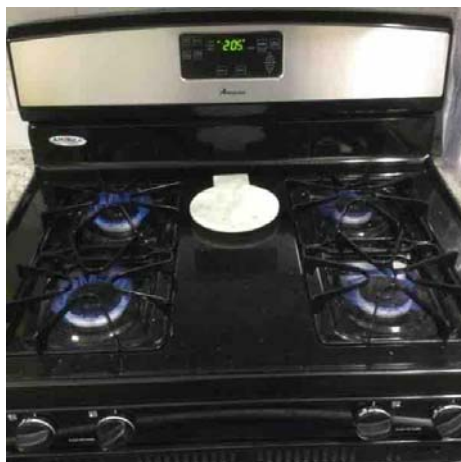
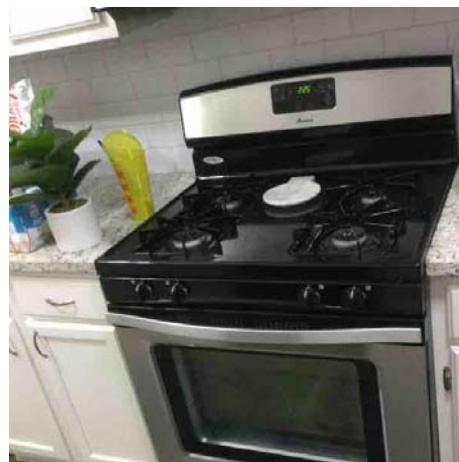
- All Burners on gas Range functioned properly.

Oven Temperature was 348 degrees when set at 350 within the 25 degree tolerance.

- **No anti tip device installed on freestanding range. Recommend adding anti-tip device to reduce the possible hazards associated with range tipping.**

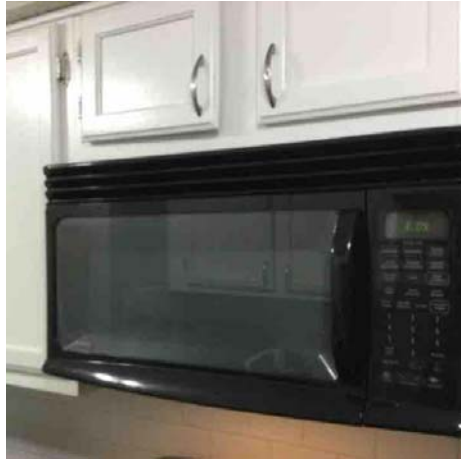
- Microwave built-in unit functioning as intended at time of inspection.

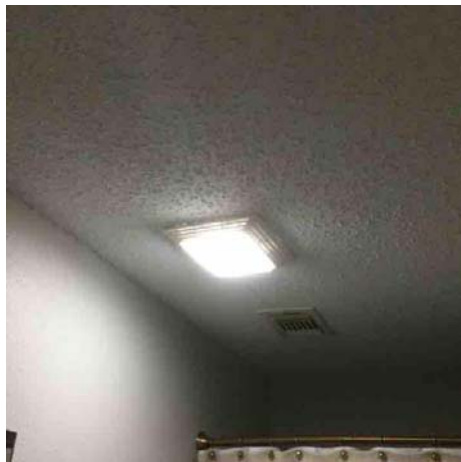
- Functioned properly.

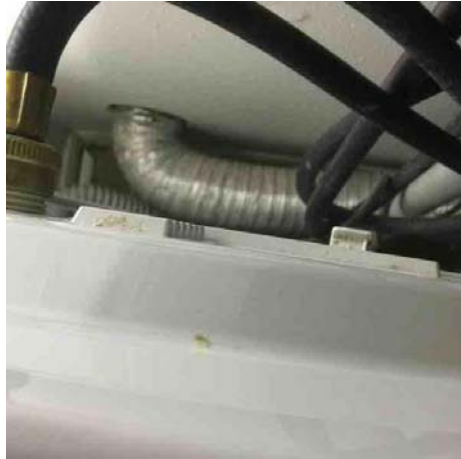
- Functioned properly.
