RESIDENTIAL INSPECTION REPORT

303 Mellon St
Richmond TX 77469

Paul Edwards
MARCH 27, 2021

Inspector
Neal Harris
TREC #23748
(281) 484-8318
office@inspectorteam.com

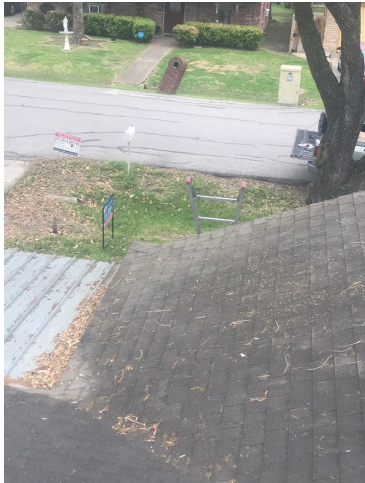
Roof Access was limited: Unsafe to access -
Direct access to the roof was limited because of constraints encountered during the inspection. The inspector did employ other methods in determining the overall functionality of the roof covering. If further evaluation of the roof covering is desired, consult with a qualified roofing contractor.

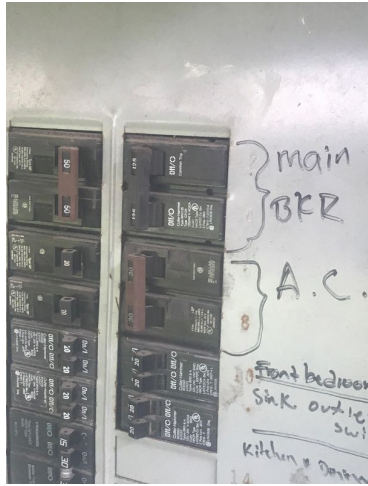
1: White Wires Not Marked

White wires connected to breakers are not marked with black or red electrical tape to indicate that they are "hot". Remedy as needed.

Recommendation: Contact a qualified electrical contractor.

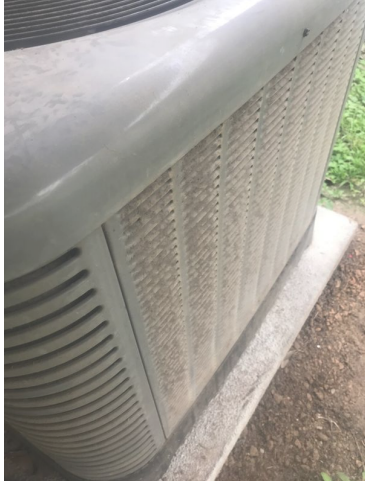
No access to internal coils:

Recommendation: Contact a qualified HVAC professional.

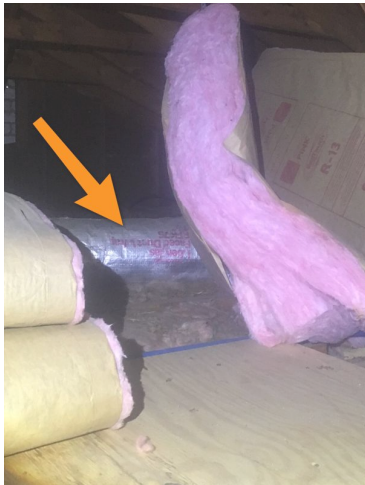
Sections of ducting were resting on the attic floor. Evaluate and remedy as needed.

Recommendation: Contact a qualified HVAC professional.

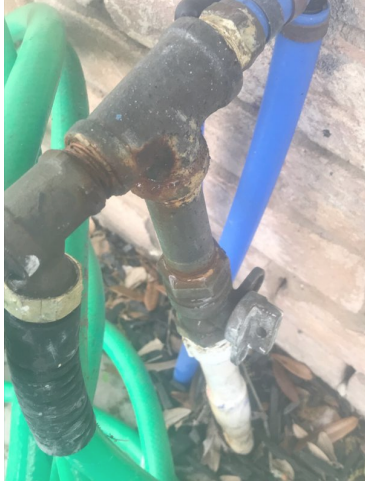
4: Supply Piping: Corroded fittings

Water line fittings were corroded. Remedy as needed.

Recommendation: Contact a qualified plumbing contractor.

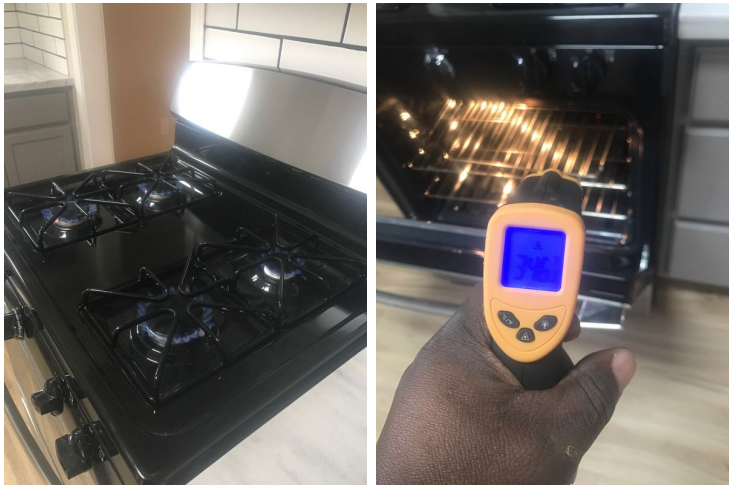
1: Missing Anti-Tip Device

There was no anti-tipping device installed on the oven/range to prevent tipping if the door is climbed on while opened. This is a possible safety hazard. Evaluate and remedy as needed.

Recommendation: Contact a qualified professional.
