# PROPERTY INSPECTION REPORT

Concerning: 15123 Green Whisper Dr, Cypress TX 77433

By: Dan Richter - TREC#21351

01/07/2020 9:00 am

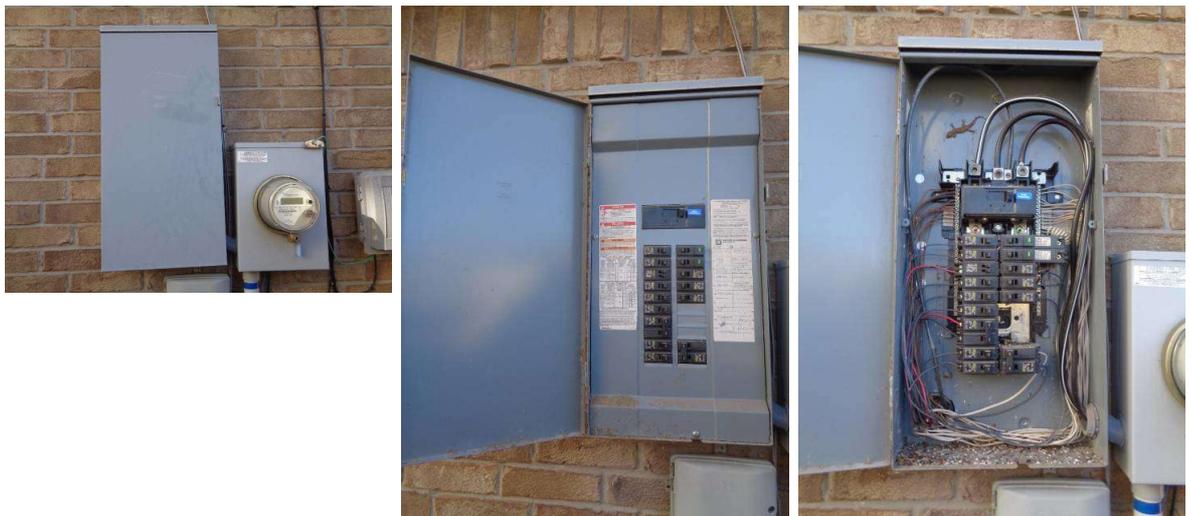
Right exterior

3 wire 120/240v service lateral feeds electrical panel with 1/0 AWG(size estimated) aluminum wire which is rated for 125 amps. The main disconnect breaker was 125 amps. The cabinet (rated for 200 amps) appeared to be grounded. Trip ties appeared to be installed properly. It appeared that AFCI circuits were installed in bedrooms only.

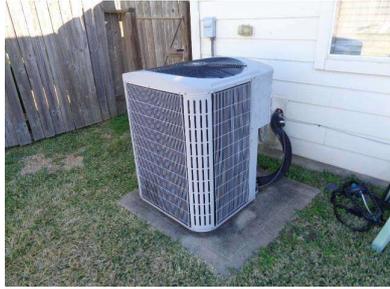
Condensing unit appeared to be manufactured by Carrier. There was no manufacturer's label on the unit. Age, size, and proper breaker sizing was not .

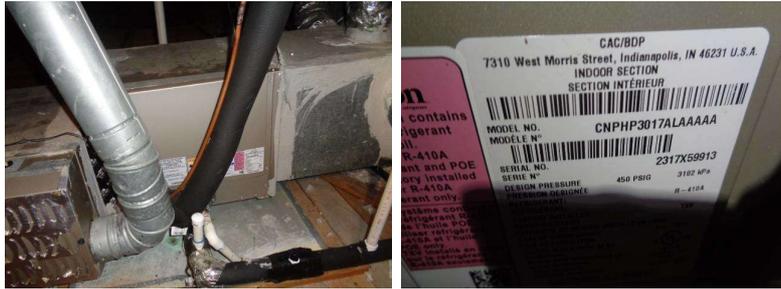
Attic

Evaporator unit appeared to be manufactured by Carrier in 2017. Unit appeared to be 2.5 ton.

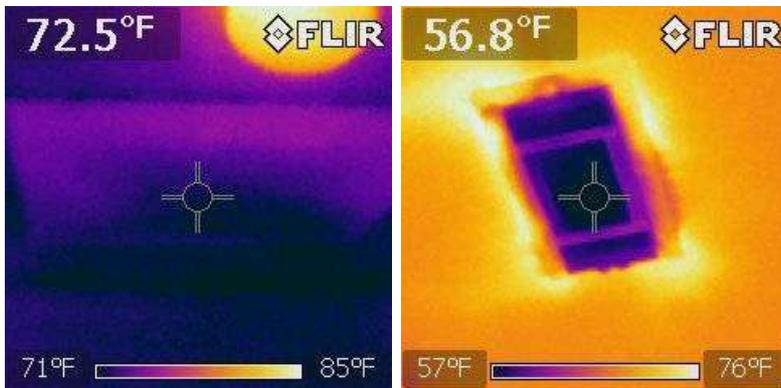
AC appeared to be cooling properly. Temperature differential measured 16 degrees between air supply and registers. Typical range should be 15 to 20 degrees.

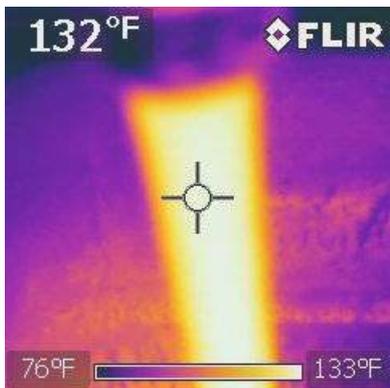
In our opinion, hot water was too hot. Suspect this could be corrected by turning down the thermostat.

Recommendation: Contact a qualified professional.

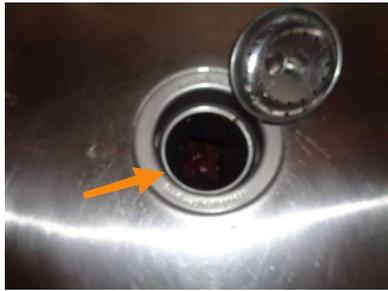
Splash guard was worn.

Recommendation: Contact a qualified professional.

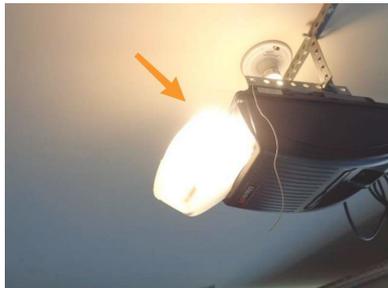
Light fixture cover was loose on the opener.

Recommendation: Contact a qualified professional.

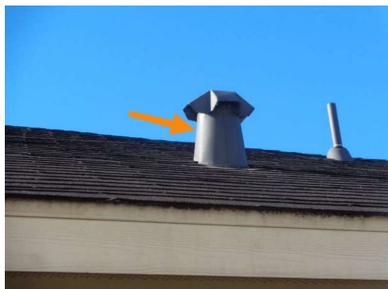
Dryer vent appeared to terminate at the roof in a generic exhaust vent. We recommend a dryer approved vent cover be installed with a proper back draft device.

Recommendation: Contact a qualified professional.
