Your Inspection Report

404 South Beauregard Street
Alvin, TX 77511

INSPECTION DATE:
Thursday, March 16, 2023

PROPERTY INSPECTION REPORT FORM

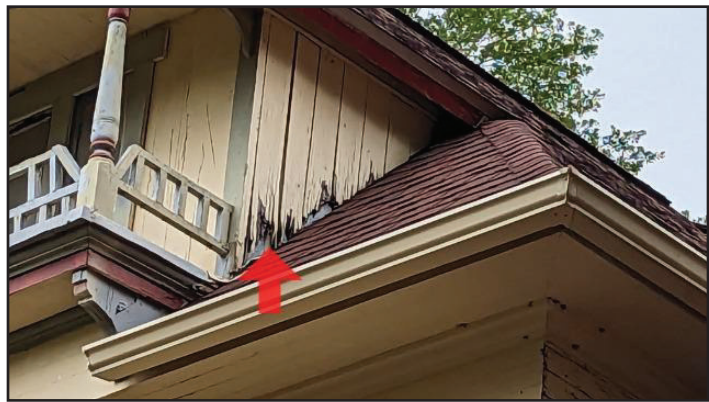
7. Siding not cut back

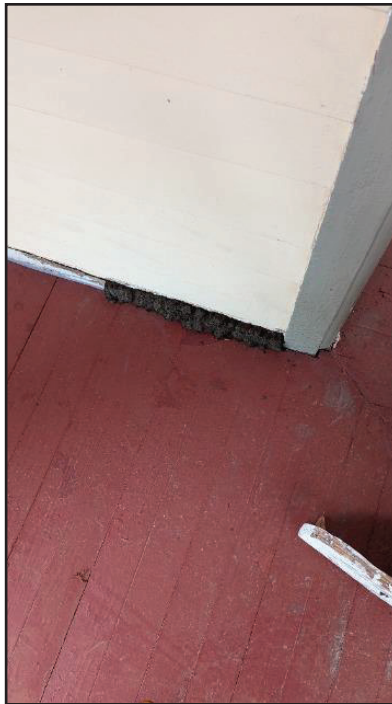
10. **Condition:** • Siding - incomplete / missing

Location: Left Side Second Floor Exterior Porch

12. *Siding - incomplete / missing*

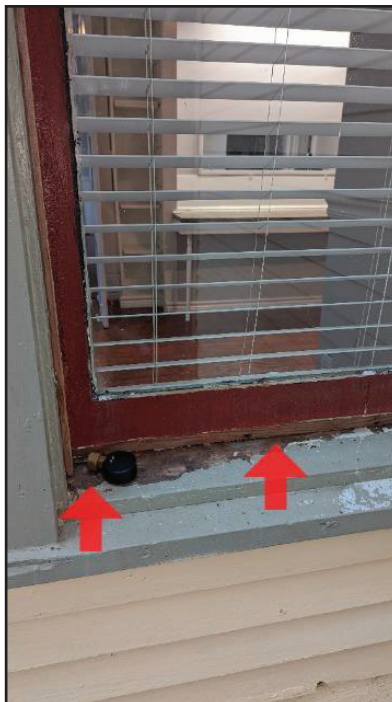
Implication(s): Chance of water damage to structure, finishes and contents

Location: Various Exterior

19. Caulking missing, loose or deteriorated

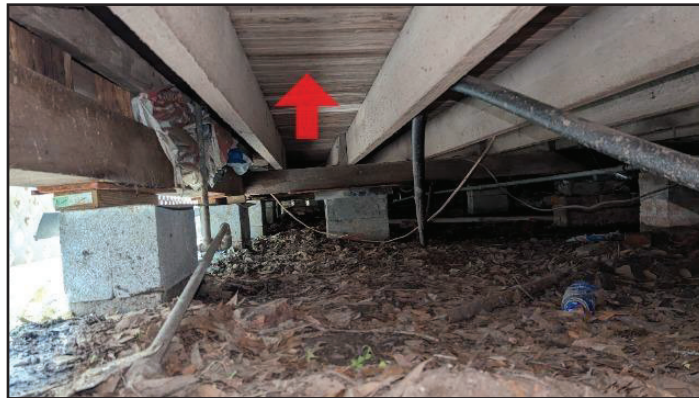
44. No blocking, bracing or bridging

37. Condition: • [No blocking, bracing or bridging](#)

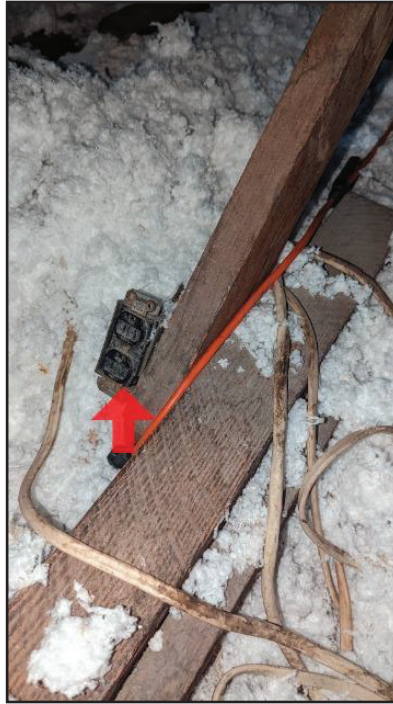
61. Cover loose or missing

52. **Condition:** • [Cover loose or missing](#)

Implication(s): Electric shock | Fire hazard

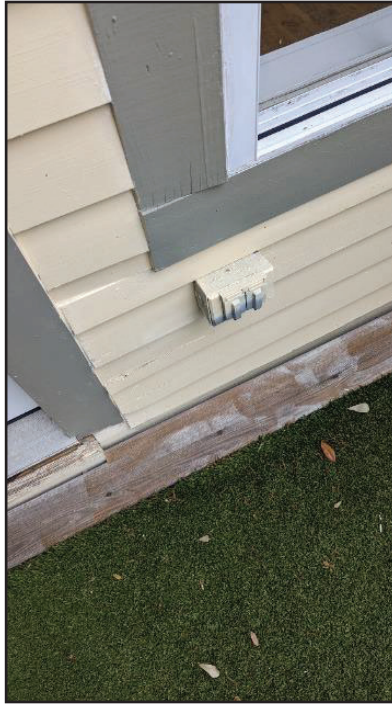
68. GFCI/GFI needed (Ground Fault Circuit...

59. Condition: • [GFCI/GFI needed \(Ground Fault Circuit Interrupter\)](#)

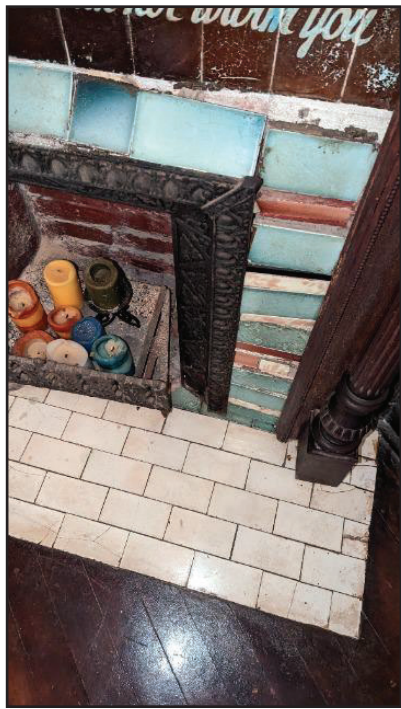
69. Condition: • [Gaps or cracks](#)

Implication(s): Fire hazard

79. Gaps or cracks

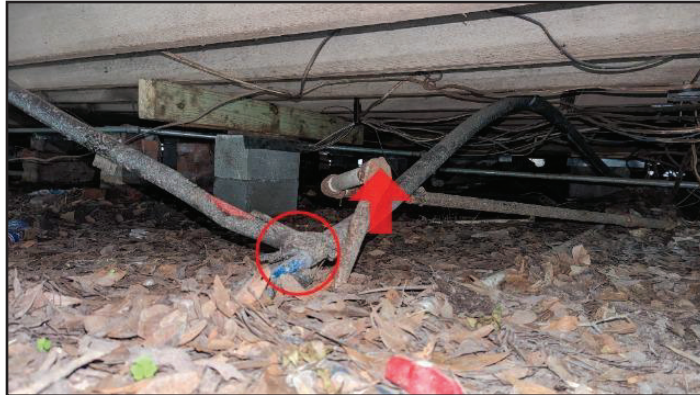
76. Condition: • [Split, damaged, crimped](#)

Implication(s): Chance of water damage to structure, finishes and contents | Leakage

95. Split, damaged, crimped

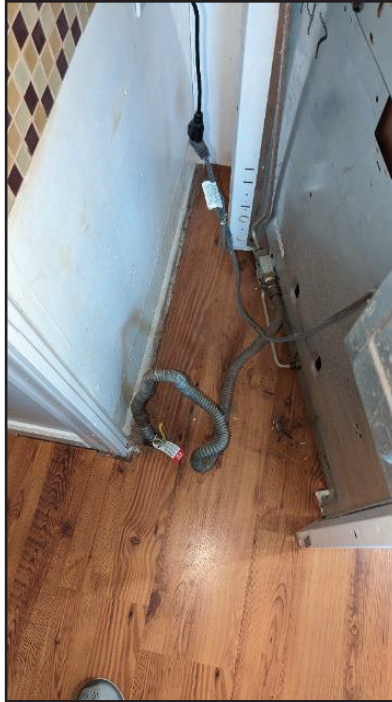
79. Condition: • [No drip leg \(sediment trap, dirt pocket\)](#)

Implication(s): Equipment not operating properly

Location: Kitchen

98. No drip leg (sediment trap, dirt pocket)

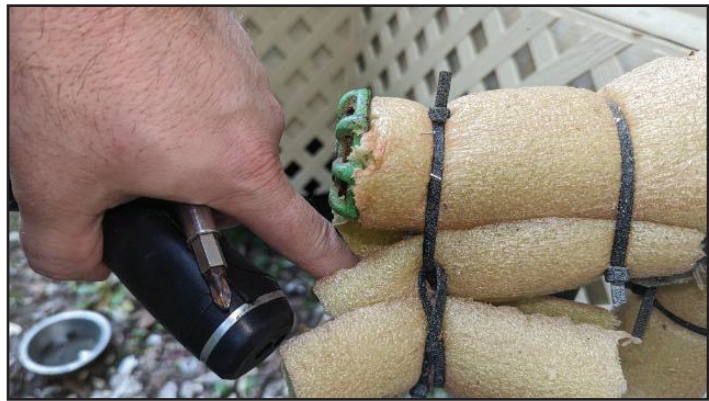
80. Condition: • [Backflow prevention missing](#)

99. Backflow prevention missing

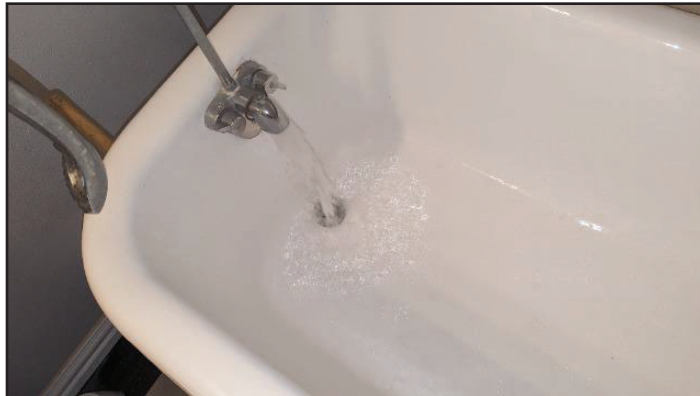
84. **Condition:** • Drain stop ineffective

Implication(s): Reduced operability

Location: Second Floor Hallway Bathroom

103. *Drain stop ineffective*

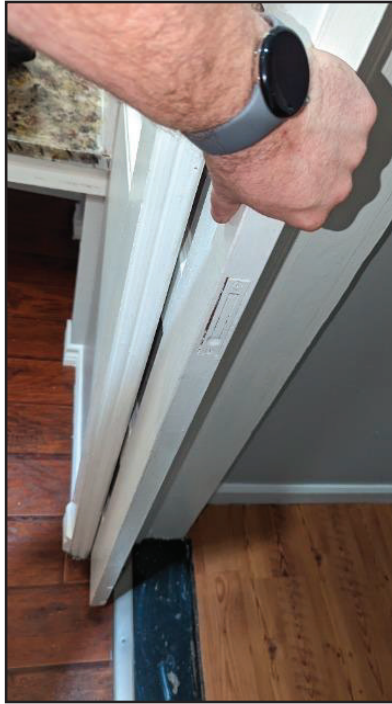
135. Does not latch properly

114. Condition: • Does not latch properly

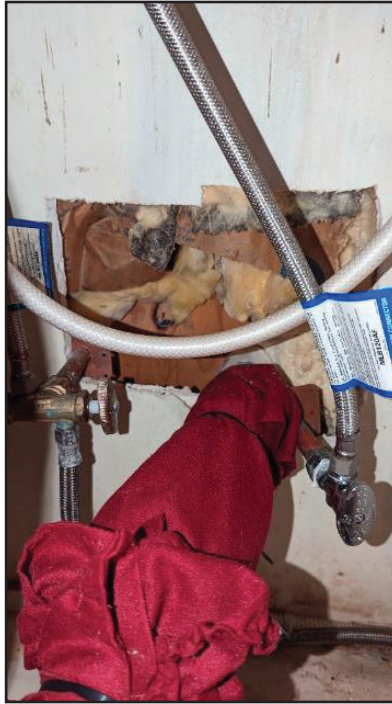
137. Pieces missing or loose

116. Condition: • [Pieces missing or loose](#)

Implication(s): Damage or physical injury due to falling materials

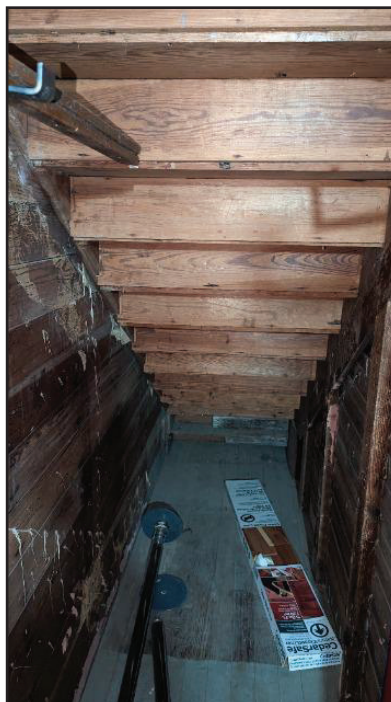
139. Drywall missing or incomplete on underside...

118. Condition: • [Drywall missing or incomplete on underside of stairs](#)

Implication(s): Increased fire hazard

Location: Right Side Older Dining Room

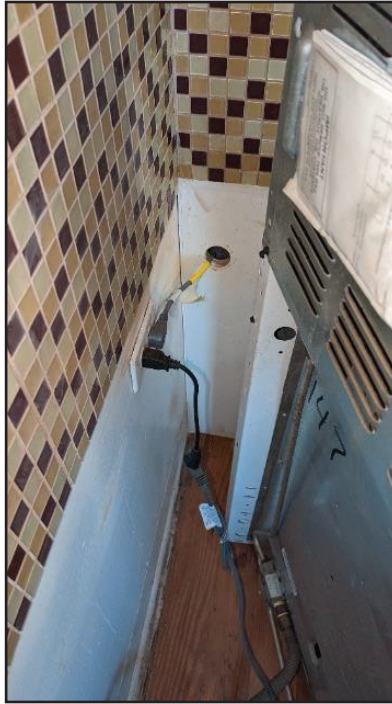
141. Anti-tipping device missing

120. Condition: • Anti-tipping device missing

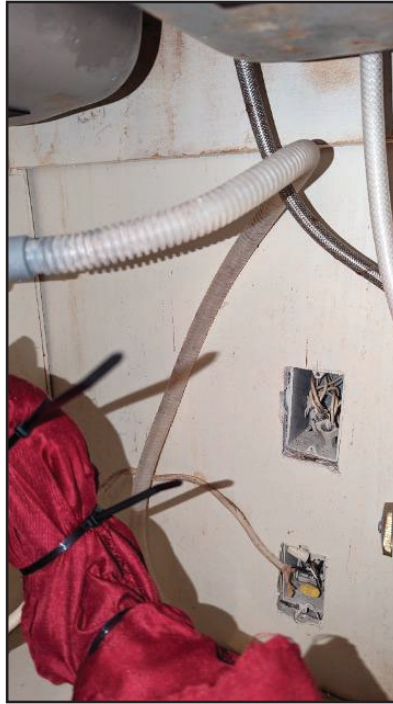
144. Backflow prevention high loop missing

123. Condition: • Backflow prevention high loop missing
