# REDSTAR PROFESSIONAL HOME INSPECTION, INC

## REDSTAR RESIDENTIAL INSPECTION REI 7-6

404 S Beauregard St  
Alvin, TX 77511

# PROPERTY INSPECTION REPORT FORM

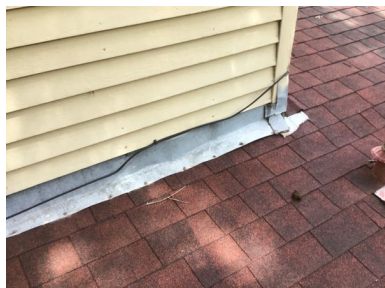
**1: Unpainted Materials**

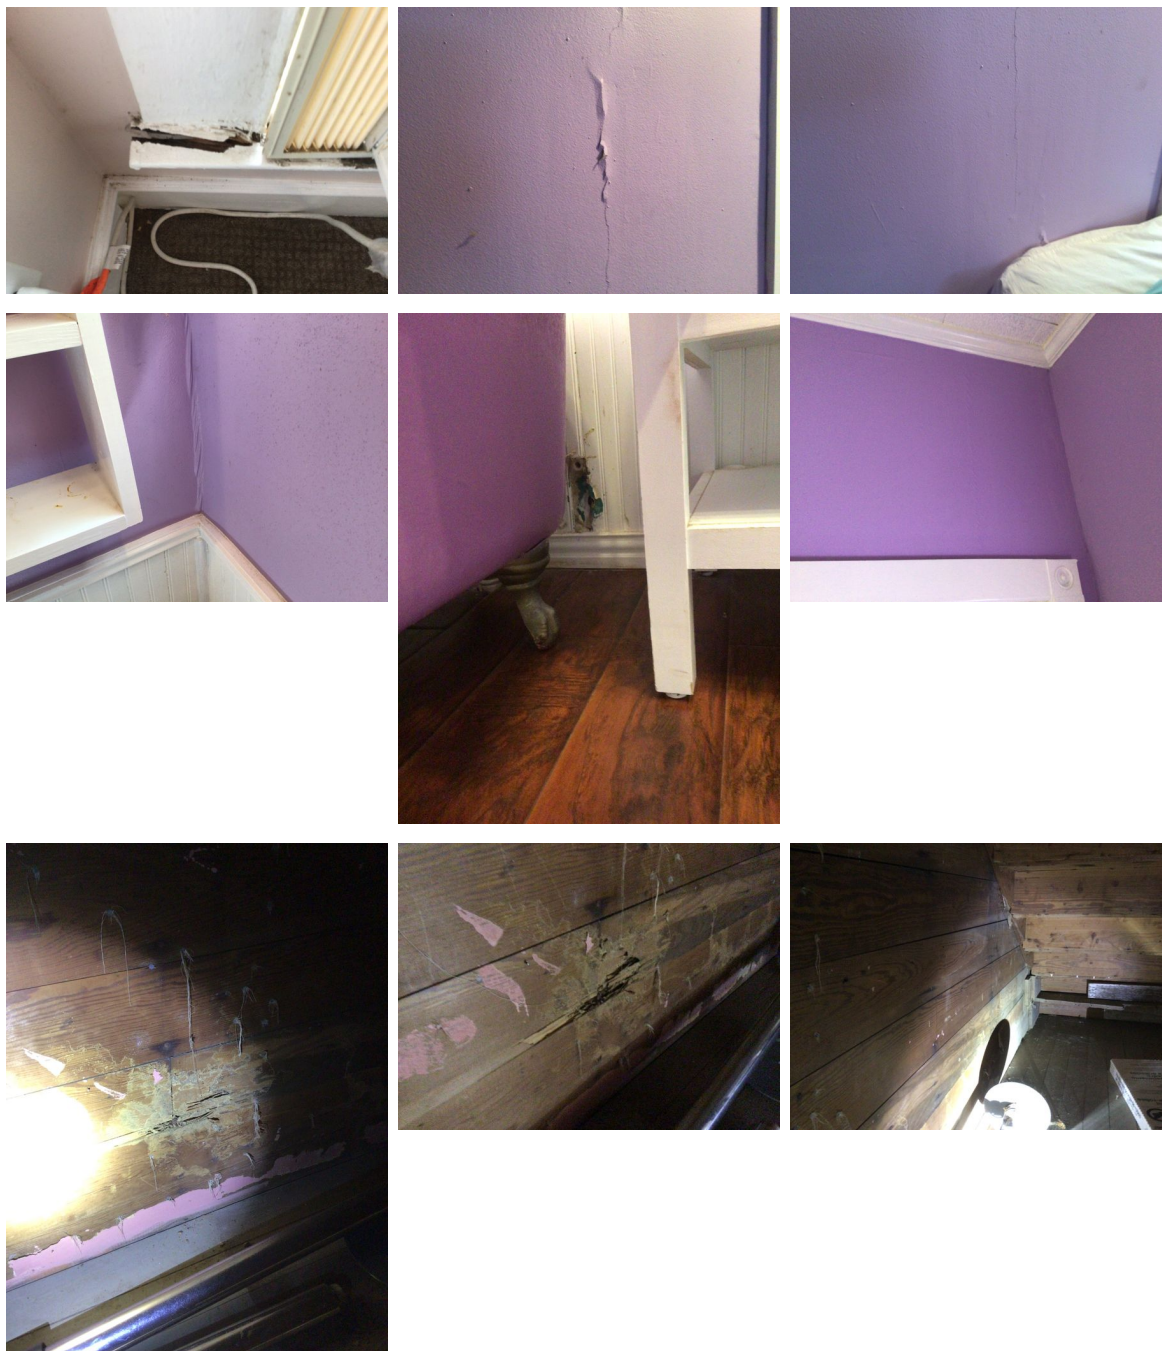
Inspector observed multiple issues with the interior walls/trim inside the property including but not limited to cracking, deteriorated paint, damaged areas, and bubbling paint. Recommend evaluation and correction by qualified contractor.

Recommendation: Contact a qualified professional.

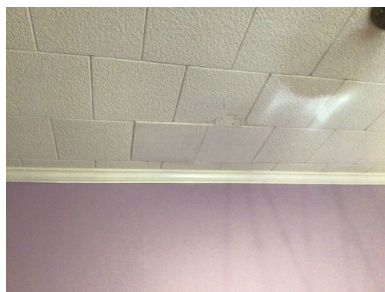
A patched ceiling area was observed at the above stated location at the time of the inspection. Recommend you consult with seller to try and determine any previous issues at this location. Thermal imaging and inspection of this area did not reveal any active issues at the time of inspection. Recommend cosmetic repair as desired, and further monitoring of this location.

Recommendation: Contact a qualified professional.

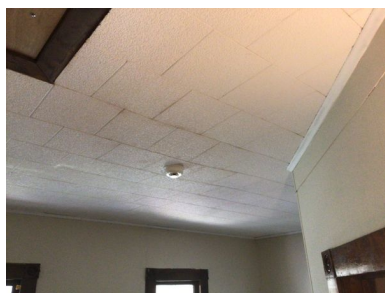
**3: Ceiling: Sagging Drywall**

Ceiling drywall sagged visibly at the time of the inspection. The exact cause was not determined, but this condition is typically caused by prior moisture damage. Further evaluation is recommended.

Recommendation: Contact a qualified professional.

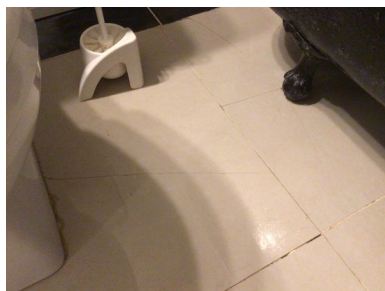
Floor tiles are cracked or chipped at various locations. Recommend you budget for repair or replacement as desired.

Recommendation: Contact a qualified flooring contractor

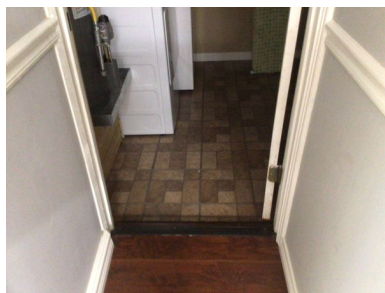
**6: Flooring: Flooring is Sloped**

The flooring is noticeably sloped. This is common in aged, multi story structures and may be due to flooring installation, loosening of floor joists, typical settlement or an as built condition. See additional comments on foundation performance and other areas for additional detail if any.

Recommendation: Contact a qualified professional.

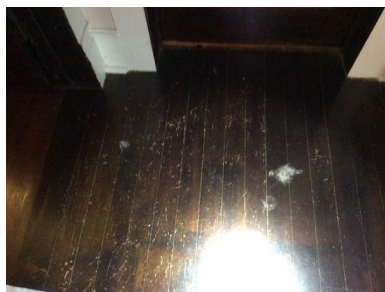
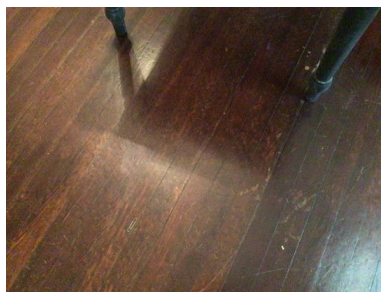
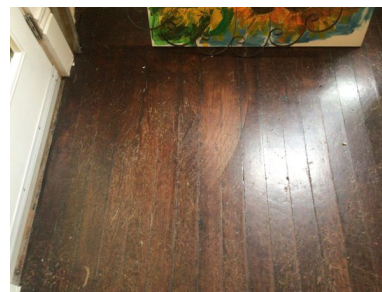
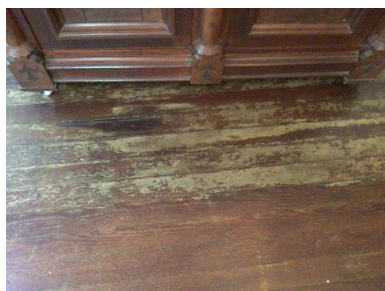
**9: Floors - Surface Damage**

Some areas of the flooring covering was observed having surface damage. Some of the top coat gloss is in need of repair or refinished. Recommend a qualified person to further evaluate and repair as needed.

Recommendation: Contact a qualified professional.

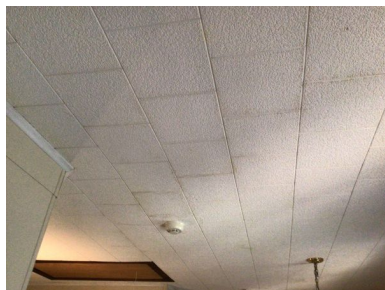
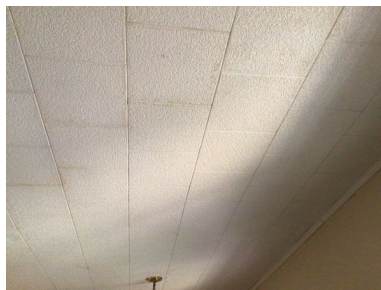
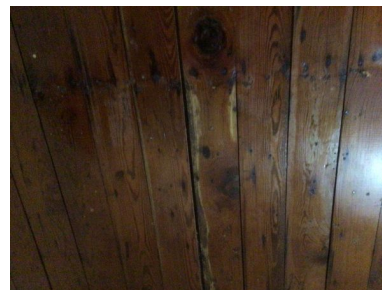
**10: Ceiling stains**

Inspector observed multiple areas where it appeared the ceiling was stained at the time of inspection. Recommend evaluation and correction.

Recommendation: Contact a qualified professional.

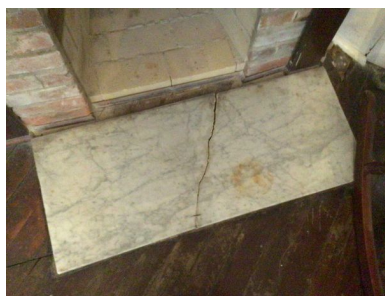
**11: Cracked tile hearth**

Inspector observed what appeared to be a decorative tile hearth to be cracked at the time of inspection. Recommend evaluation and correction if desired.

Recommendation: Contact a qualified professional.

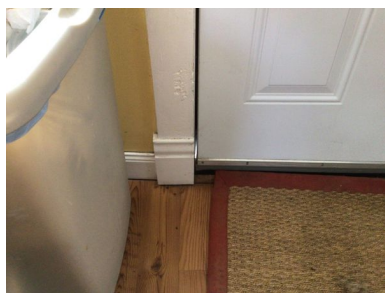
Multiple exterior doors showed damage or were missing its weatherstripping. Recommend installation or repair of standard weatherstripping to prevent energy loss and/or moisture intrusion.

Recommendation: Contact a qualified professional.

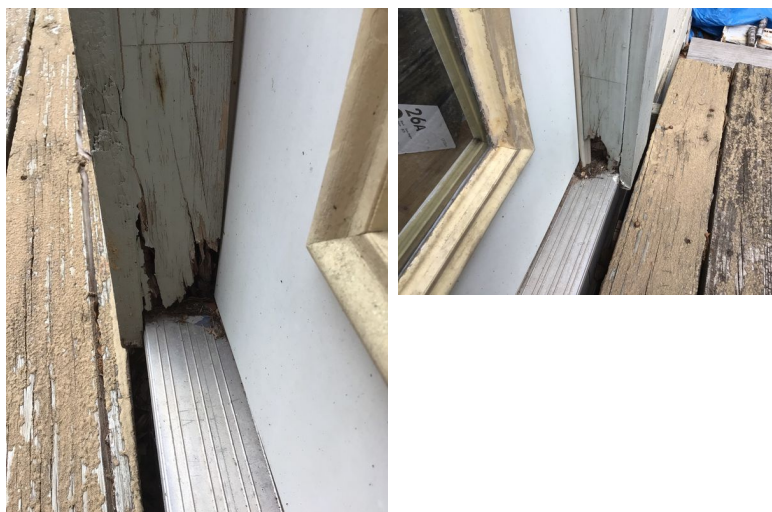
**2: Exterior Door: Wood Rot at Base of Door**

The inspector observed wood rot at the base of one or more exterior doors. Remedy as needed.

Recommendation: Contact a handyman or DIY project

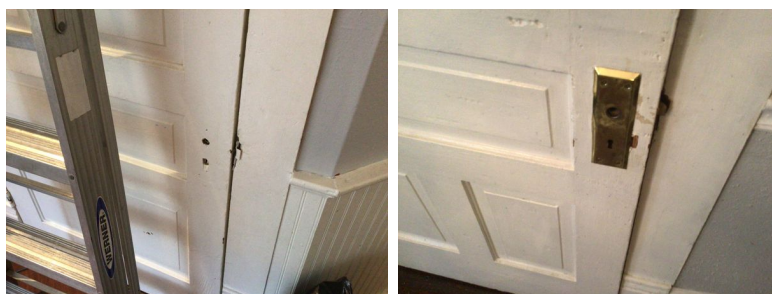
**4: Interior Door Hardware: Missing Handle**

The hardware for one or more doors around the home was loose. Repair as needed.

Recommendation: Contact a qualified professional.

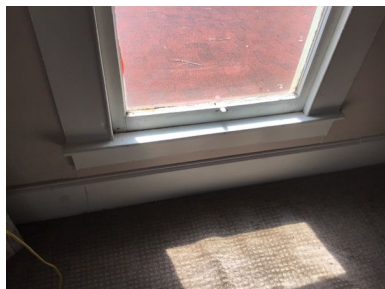
Window sill height for the upstairs windows were below 24 inches. Modern codes do not permit this window height as it can be a potential hazard for small children when windows are opened. Recommend safety locks or guarding be placed so that a child cannot open it more than 4 inches.

Recommendation: Contact a handyman or DIY project

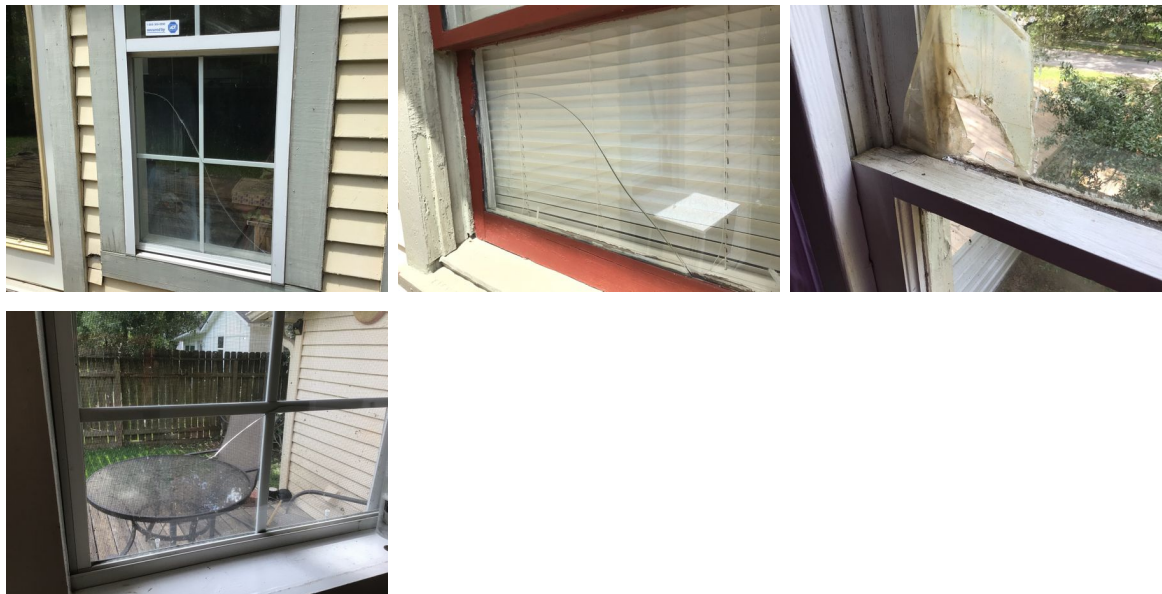
The inspector observed sections of the window glass to be cracked at above stated locations. Recommend budgeting for replacement of these glass panes to avoid a potential hazard.

Recommendation: Contact a qualified window repair/installation contractor.

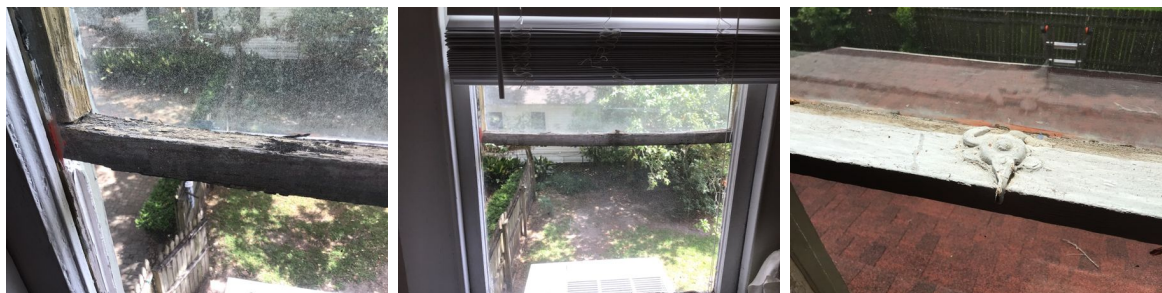
## 3: Aged windows

Several of the windows on the home are the original units. Multiple windows were observed to be difficult to operate or lock and are in need of proper repair and maintenance to avoid further issues. Recommend further evaluation of all locations and proper maintenance as needed. Recommend you consider replacement if remodeling is going to be undertaken.

Recommendation: Contact a qualified window repair/installation contractor.

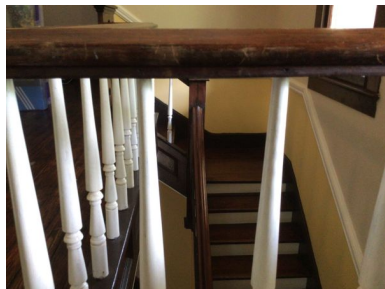
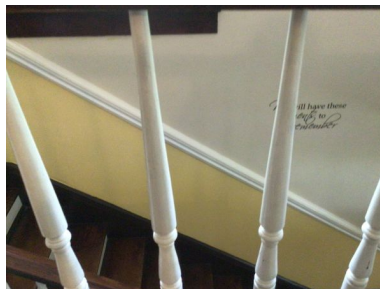
**1: Baluster: Greater Than 4 inches**

Baluster spacing is greater than 4 inches. While this may have not been an issue when the home was constructed, modern building codes require that the space between balusters not be greater than 4 inches. **Recommend caution and considering repair to prevent injury to small children and pets.**

Recommendation: Contact a qualified carpenter.

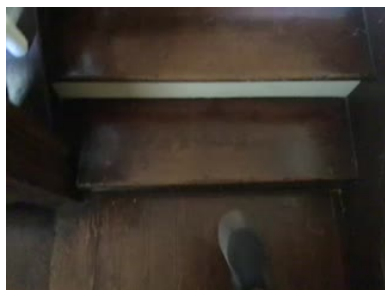
**2: Loose stair tread**

Inspector observed what appeared to be one of the stair treads to be loose at the time of inspection. Recommend evaluation and correction.

Recommendation: Contact a qualified professional.

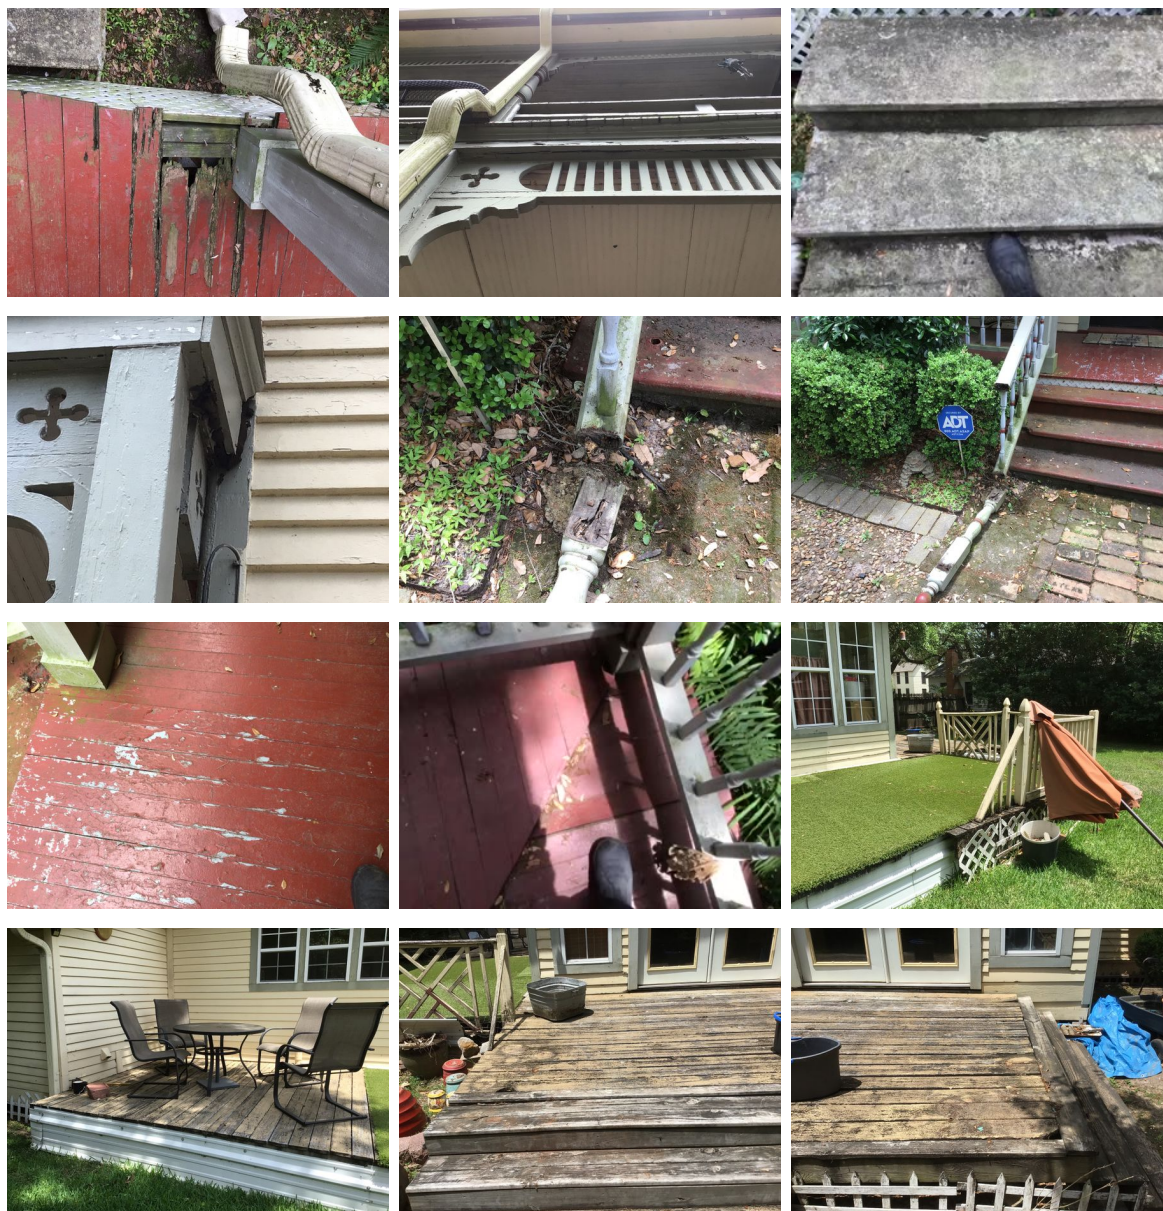
Inspector observed multiple issues with the porch/balcony areas including but not limited to decking rot, wood destroying insect damage, guard rails/handrails not meeting modern building standards, and deteriorated finish. Recommend evaluation and correction by qualified contractor to determine the extent of repairs necessary.

Recommendation: Contact a qualified professional.

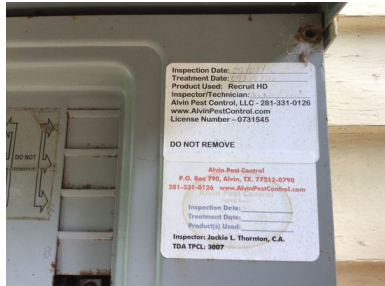
Note: A previous subterranean termite treatment has been performed on this property as indicated by the drill holes observed in the concrete around the foundation. Recommend you consult with the seller to try and obtain information on the extent of repairs and possible **warranty**.

Recommendation: Contact the seller for more info

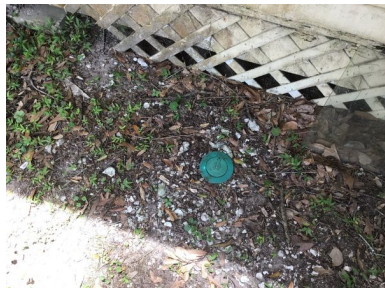
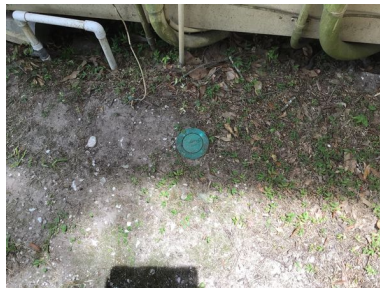
**2: Subterranean termite monitoring stations**

Inspector observed termite monitoring stations around the perimeter of the foundation. Recommend consulting with the seller regarding these items to determine why the system was installed and if the system is currently being monitored or is under warranty. Recommend consulting with a qualified pest control to evaluate the system or removal as desired.

Recommendation: Contact the seller for more info

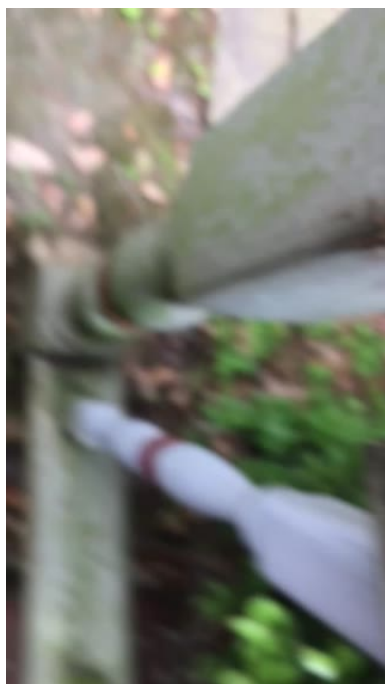
**3: Active termite infestation**

Inspector observed what appeared to be an active termite infestation in the front porch stairway handle at the time of inspection. Recommend evaluation and correction by qualified pest control company to determine the extent of repairs necessary.

Recommendation: Contact a qualified professional.

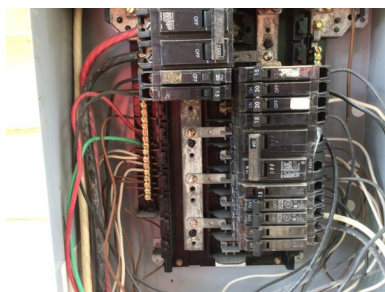
**1: Arc-Fault Safety Protection Missing**

Arc-fault safety protection was not installed for *all currently* required 15 and 20 amp circuits. While this protection may not have been required when this property was built, recommend you consider upgrading to satisfy modern code requirements and for safety reasons.

**Note:** This protection was required by the National Electric Code for homes built after 2008. The Texas Real Estate Commission recognizes that the building codes have not always required AFCIs, however the agency believes that it is important for consumers to be made aware of these safety devices when they are not present and functioning in a home as a consumer protection issue, and requires inspectors to comment regardless of the homes age.

Recommendation: Contact a qualified electrical contractor.

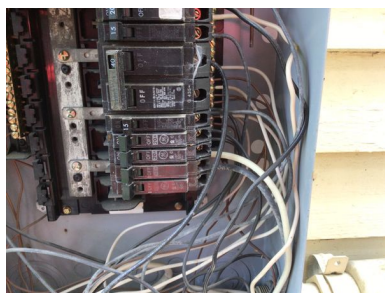
**2: White Wires not Marked**

White wires were observed connected to breakers. White wires are typically neutral but when they are connected to a breaker they become hot/live and should be marked as such. Recommend to have an electrician evaluate for remedy.

Recommendation: Contact a qualified professional.

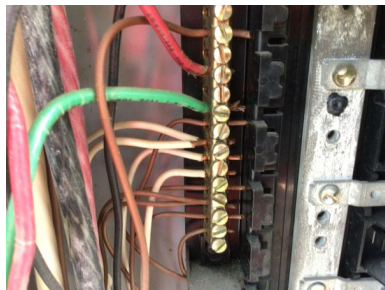
**3: Double Lugged Neutral Wires**

Double lugged neutral wires were on the neutral bus bar inside the distribution panel. While this may have not been a requirement when the home was built, One neutral wire per lug is recommended. Remedy as needed.

Recommendation: Contact a qualified electrical contractor.

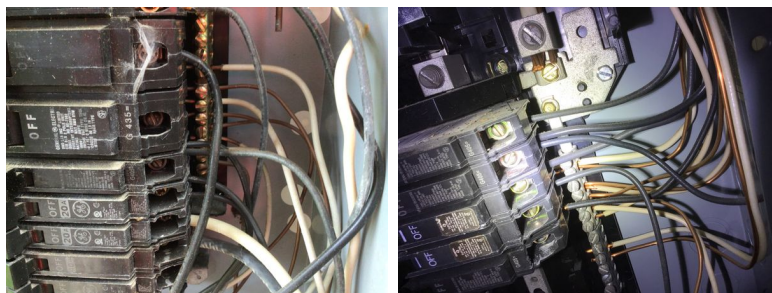
Two or more wires are attached to a single breaker. Most terminals are not designed for two wires, and is a poor installation practice. Further evaluation by an electrical contractor is recommended.

Recommendation: Contact a qualified electrical contractor.

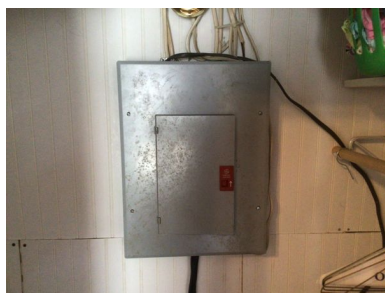
**8: Improper Location**

Modern building practices do not allow electrical panels to be installed in areas such as clothes closets, bathrooms, pantries, or areas in which they are exposed to physical damage. Additionally shelves should not be installed in front of the panel that would prevent proper opening of the panel.

Recommendation: Contact a qualified electrical contractor.

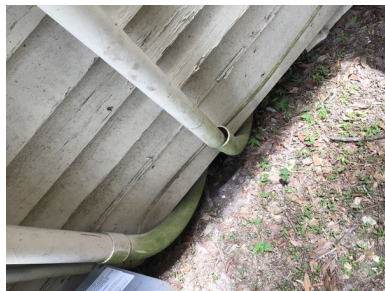
**9: Gap in Conduit**

There was a gap in the conduit under the service meter. Evaluation and/or remediation by a licensed electrician is recommended.

Recommendation: Contact a qualified electrical contractor.

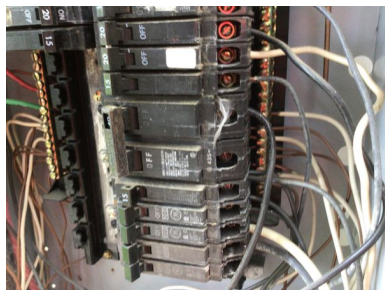
**10: Undersized Conductors**

One or more conductors appear to be undersized for the breakers that they are attached to. Evaluation by a licensed electrician is recommended.

Recommendation: Contact a qualified electrical contractor.

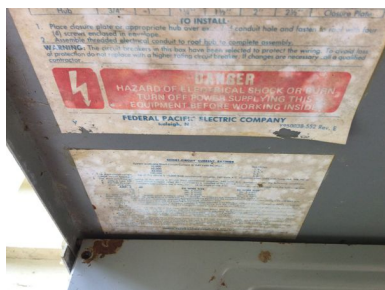
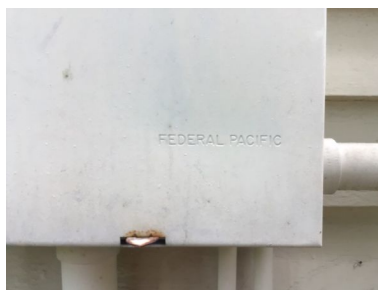
**11: FPE (Federal Pacific Equipment) panel**

The panel for this property is a brand called Federal Pacific Equipment or FPE. This panel brand has been proven to fail in overcurrent situation, and presents a potential fire hazard. I recommend you budget for replacement of this panel to avoid potential hazard. Consult with a qualified electrician to evaluate further.

Recommendation: Contact a qualified electrical contractor.

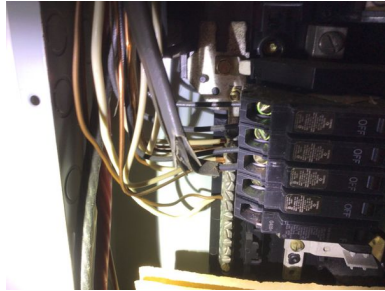
Inspector observed multiple wires with the plastic sheathing appeared to have been damaged or weathered at the time of inspection. Recommend evaluation and correction.

Recommendation: Contact a qualified professional.

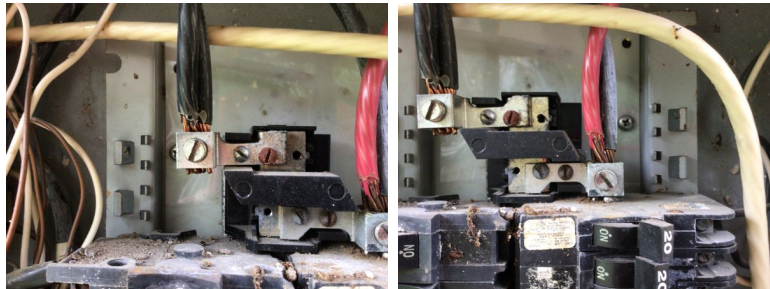
**15: Double lugged supply**

Inspector observed what appeared to be supply wires that were double lugged at the time of inspection. Recommend evaluation and correction by qualified electrical contractor to determine the extent of repairs necessary.

Recommendation: Contact a qualified professional.

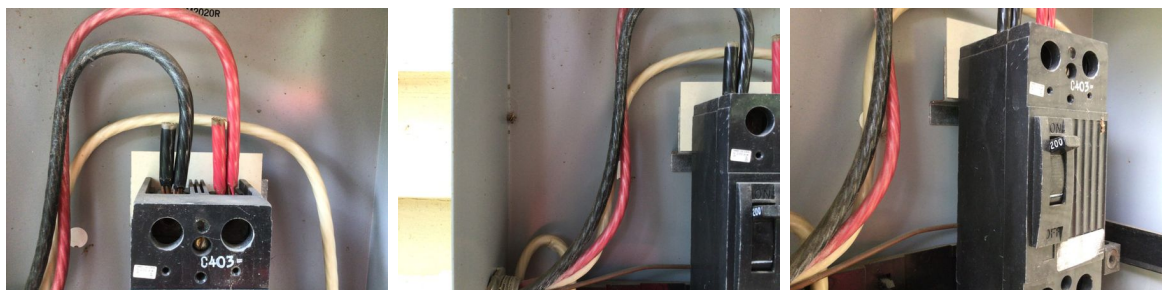
**16: Undersized service wires**

Inspector observed what appeared to be undersized service wires at the time of inspection. Recommend evaluation and correction by qualified electrical contractor to determine the extent of repairs necessary.

Recommendation: Contact a qualified professional.

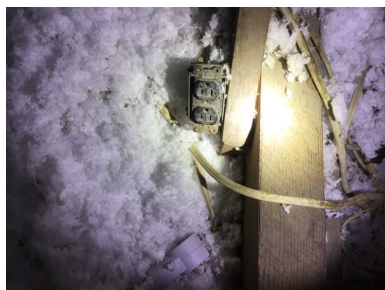
**1: Cover Plates:Missing**

One or more switches/receptacles are missing a cover plate. Recommend correction as needed to avoid potential hazard.

Recommendation: Contact a qualified electrical contractor.

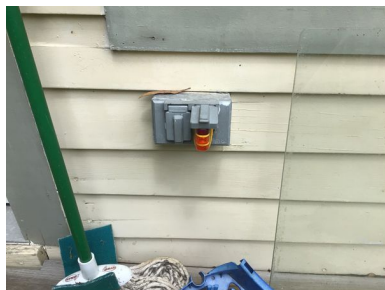
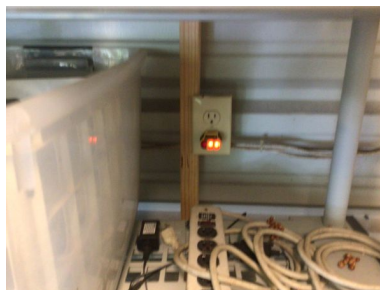
**2: Outlets: No GFCI Protection**

No GFCI protection was observed at the required locations. Repair as needed for safety purposes as all electrical outlets within 6 feet of water source should be GFCI protected.

Recommendation: Contact a qualified electrical contractor.

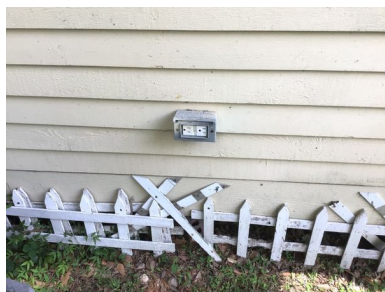
**3: Outlets: Missing Weather Cover**

All exterior outlets should have a weatherproof cover installed to prevent moisture penetration. Recommend to have an electrician evaluate for remedy.

Recommendation: Contact a qualified professional.

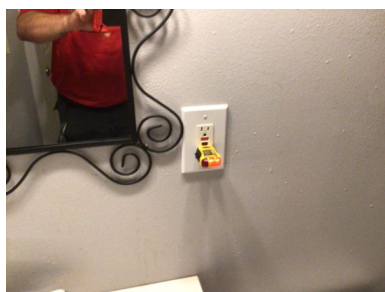
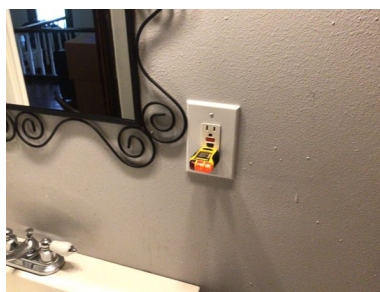
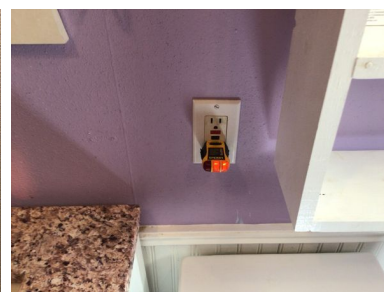
**4: Outlets: GFCI failed to trip**

One or more of the GFCI outlets installed for the home failed to trip when tested. This is indicative of an issue with the device and I recommend correction.

Recommendation: Contact a qualified electrical contractor.

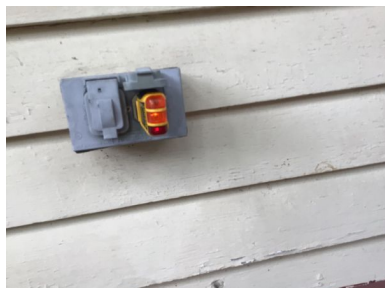
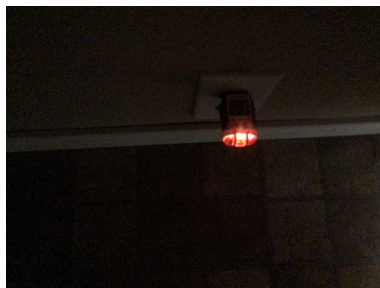
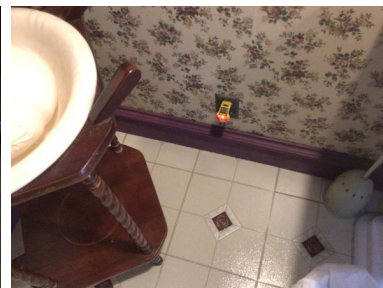
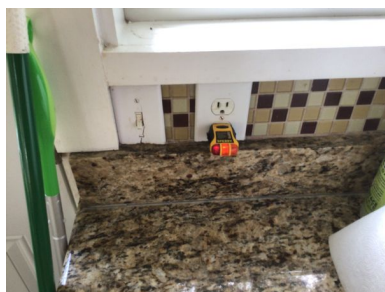
**5: Outlet: Hot / Neutral Reversed**

The hot and neutral wires are reversed on the outlet. Recommend to have an electrician evaluate and remedy.

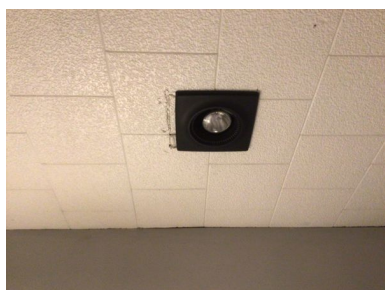
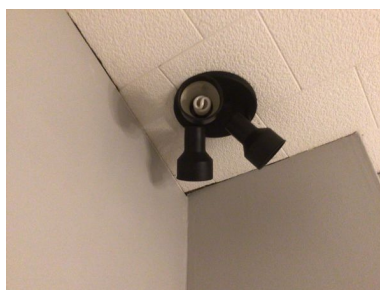
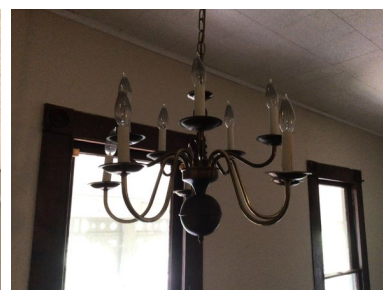
**6: Light: Inoperable**

One or more light fixtures around the home did not function, possibly bulb related. Correct as needed.

Recommendation: Contact a qualified electrical contractor.

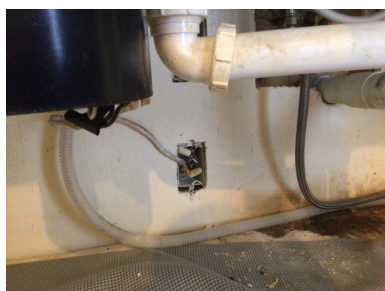
**7: Wiring: Exposed Ends & Splices**

All wire connections & charged wires with exposed ends and splices should be covered in junction boxes for safety. Recommend a qualified electrician correct.

Recommendation: Contact a qualified electrical contractor.

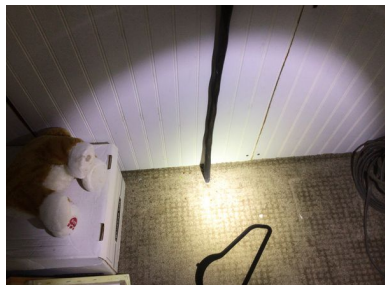
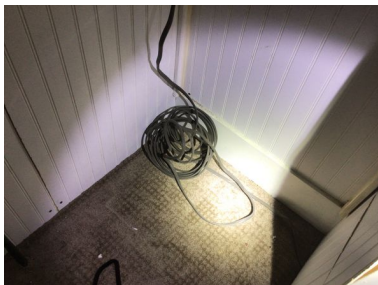
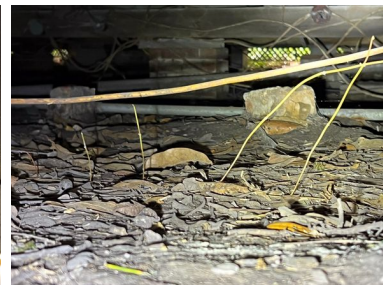
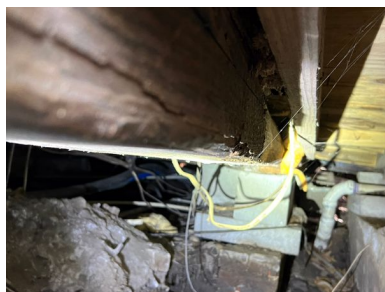
**8: Wiring: Improper Wiring**

Improper wiring was observed at the time of inspection. Recommend a licensed electrician evaluate and repair.

Recommendation: Contact a qualified electrical contractor.

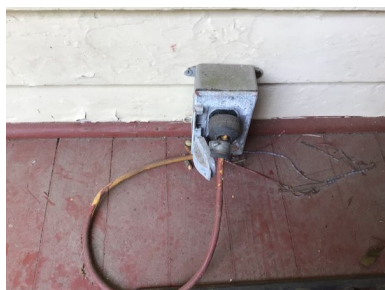
Extension cord is being used as fixed or permanent wiring for some of the circuits. Extension cord is not approved for use as fixed wiring or with permanent loads. Recommend further evaluation and correction as needed.

Recommendation: Contact a qualified electrical contractor.

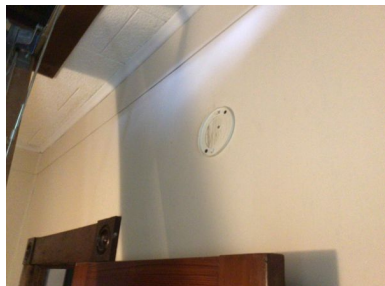
The inspector observed one or more smoke alarms missing in the home. Evaluate and replace as needed.

Recommendation: Contact a qualified professional.

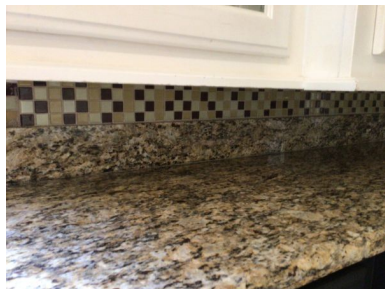
There are only two outlets observed for the kitchen countertop. Kitchen countertop receptacles should be spaced minimum 24 inches apart and also be GFCI protected. Recommend a licensed electrician to further evaluate and repair as needed.

Recommendation: Contact a qualified professional.

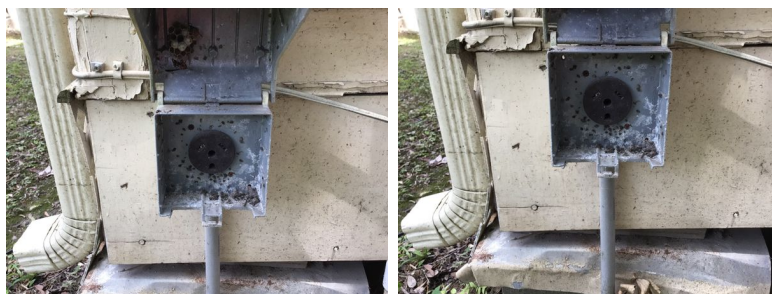
Inspector observed what appeared to be a 220 outlet on the exterior of the home to be quite dirty at the time of inspection. Recommend evaluation and correction by qualified electrical contractor.

Recommendation: Contact a qualified professional.

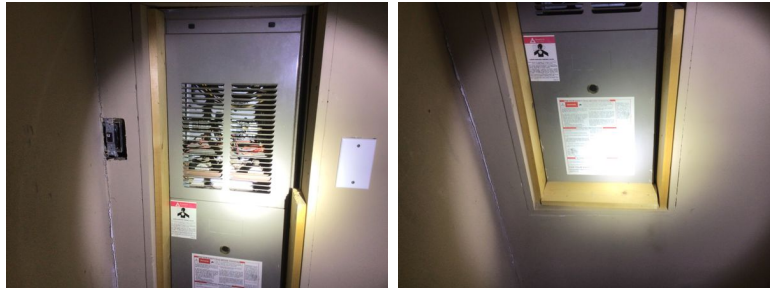
Heating element was inoperable at time of inspection. Recommend qualified HVAC professional evaluate & ensure functionality.

Recommendation: Contact a qualified HVAC professional.

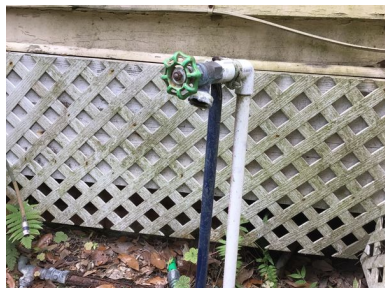
**1: Hose Bibb (outdoor faucet): Backflow Prevention Missing**

One or more hose bibb(s) Missing a backflow preventer. These devices are inexpensive, easily installed and help prevent contamination of potable water. Repair as needed.

Recommendation: Contact a handyman or DIY project

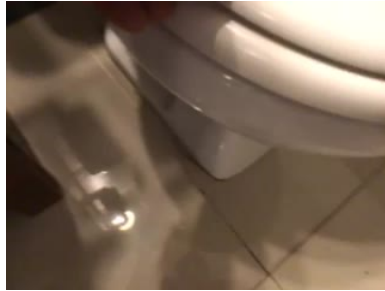
**2: Toilet: Not Secure to the Floor**

The toilet was not fastened securely to the floor. This can cause a leak in between the wax seal and the pipe. Remedy as needed.

Recommendation: Contact a qualified plumbing contractor.

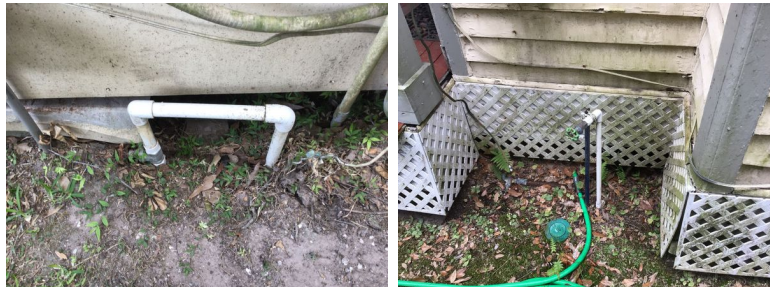
Plumbing insulation repairs were needed at the main shut off at the time of the inspection. Recommend a qualified person to repair as needed.

Recommendation: Contact a qualified professional.

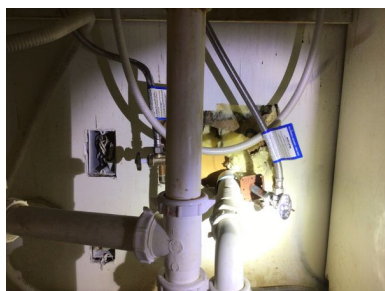
**2: Escutchen Plate Missing/ Damaged**

Wall penetration coverings under sinks were noted to be missing or damaged in one or more locations. Recommend repair to prevent pest or moisture intrusion into unwanted areas.

Recommendation: Contact a qualified professional.

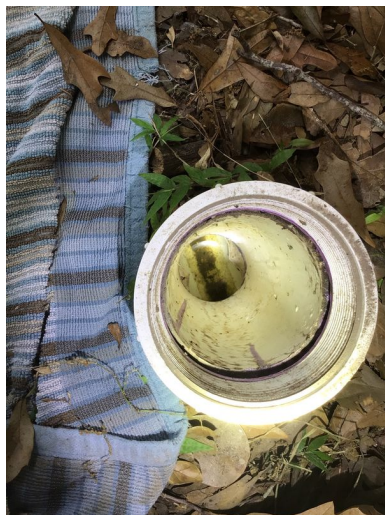
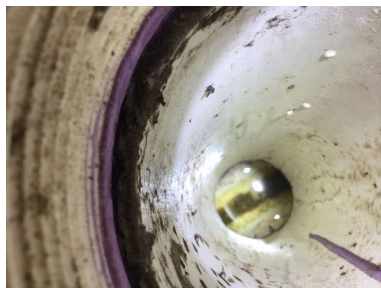
**3: Standing water in cleanout**

Inspector observed what appeared to be standing water about two or three inches deep in the clean out at the time of inspection. This indicates that there is an issue with the main drain line, as this area of the drain should not have standing water. Recommend evaluation and correction by a qualified plumbing contractor to determine the extent of repairs necessary.

Recommendation: Contact a qualified professional.

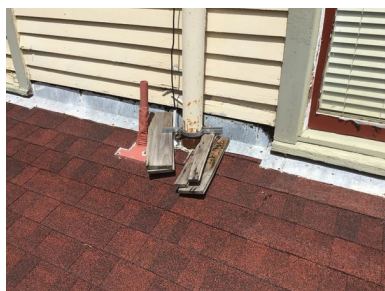
#### 4: Vent support

Inspector observed what appeared to be improper vent support on the rear of the home at the time of inspection. Recommend evaluation and correction.

Recommendation: Contact a qualified professional.

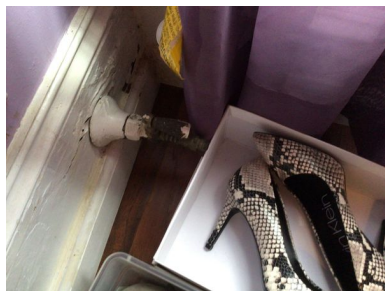
Inspector observed what appeared to be uncapped gas lines inside the property at the time of inspection. Recommend evaluation and correction.

Recommendation: Contact a qualified professional.

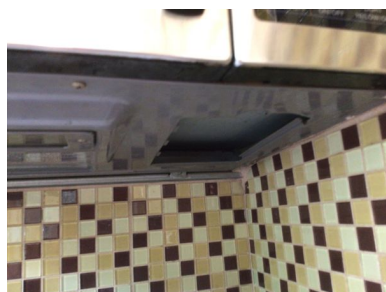
**3: Missing Filter**

Exhaust filter is missing. Remedy as needed.

Recommendation: Contact a qualified professional.

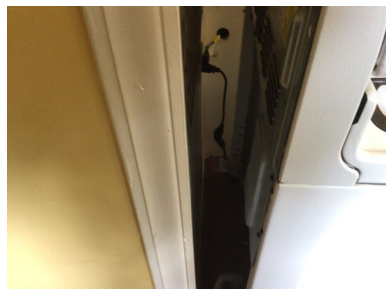
**1: Anti-Tip Device Missing**

The oven should have an anti-tip device installed for the rear legs of the cook top to prevent it from tipping over when the door is open. Repair as needed for safety purposes.

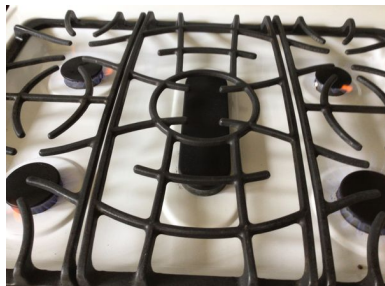
May be caused by dirty or clogged gas vents. Recommend cleaning. If not effective, evaluation and repair.

Recommendation: Contact a qualified appliance repair professional.

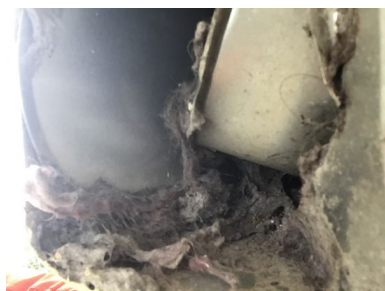
**1: Cleaning Vent Recommended**

Cleaning of the dryer vent line is recommended as normal maintenance to prevent lint build up in line.

Recommendation: Contact a qualified professional.
