PROPERTY INSPECTION REPORT

Concerning: 14426 Rosehill Estates Ln, Cypress, TX 77429
(Address or Other Identification of Inspected Property)

By: Daniel Beard, Lic #TREC #8004 07/09/2020
(Name and License Number of Inspector) (Date)

Report Identification: 20200709-01 Jerry Morton, 14426 Rosehill Estates Ln, Cypress, TX

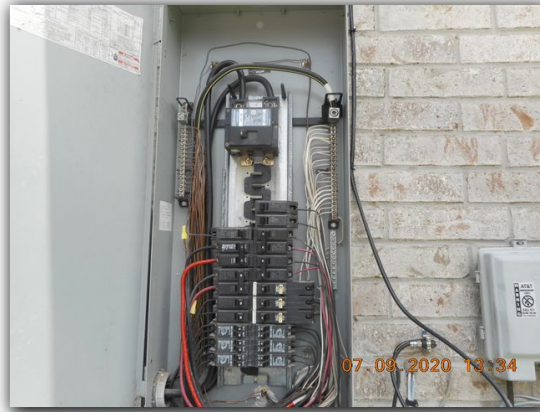
Location: West Wall

No Issues to Report. In my opinion, the inspection of this category did not appear to have any detrimental issues, obvious abnormalities or visible indications of any problems to comment on at this time during the inspection.

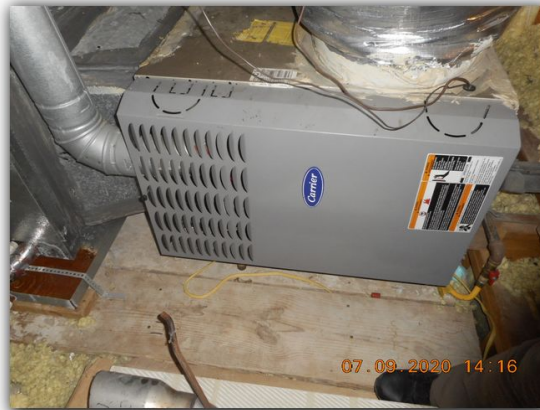
Location: Attic

No Issues to Report. In my opinion, the inspection of this category did not appear to have any detrimental issues, obvious abnormalities or visible indications of any problems to comment on at this time during the inspection.
