PROPERTY INSPECTION REPORT

Concerning: 15218 Tresch Ln., Houston, TX 77598
(Address or Other Identification of Inspected Property)

By: Randy Irwin TREC #5957 Nov 05, 2020
(Name and License Number of Inspector) (Date)

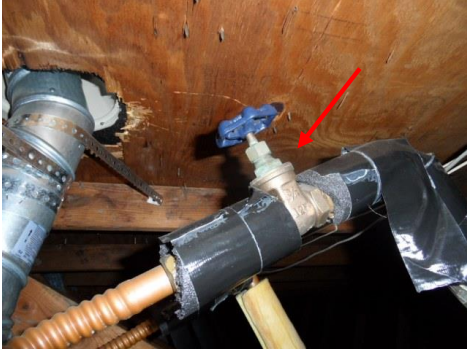
What appears to be csst type tubing was observed connecting the iron gas line to the unit, proper bonding could not be verified. (CSST) tubing is known to be controversial. You should consult with a licensed plumber and or electrician to confirm a proper installation and bonding of the tubing.

Gate valve
