Cal-Pro Home Inspections Team 5903 Barkaloo Rd., Baytown), Texas I=Inspected NI=Not Inspected NP=Not Present D=Deficient I NI NP D Tile in the was noted to be cracked/damaged.

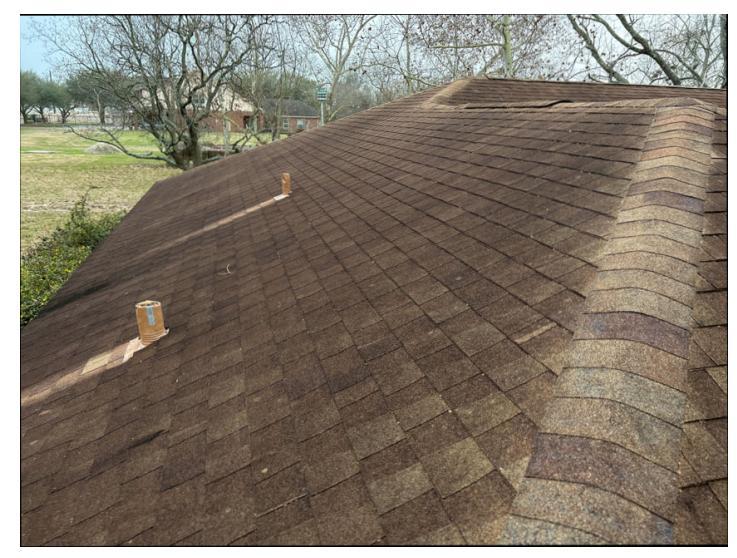
Roof Cover

Damaged roof shingles noted, repairs to the roofing are recommended. Damaged or missing roofing material should be repaired. All roof penetrations should be examined and sealed as necessary.

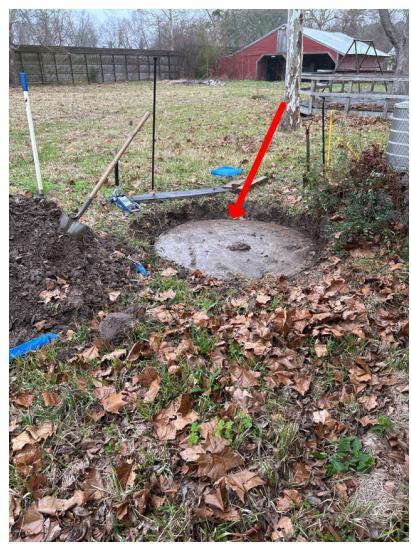
Preinspection

The Liquid level in the tank was noted to be above the drain lines in the tanks into the baffles. Recommendation is to have the tanks pumped out. Septic tank interior was not inspected.

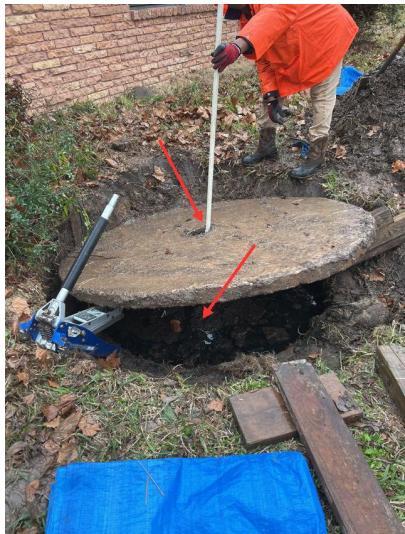
Checking the sludge level

The Liquid level in the tank was noted to be above the drain lines in the tanks into the baffles. above the drain lines in the tanks into the baffles. Recommendation is to have the tanks pumped out. Septic tank interior was not inspected.
