**Mallisa Amo
4622 Ella Blvd
Houston, TX 77018**

PROPERTY INSPECTION REPORT

Concerning: 4622 Ella Blvd, Houston, TX 77018
(Address or Other Identification of Inspected Property)

By: Robert Ramirez, Lic #10013 06/10/2019
(Name and License Number of Inspector) (Date)

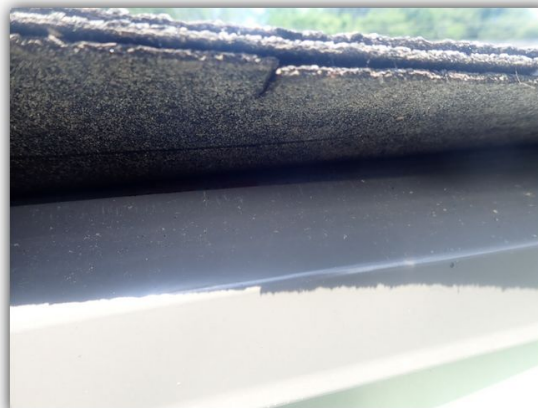
- The felt paper was observed to be installed under the lower metal drip edge flashing detail. The manufacturer installation requires the felt paper to be installed over the top of the metal drip edge flashing, in shingle like fashion, to help prevent water intrusion and/or damage to occur behind the fascia board and soffit/eave areas.

You are strongly encouraged to have a properly certified roofing contractor to physically inspect the roof, prior to the expiration of any time limitations such as option or warranty periods, to fully evaluate the condition of the roofing material. The observation made to support the rendering of this opinion are listed but not limited to the following:

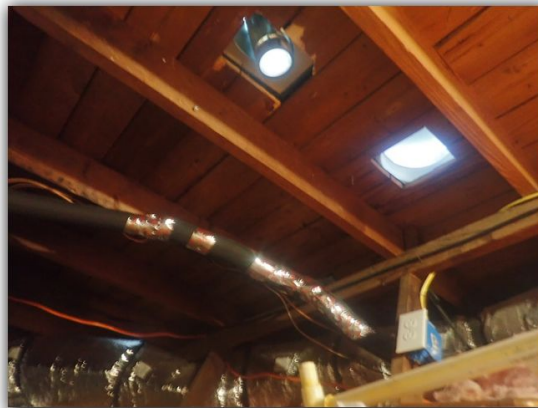
Flashing Details

Note: Recommend removing unused gas flue and flashing. This area could allow water intrusion.

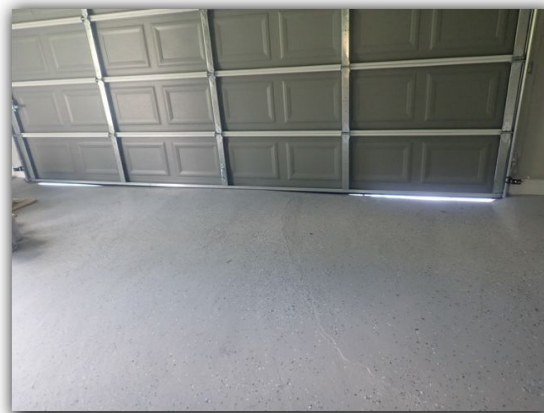
Overhead Garage Door

- The overhead garage door does not appear to fit the opening properly.

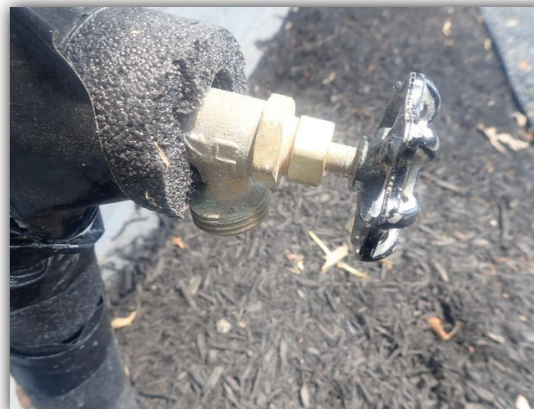
Exterior Faucets/Fixtures

- One or more of the exterior water hose bibbs (faucet) do not have a back-flow or anti-siphon device (Vacuum Breakers) in place. **Note:** *This is not uncommon to observe with a home of this age.*

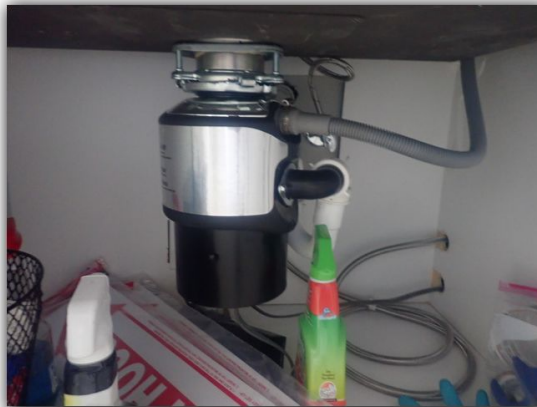
- The food waste disposer is leaking water into the cabinet area. This condition should be further evaluated and corrected as necessary.

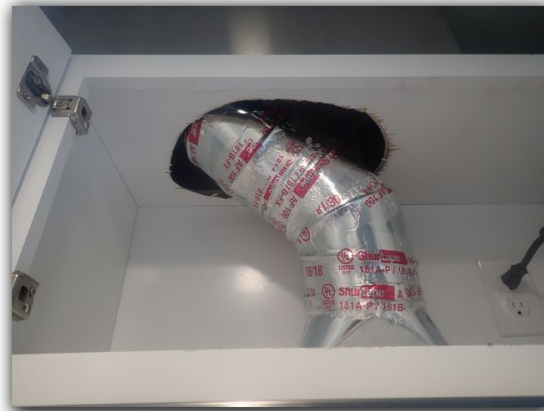
- The range exhaust vent pipe termination is not properly sealed in the cabinet.

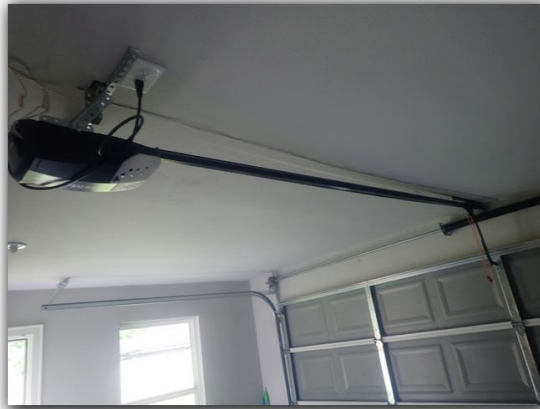
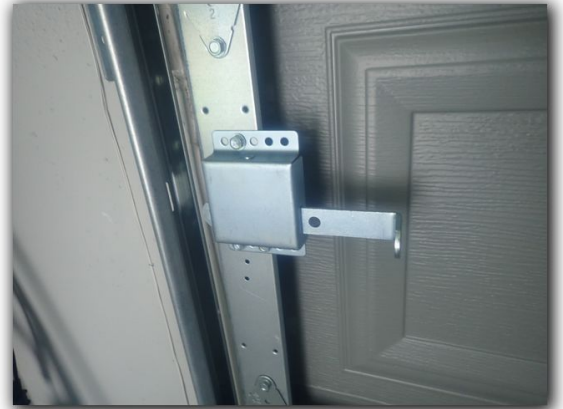
- When an automatic garage door opener is in use, the manual lock should be disabled or removed.

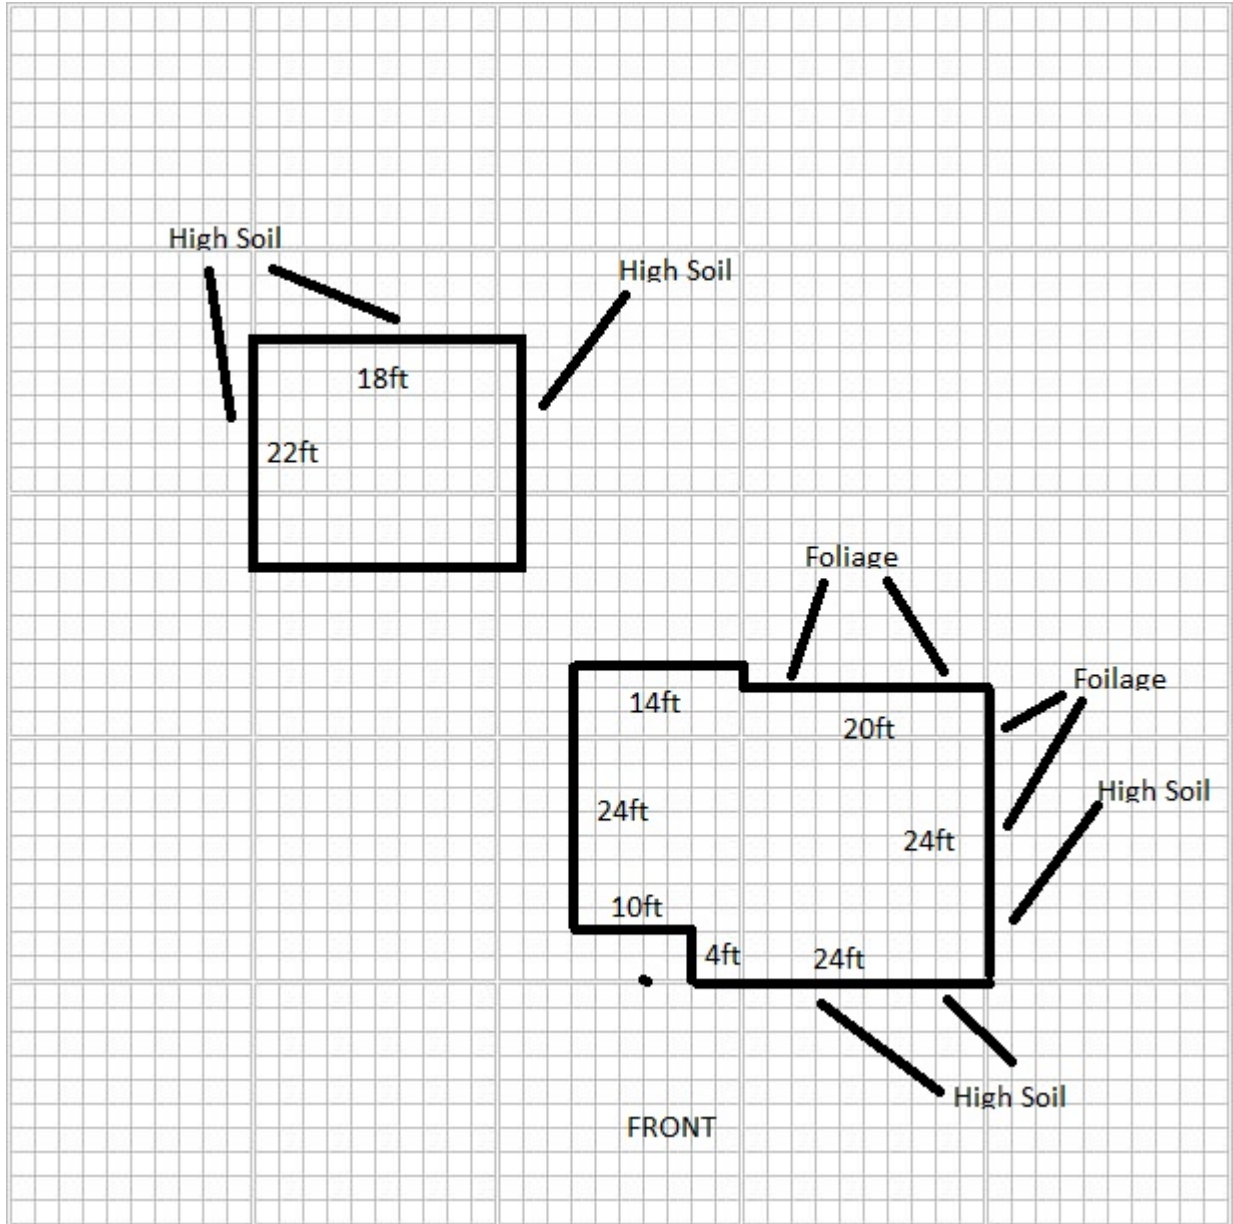
Additional Comments There is no visible evidence of active wood destroying insects found at the time of this inspection.
