FIG Services LLC d/b/a FOX INSPECTION GROUP
Property Inspection Report #190908SG-1108 Omar Street
8616 Daffodil St. Houston, TX 77063

PROPERTY INSPECTION REPORT

Concerning: 1108 Omar Street, Houston, TX 77009
(Address of Inspected Property)

By: Steven Gibson, RI #20994 09/08/2019
(Name and License Number of Inspector) (Date)

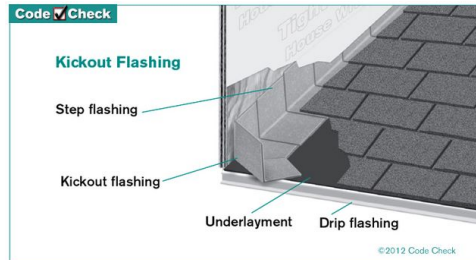
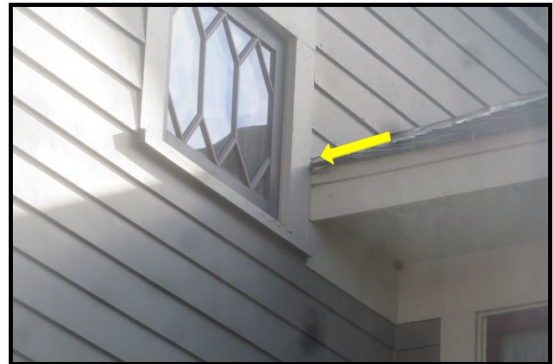
Did not observe "kick out" flashing where a roof terminates along a vertical wall. Kick out flashing encourages rain water running down roof to be diverted / "kicked out" away from vertical wall and reduce water running down vertical wall.

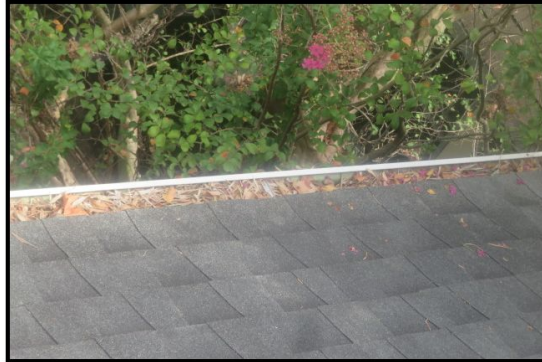
Full of debris and/or holds standing water.

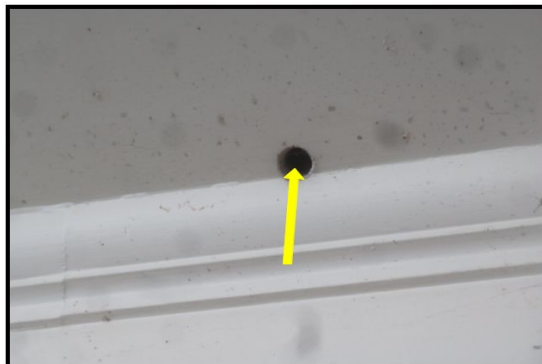
Potential rodent entry, (West exterior)

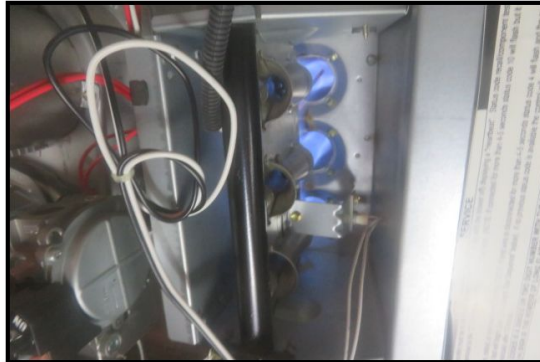
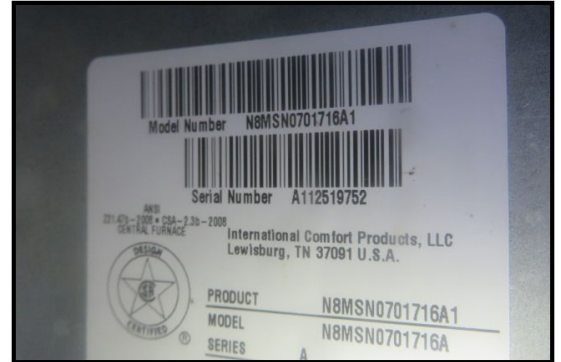
HEATING UNIT: FIRST FLOOR (2011) INTERNATIONAL COMFORT

No significant deficiencies or anomalies observed at the time of inspection.

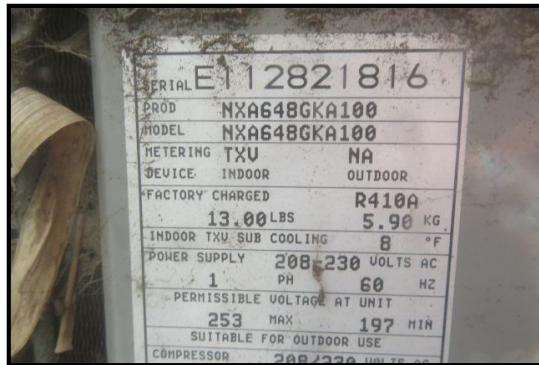
**CONDENSING UNIT: FIRST FLOOR (2011) 4 TON INTERNATIONAL COMFORT
Older unit, limited service life remaining.**

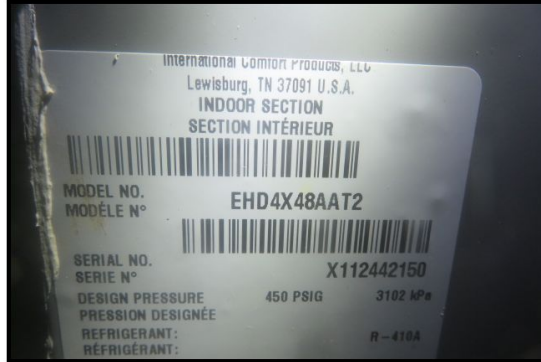
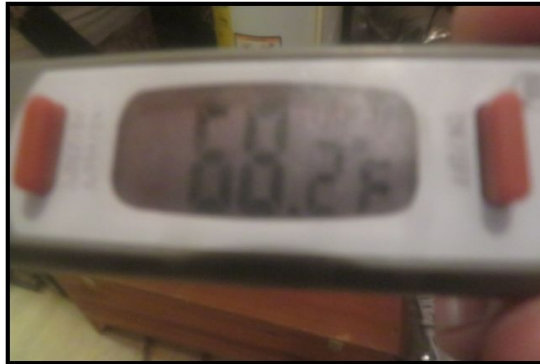
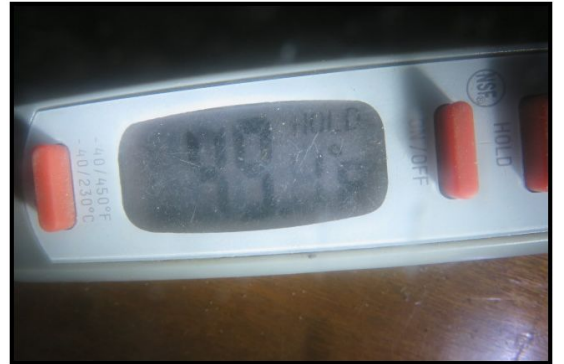
EVAPORATOR COIL: FIRST FLOOR (2011) 4 TON INTERNATIONAL COMFORT

Temperature Differential:

Return Temp: 68.2

Supply Temp: 49.1

Difference: 19.1

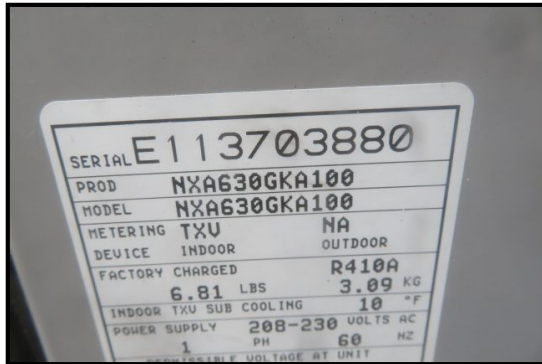
CONDENSING UNIT: SECOND FLOOR (2011) 2.5 TON INTERNATIONAL COMFORT

Older unit, limited service life remaining.

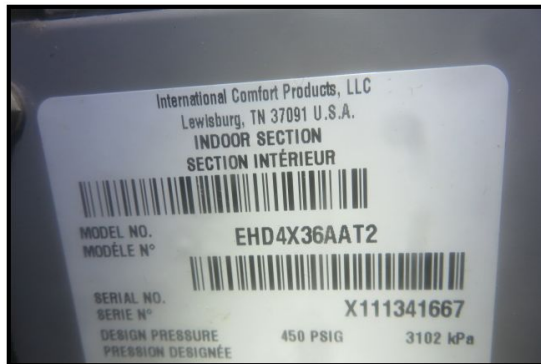
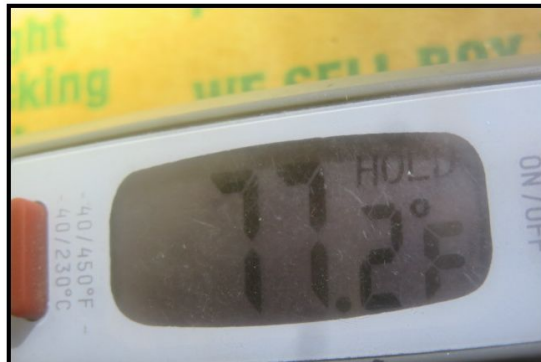
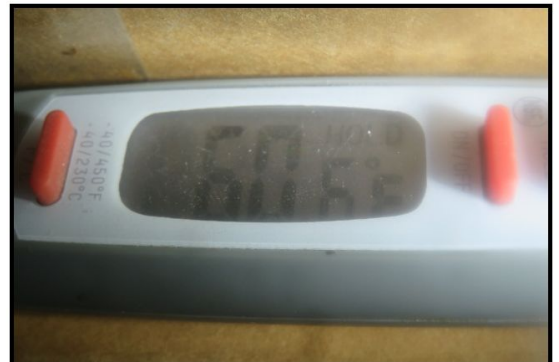
EVAPORATOR COIL: SECOND FLOOR (2011) 3 TON INTERNATIONAL COMFORT

Temperature Differential:

Return Temp: 77.2

Supply Temp: 60.6

Difference: 16.6

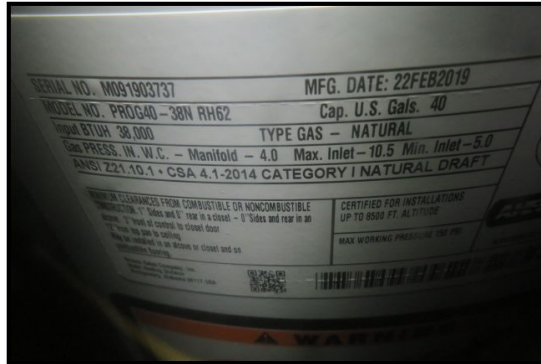
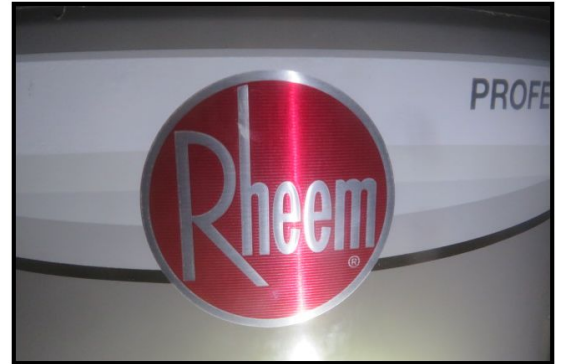
WATER HEATING UNIT(S): (2019) RHEEM

Vent pipe(s) is (are) not properly secured (strapped) in place.

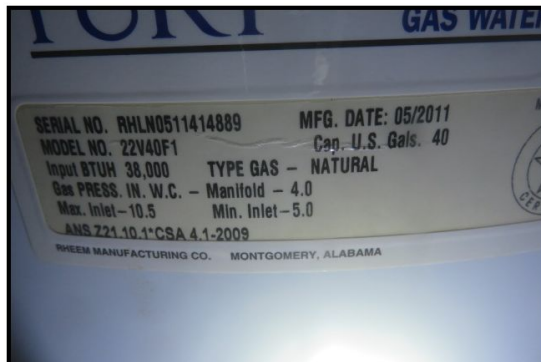
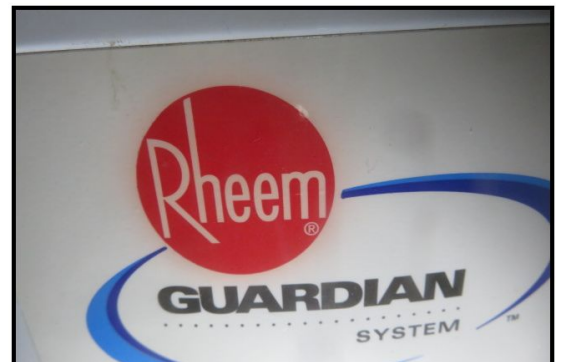
WATER HEATING UNIT(S): (2011) RHEEM

Older unit, limited service life remaining.

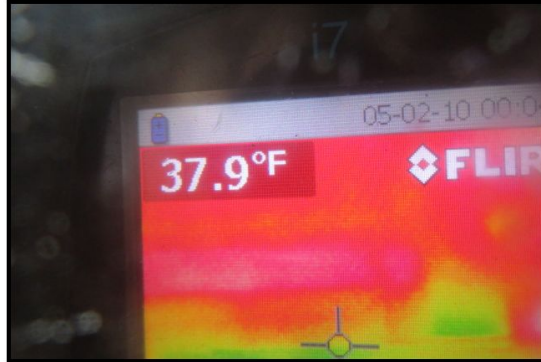
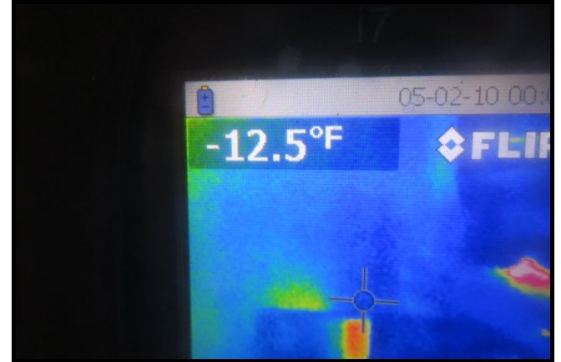
Temperature measures: Refrigerator
37.9°F Freezer_-12.5 °F

Coils are dirty, needs cleaning. Dirty coils reduce air flow thru the system and create high head pressures at the compressor, thereby unduly stressing and reducing life span of system components.
