# *Texan Inspection Services LLP*

## **Property Inspection Report**

4418 Trailwood Dr., Sugarland, TX 77479  
Inspection prepared for: Shaiju Murithottathil Belsus Mini Skaria  
Real Estate Agent: Minal Vyas - RE/MAX Fine Properties

Date of Inspection: 2/19/2019 Time: 1:00 PM  
Age of Home: 1994 Size: 2798  
Weather: Cloudy/Rain/50 Degrees  
Interested Parties Present: Buyer and Buyer's Agent  
Home Occupied: Yes  
Seller's Disclosure Provided: No

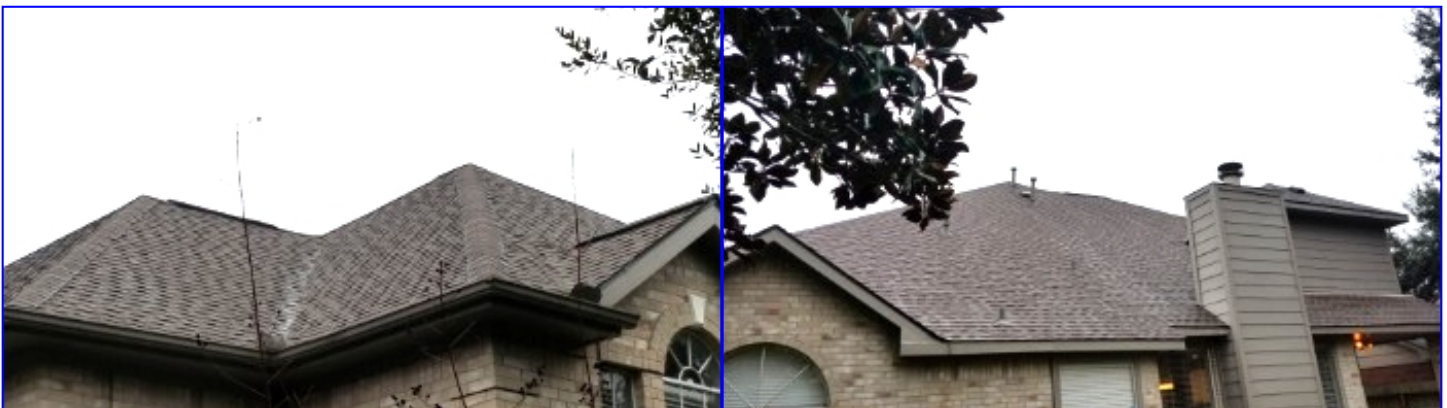
- Approximant Average Age: Appears to have been recently replaced
- Overall visual Condition:
- The visible materials installed on the roofing application appear to be performing as intended. No notable deficiencies or defects were observed at this inspection.

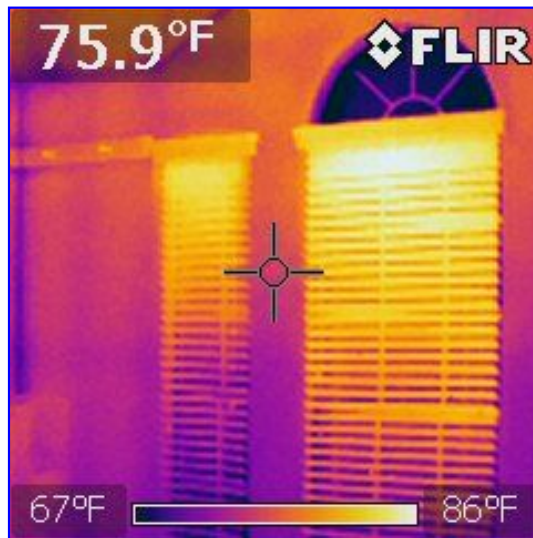
An infrared scan was performed during inspection. No deficiencies were observed at this time.

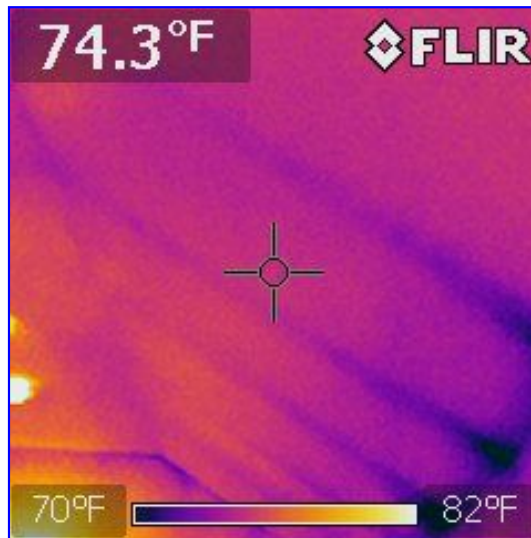
Water staining was observed in the garage. The cause/source should be determined and repairs undertaken, if necessary, to prevent further damage. Area dry at this time.

An infrared scan was performed during inspection. No deficiencies were observed at this time.

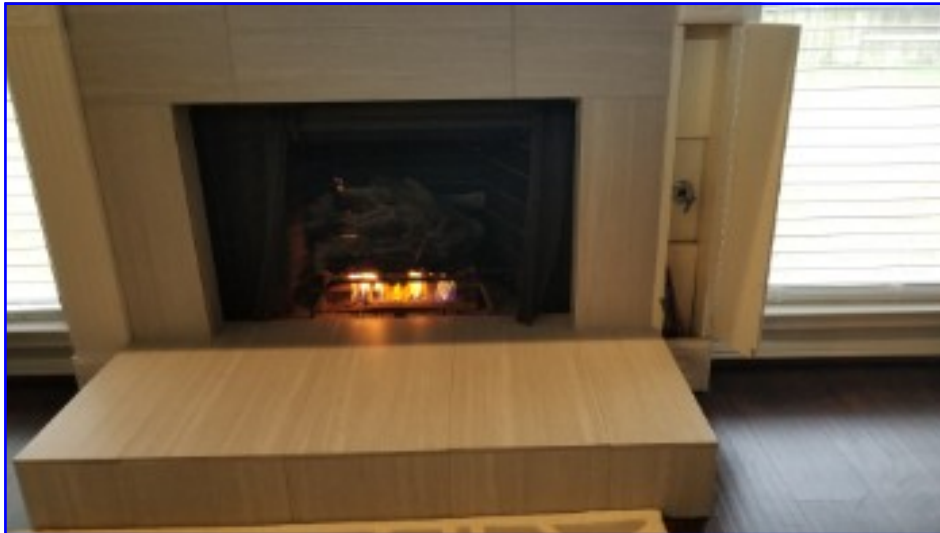
- The unit was operated and appears to be properly vented/connected to the exterior of the structure at time of inspection.

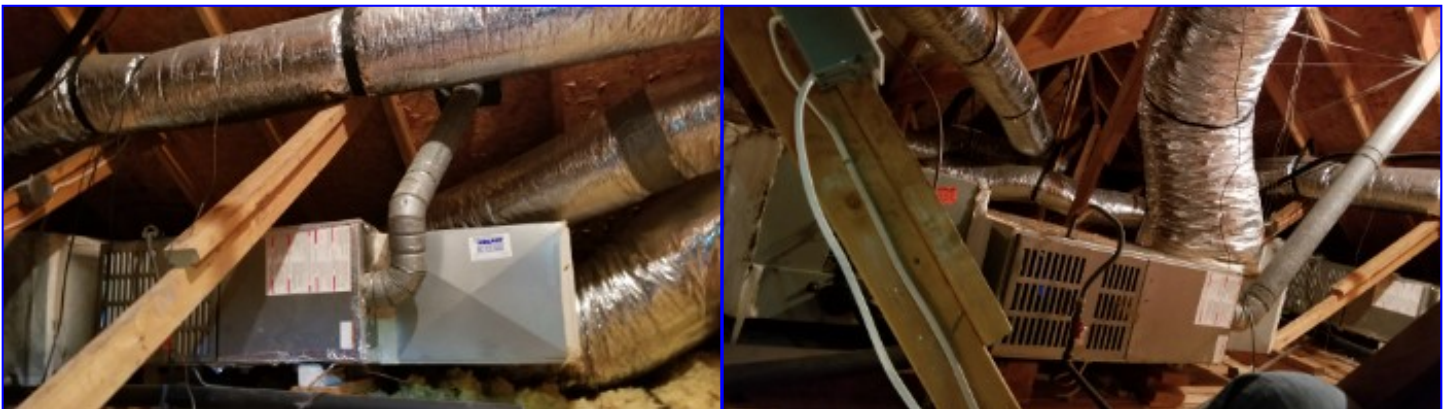
- The units operated and visually inspected for defects. The system functioned as intended and was properly vented/connected to the exterior of the structure at time of inspection.
- The systems appear to be older. They may require a higher level of maintenance, and may be more prone to major component breakdown. Predicting the frequency or time frame for repairs on any mechanical device is virtually impossible. If the system fails, or if breakdowns become chronic, replacing the entire system may be more cost-effective than continuing to undertake repairs.

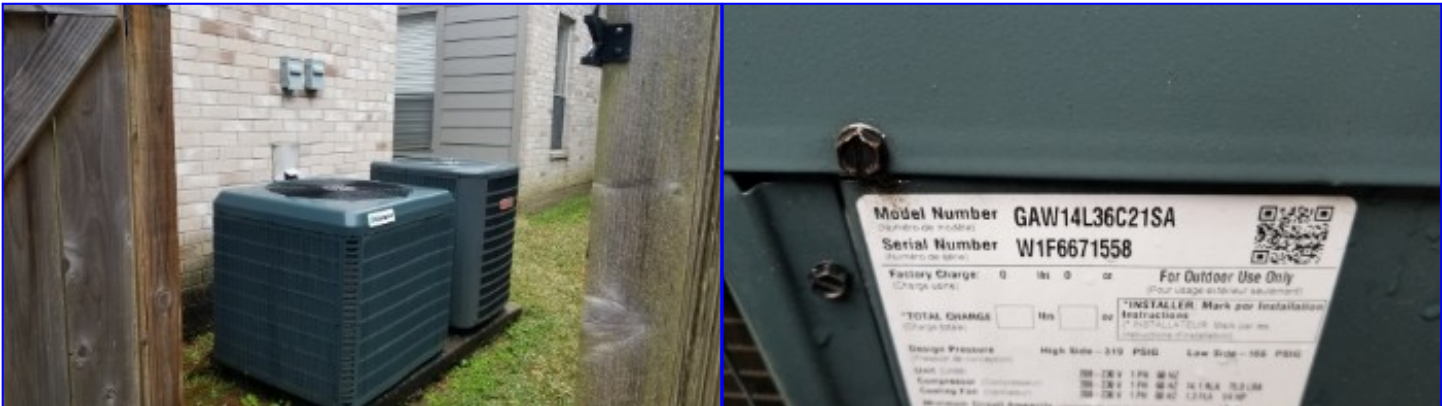
- Comments:
- The **A/C** equipment was visually inspected but not operated due to the ambient exterior temperature below 60 Degrees. Operating the equipment at these temperatures has the potential to cause damage to the unit. No deficiencies were noted at time of inspection.
  - The primary condensate drain lines are tied together. This is not an ideal installation because if the line becomes obstructed, then both units are backed up. Recommend separating lines so that each unit is served by separate drain lines.
  - Missing insulation on primary condensate lines should be repaired/replaced to prevent moisture damage to the adjacent materials.

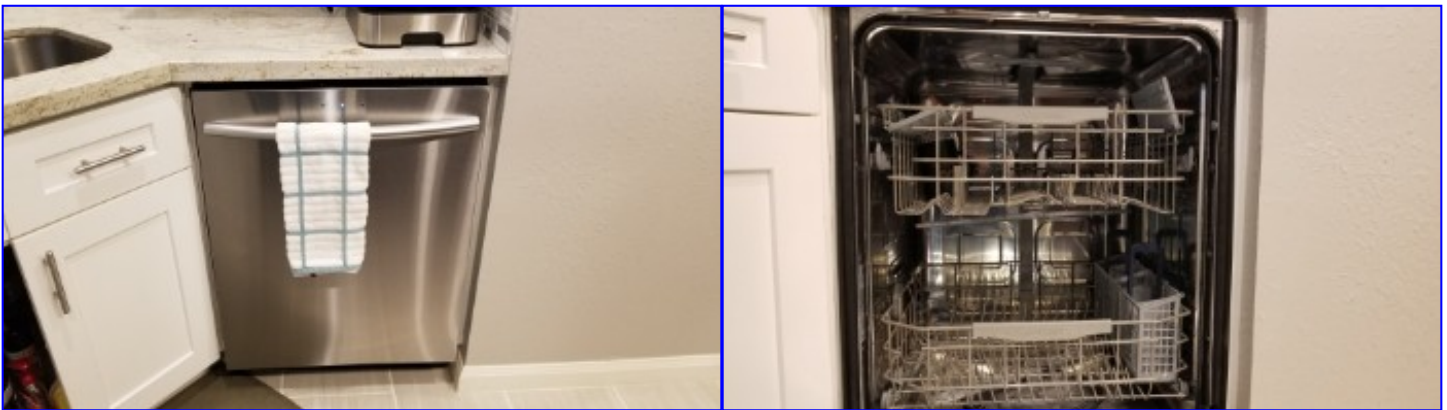
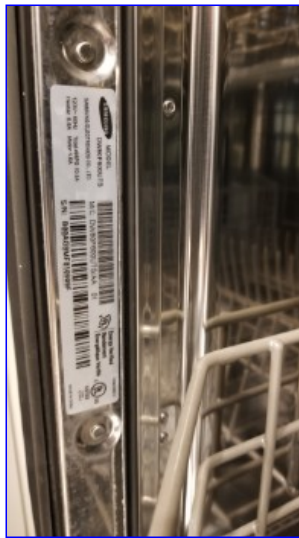
- Samsung Brand
- Dishwasher was run through a normal cycle and operated/drained properly during inspection.

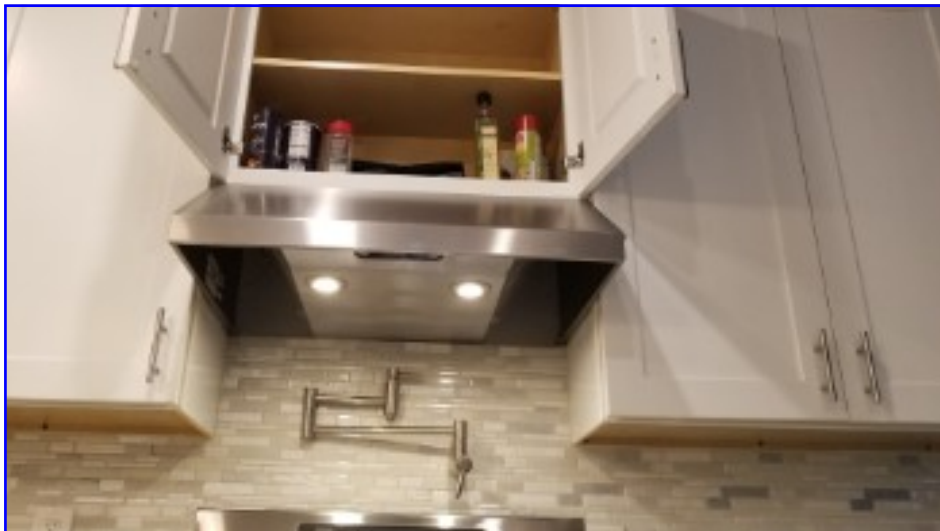
- Ducted vent to the exterior
- Note: Only the visible portions of the exhaust system is inspected for proper connectivity, installation and termination. Areas of the system concealed in or behind walls cannot be inspected.
- The vent hood was operated using all speed setting during inspection and verified connectivity to the exterior of the structure. No deficiencies observed at this time.

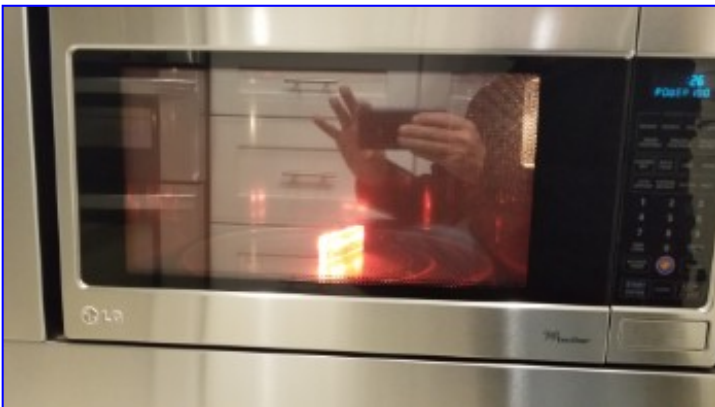
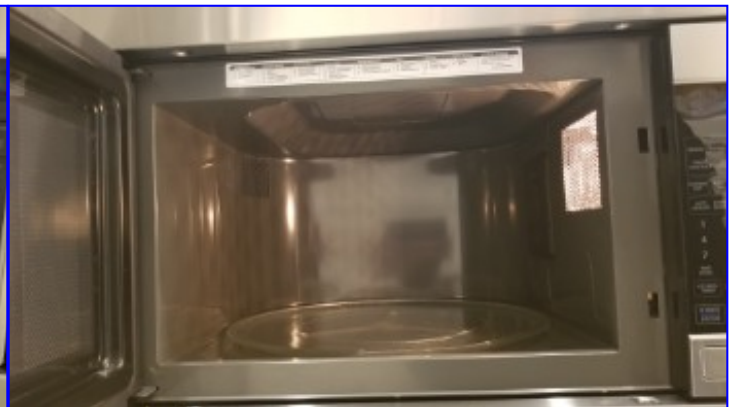
- LG Brand
- The microwave operated properly during inspection. No deficiencies were noted.

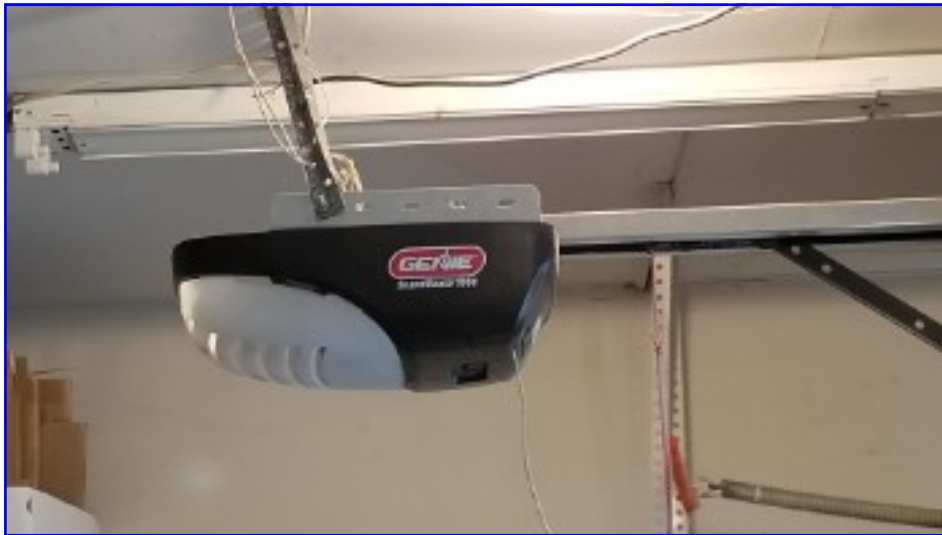
Comments:  
 • Genie Brand  
 • Manual operation of the door was performed. The unit and it's components appear to be properly installed and performing at this time.  
 • The reversing functions (photo electric sensor/resistance) for the automatic opener operated properly at time of inspection. No deficiencies noted.

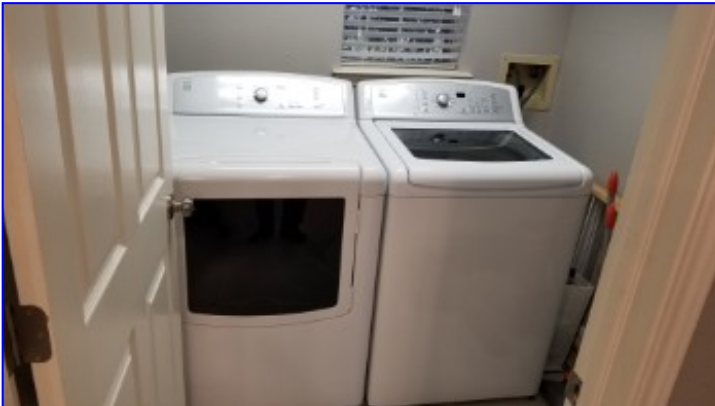
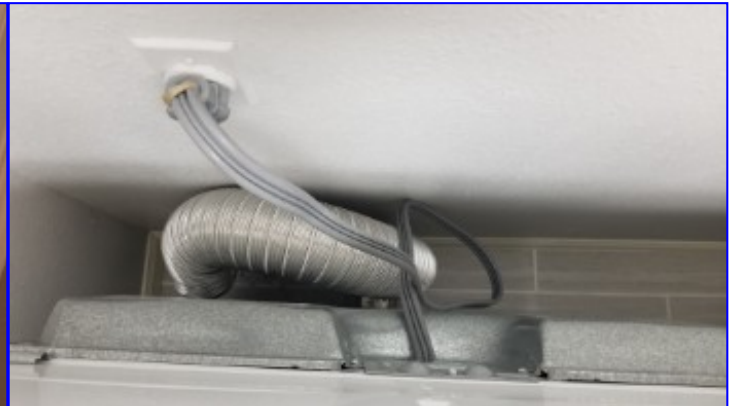
The dryer vent/ducting is not visible for inspection as the ducting is concealed behind the wall and or ceiling. Only the visible portions of the exhaust system can inspected for proper connectivity, installation and termination. Appliances are not operated, if present, to determine function.
