## PROPERTY INSPECTION REPORT FORM

Jeremy Hope <i>Name of Client</i>	05/16/2022 <i>Date of Inspection</i>
4430 Rusk Street , Houston, TX 77023 <i>Address of Inspected Property</i>	
Ron Grant <i>Name of Inspector</i>	<i>TREC License #</i>
<i>Name of Sponsor (if applicable)</i>	<i>TREC License #</i>

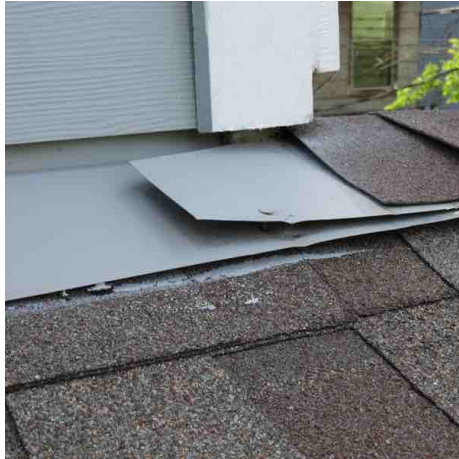
• **Flashing not sealed at several locations around the structure. Recommend repair by a qualified roofing contractor. (Throughout)**

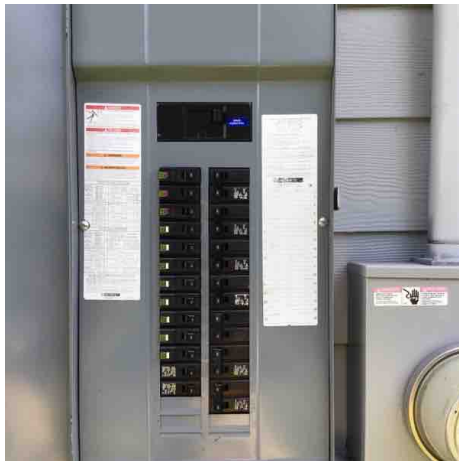
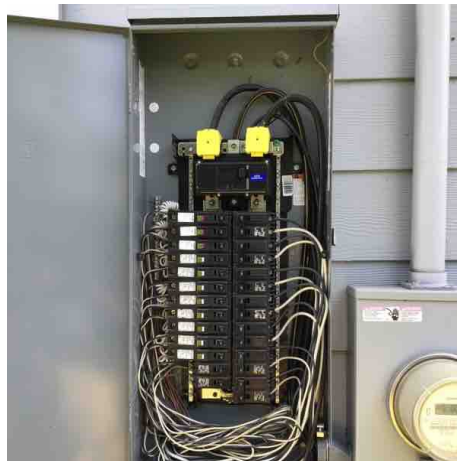
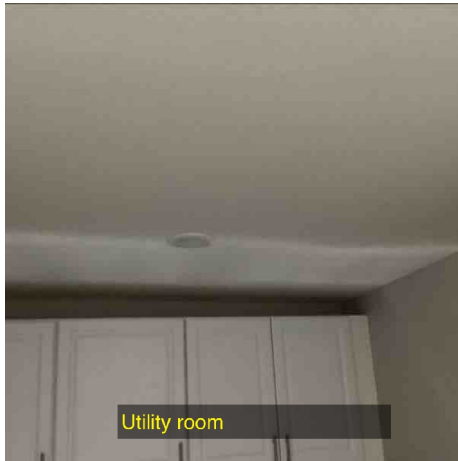
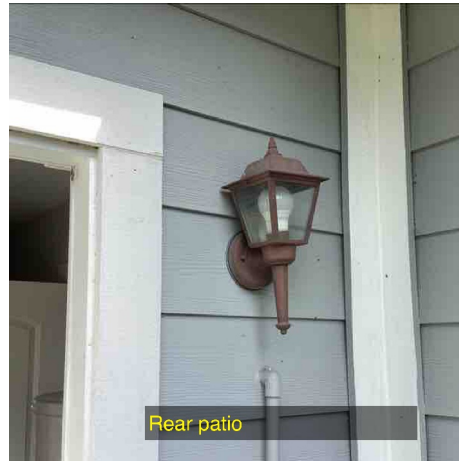
- Main distribution panel is 200 amp. Service is provided overhead from the utility company, 120/240 volt, aluminum service wires and uses breakers. Copper type wiring exist for branch circuits.

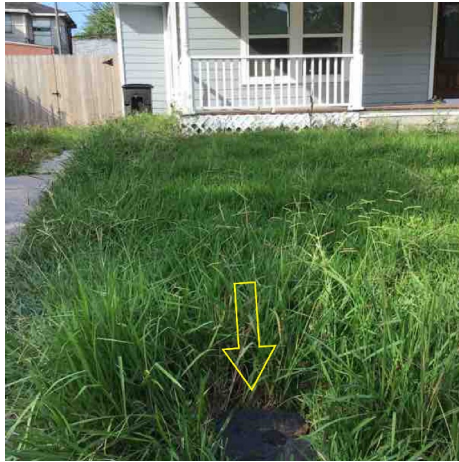
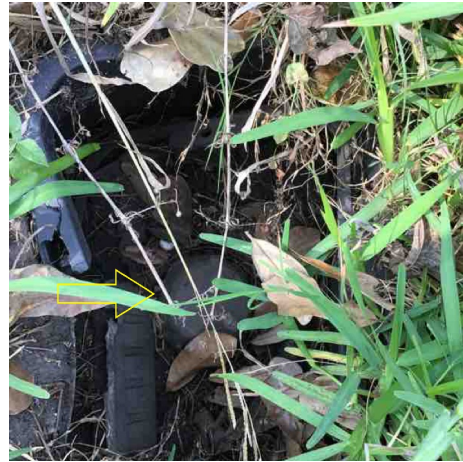
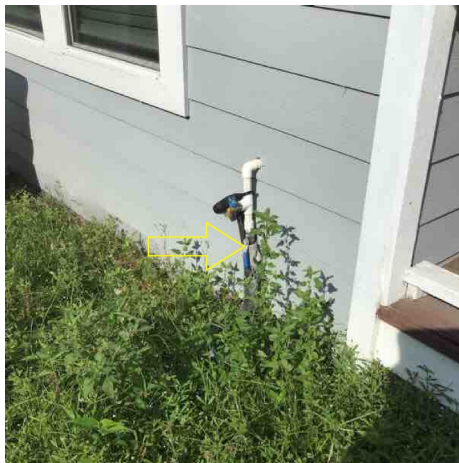
- Location of the water meter and shut off valve. No deficiencies noted.

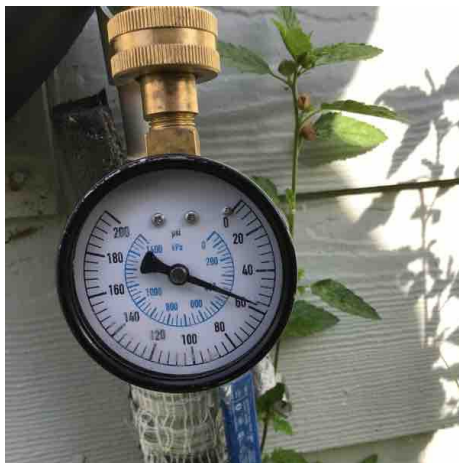
- Static water pressure below 80 PSI's - no deficiencies noted.

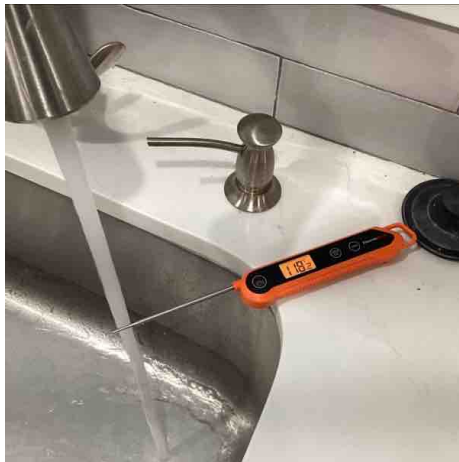
- An electric water heater is present and was in operation at the time of the inspection. The capacity of the hot water system appears adequate for the normal needs of this size house.
- Hot water temperature at the time of the inspection.

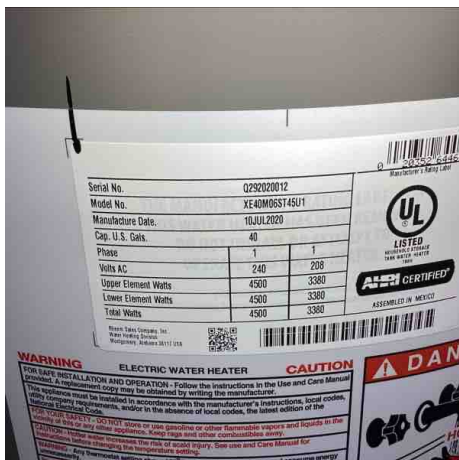
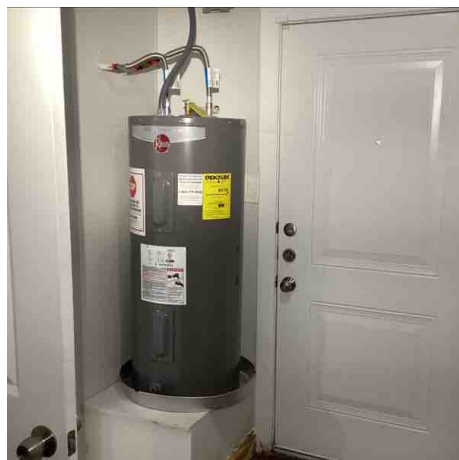
- 40 gallon unit manufactured in 2020.

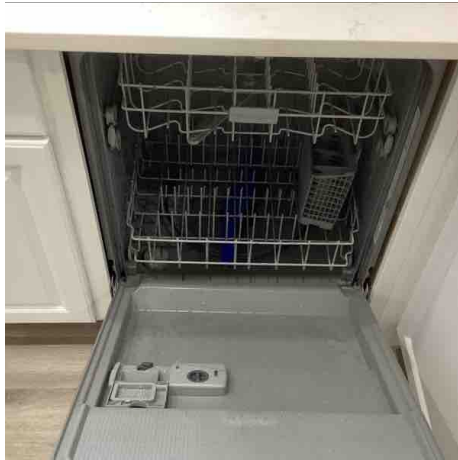
- Dishwasher was operated and run through a complete cycle. Functionality and operation appear to be normal with no leaks detected.

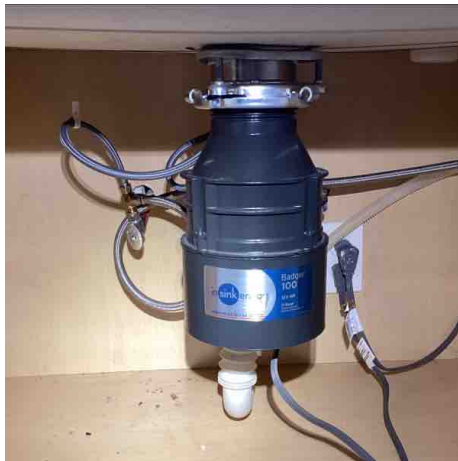
- Waste disposer is secure and operated.

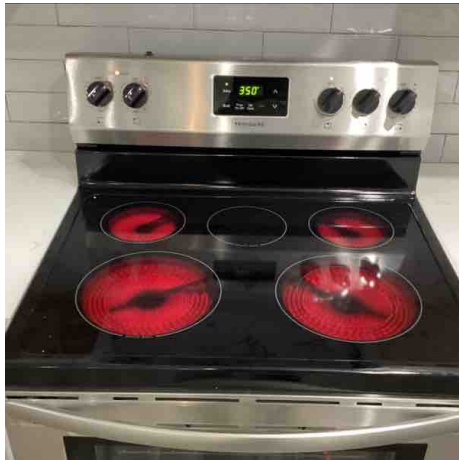
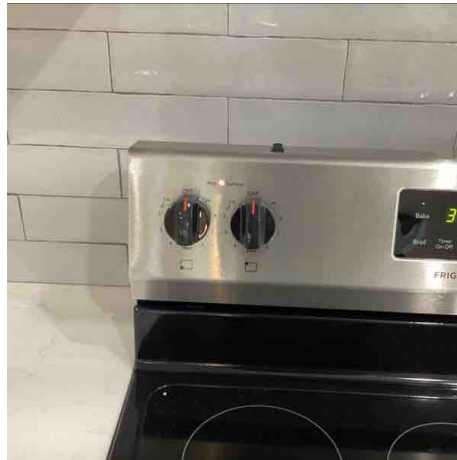
- Cook top in operation - no deficiencies noted.

Hot surface lamp remained illuminated until surface was cool.
