REDSTAR RESIDENTIAL INSPECTION REI 7-6

4221 Ohara
Alvin, TX 77511

PROPERTY INSPECTION REPORT FORM

Ron Allison & Cindy Allison <i>Name of Client</i>	04/06/2022 2:00 pm <i>Date of Inspection</i>
4221 Ohara, Alvin, TX 77511 <i>Address of Inspected Property</i>	
Devin Evans <i>Name of Inspector</i>	TREC #22225 <i>TREC License #</i>
Jeremy Benefiel TREC # <i>Name of Sponsor (if applicable)</i>	8595 <i>TREC License #</i>

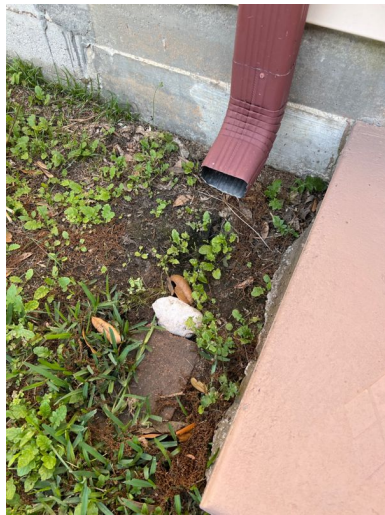
Splash blocks were missing from multiple downspouts. Splash blocks placed under the downspout discharge helps disperse the water away from the foundation and to prevent soil erosion. Correct as needed.

Recommendation: Contact a handyman or DIY project

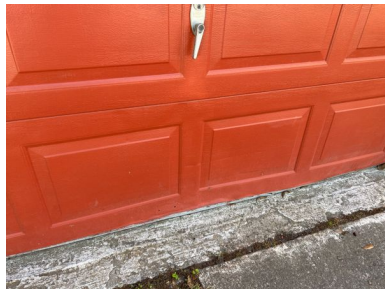
The garage vehicle door had damage/dents. Evaluate and correct as needed.

Recommendation: Contact a qualified garage door contractor.

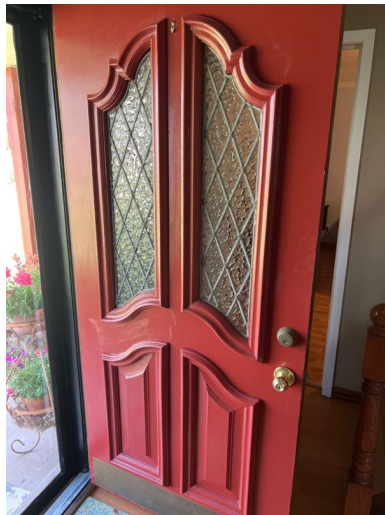
Today's standards requires tempered glass at all door glass. This is an age related deficiency, evaluate and correct as needed.

Recommendation: Contact a qualified professional.

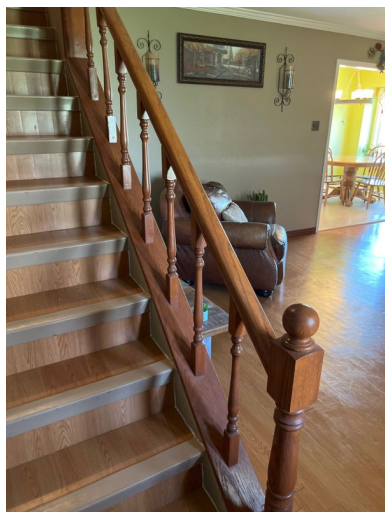
The handrail was observed to be loose. The handrail height also does not meet today's standards. Repair as needed for safety purposes.

Recommendation: Contact a qualified professional.

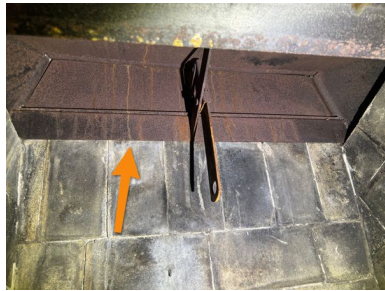
Recommend further evaluation by a chimney sweep.

Recommendation: Contact a qualified chimney contractor.

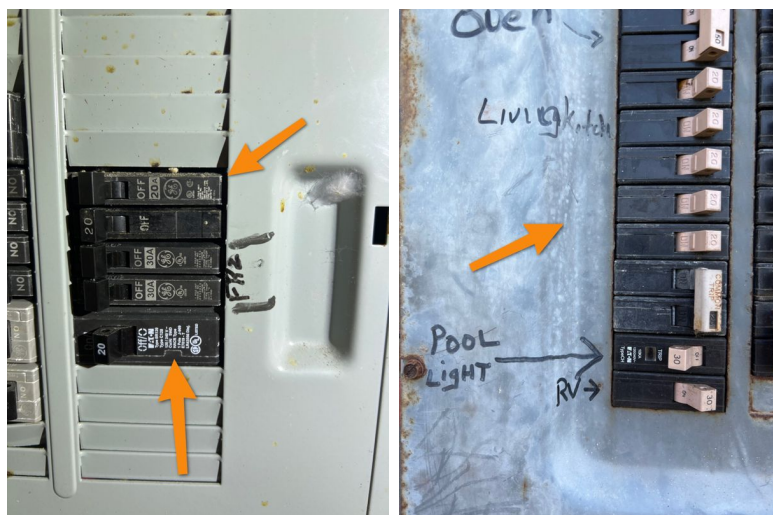
The circuits inside the panel are not fully/clearly labeled. Recommend correction.

Recommendation: Contact a qualified electrical contractor.

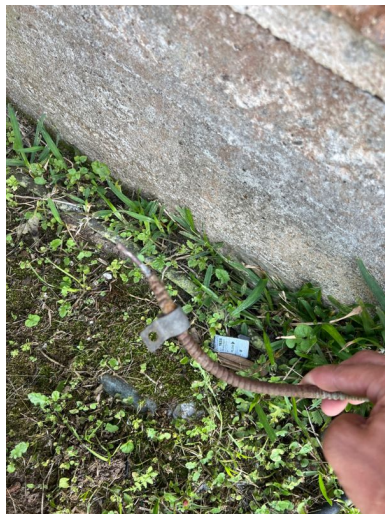
The grounding wire was missing or not connected properly to the grounding rod. Remedy as needed.

Recommendation: Contact a handyman or DIY project

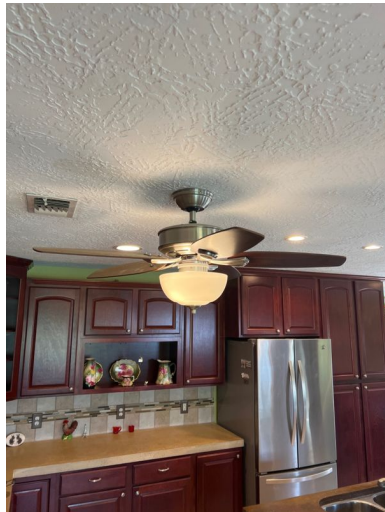
The inspector observed one or more ceiling fans inoperable. The inspector did not observed a switch or remote to operate the fan. Recommend further evaluation by electrician.

Recommendation: Contact a qualified electrical contractor.

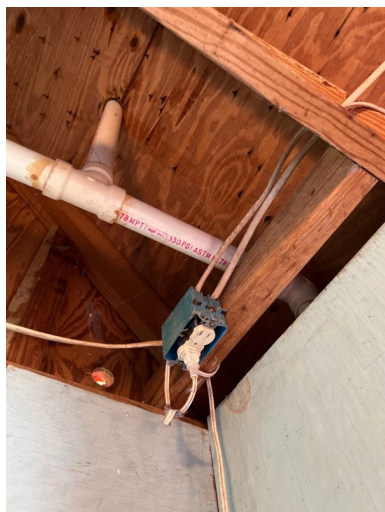
One or more switches/receptacles are missing a cover plate. Recommend correction as needed to avoid potential hazard.

Recommendation: Contact a qualified electrical contractor.

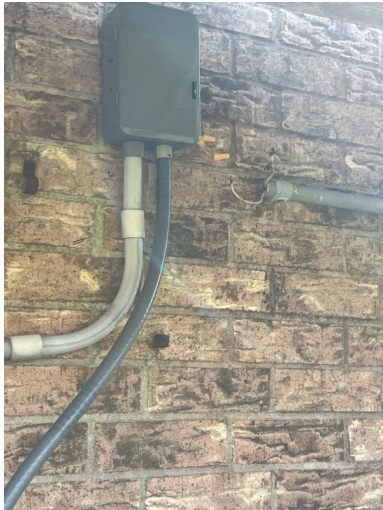
Abandoned wires were observed. Further evaluation to verify if they are properly disconnected and to determine if they can be removed is necessary.

Recommendation: Contact a qualified electrical contractor.

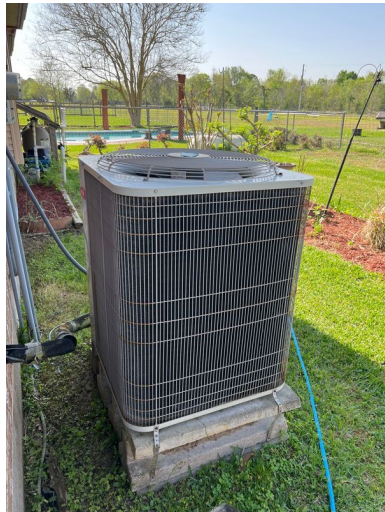
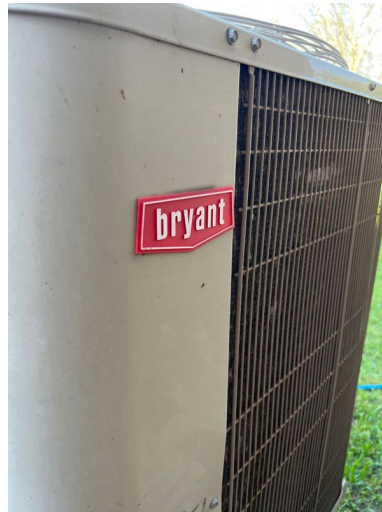
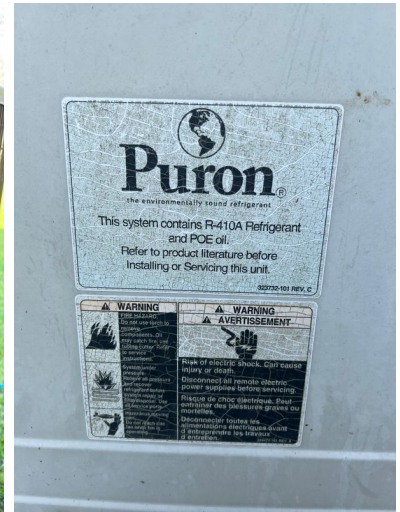
The inspector did not observe a data plate sticker on the outside air-conditioning system. The inspector is unsure of the age and other various information that is provided on the data plate.

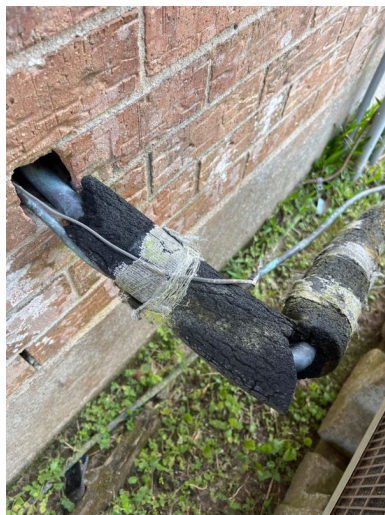
Missing or damaged insulation on refrigerant line can cause energy loss and condensation. Recommend correction.

Recommendation: Contact a qualified HVAC professional.

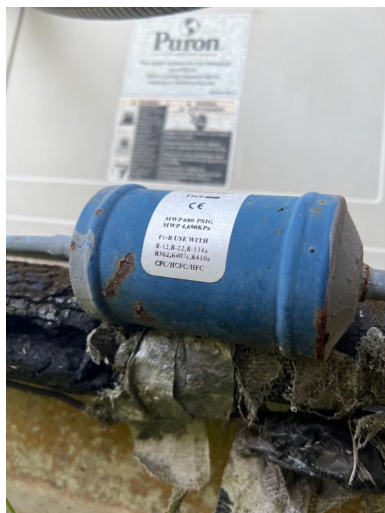
Observed rust on the exterior of the refrigerant filter. Recommend to have an HVAC contractor evaluate further to ensure no failure is possible.

Recommendation: Contact a qualified HVAC professional.

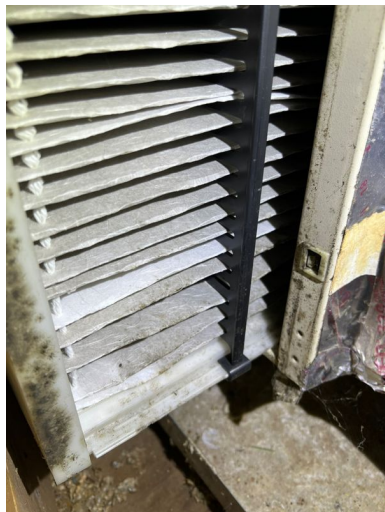
The media filter at the air handler in the attic space was observed to be dirty and needs cleaned or replaced. Recommend correction.

Recommendation: Contact a handyman or DIY project

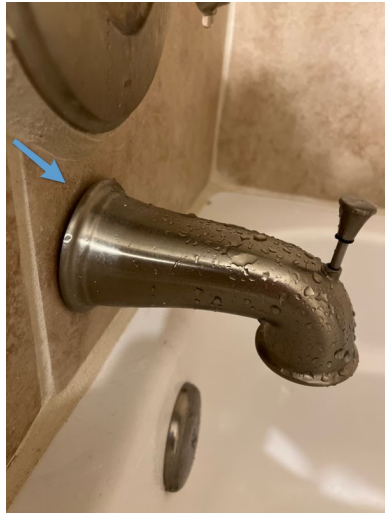
Fixtures going through the wall should be sealed with caulking to prevent moisture penetration through the walls. Remedy as needed.

Recommendation: Contact a handyman or DIY project

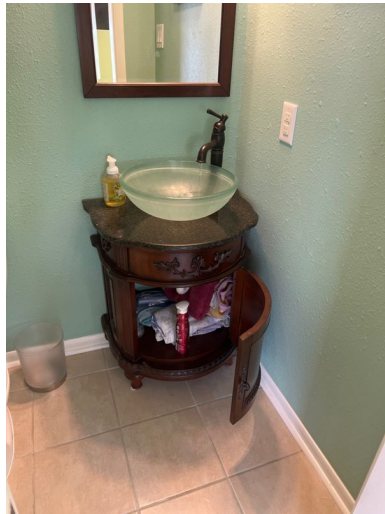
4: Sink Cabinet Not Secured

The Sink cabinet at the half bathroom was not secured at the time of inspection. The cabinet area would wiggle with little effort. Recommend securing.

Recommendation: Contact a qualified professional.

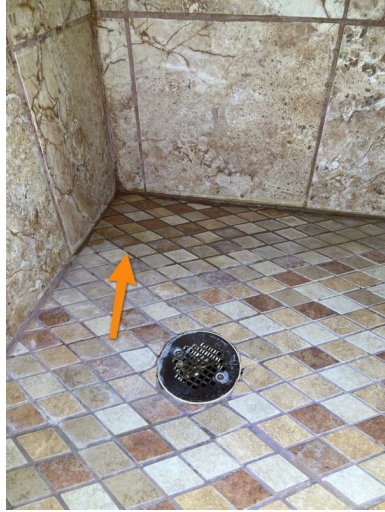
5: Shower: Improper Slope

An improper slope was observed at the master bathroom shower floor. The inspector observed pooling water at the back left corner prior to operating the fixture. Evaluate and correct as needed by a qualified contractor.

Recommendation: Contact a qualified professional.

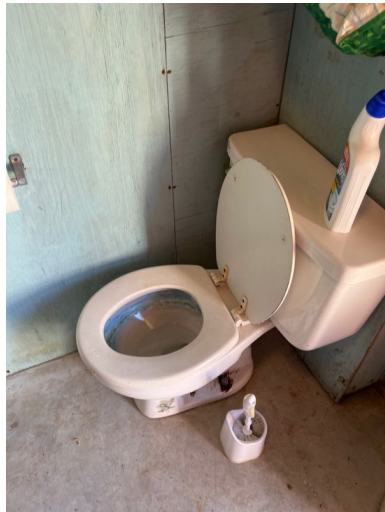
6: Toilet Spacing: Improper

Improper toilet spacing was observed at the garage toilet. 15 inch clearance from the center of the toilet should be observed. Evaluate and correct as needed.

Recommendation: Contact a qualified professional.

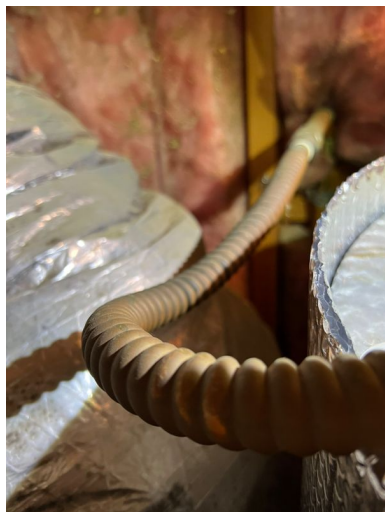
1: The Temperature and Pressure Relief valve was observed to run uphill.

The Temperature and Pressure Relief valve was observed to run uphill. This is not recommend as it does not allow the valve to function properly. Recommend repair.

Recommendation: Contact a qualified professional.

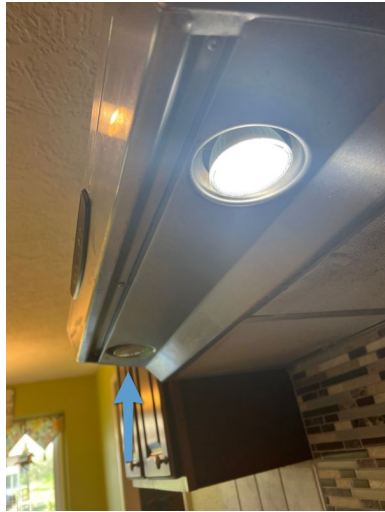
The range hood light did not function on one side. it appears to be bulb related. Repair as needed.

Recommendation: Contact a qualified professional.
