# RESIDENTIAL INSPECTION REPORT

8318 White Willow Ln Baytown, TX 77523

Concerning: <u>8318 White Willow Ln</u>, Baytown, TX 77523 (Address or Other Identification of Inspected Property)

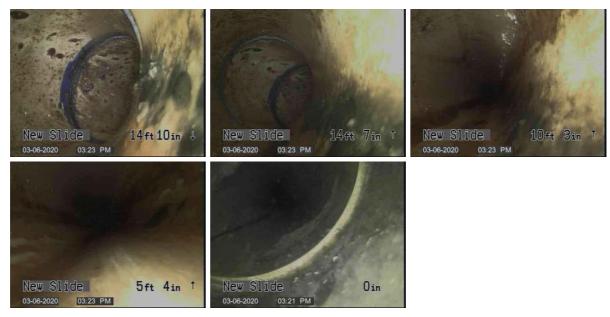
- **D D Hydro-Massage Therapy Equipment** Comments:
  - **E. Main Line Sewer Scope Assessment** Sewer Scope Photos:

*Distance scoped:* The camera was run to the main sewer utility connection *Material:* PVC
