## PROPERTY INSPECTION REPORT FORM

L RES CORP <i>Name of Client</i>	07/20/2022 <i>Date of Inspection</i>
11899 Algonquin Drive , Houston, TX 77089 <i>Address of Inspected Property</i>	
Dan Romero <i>Name of Inspector</i>	5674 <i>TREC License #</i>
<i>Name of Sponsor (if applicable)</i>	<i>TREC License #</i>

## Home Inspection Report

PROPERTY INSPECTED:  
11899 Algonquin Drive  
Houston, TX 77089

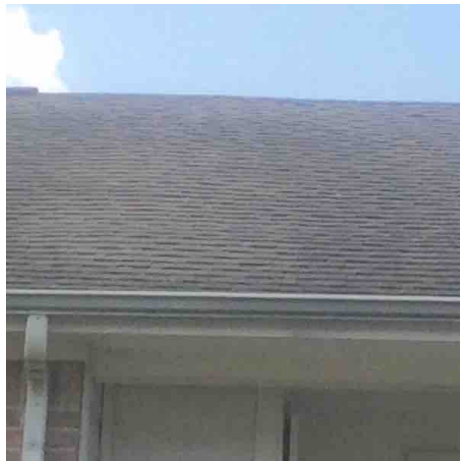
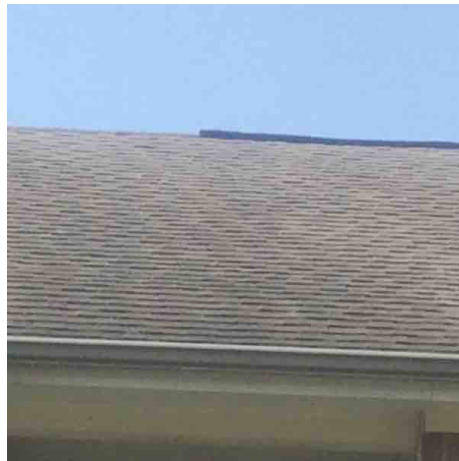
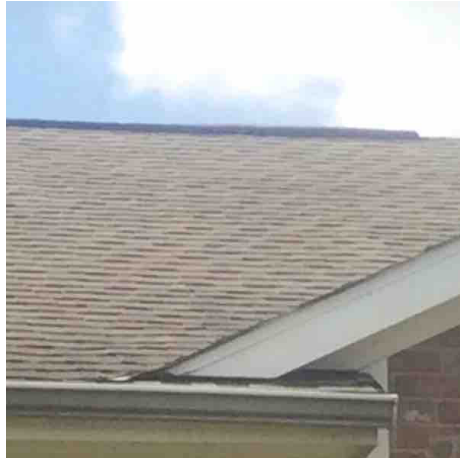
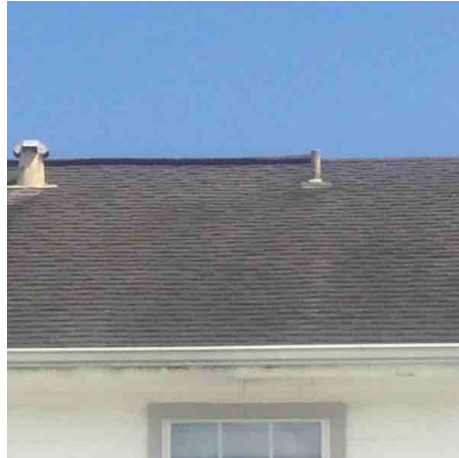
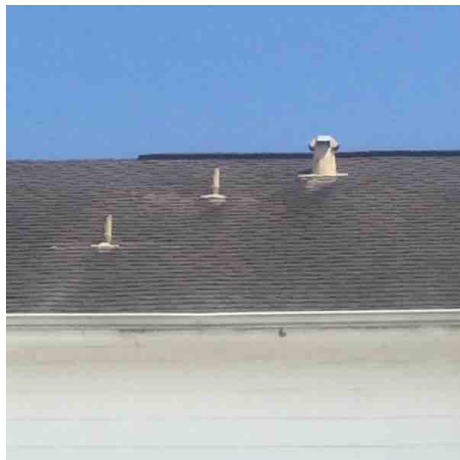
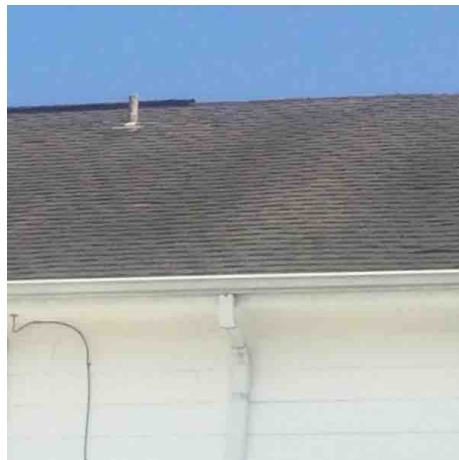
No structural deficiencies were observed.

The roof covering was part of a larger system.

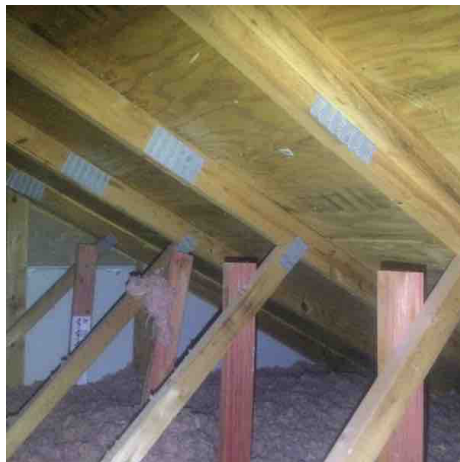
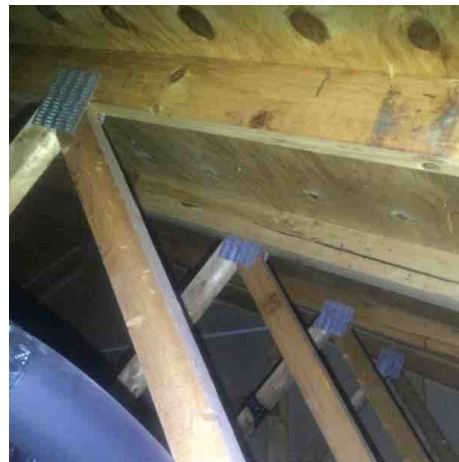
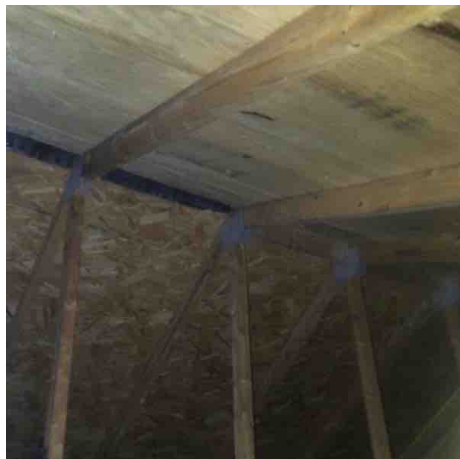
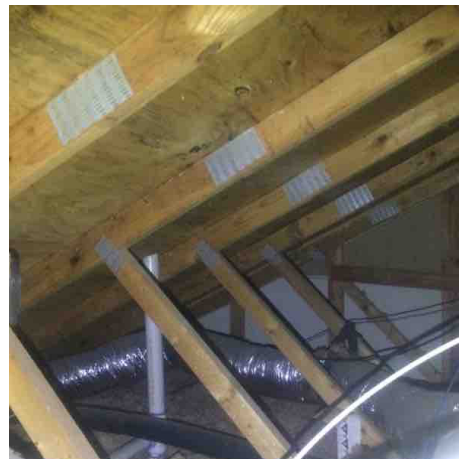
Blown & Batt insulation was noted with a depth between ( 10" –13 ").

Portions of attic were inaccessible due to inadequate catwalk and vaulted ceiling.

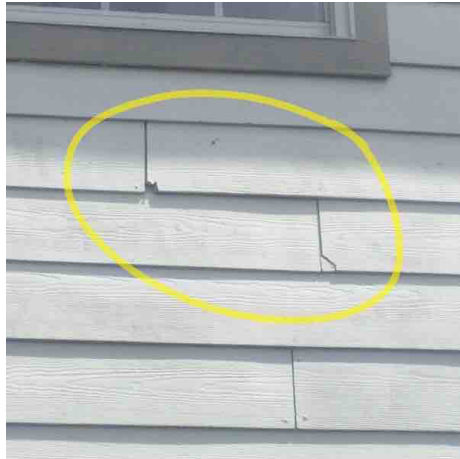
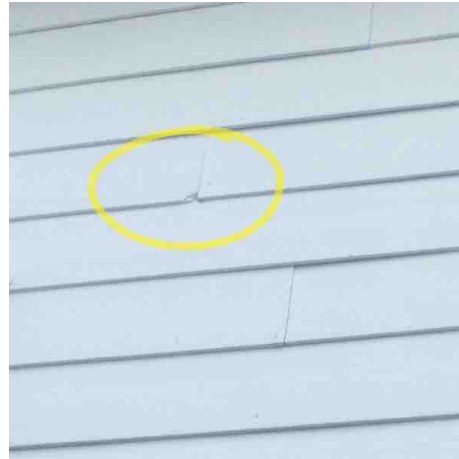
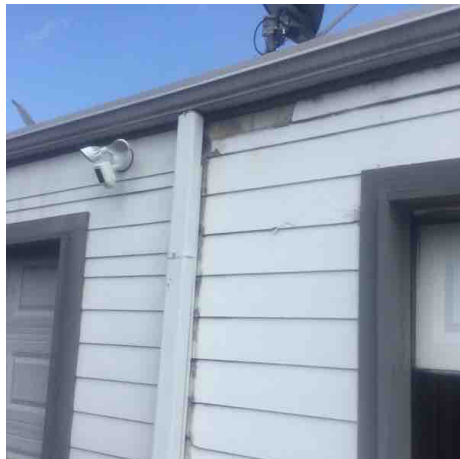
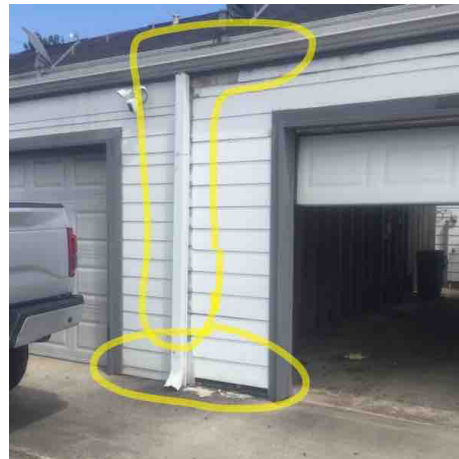
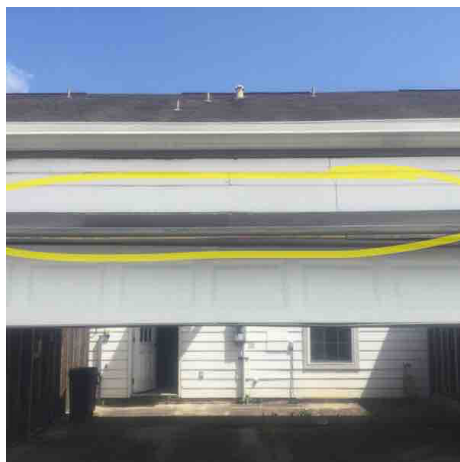
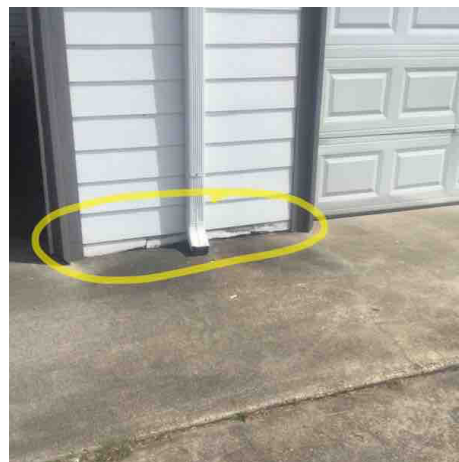
Observed open gaps damaged siding along the back entry door and back wall.

Repairs and corrections are recommended and advised.

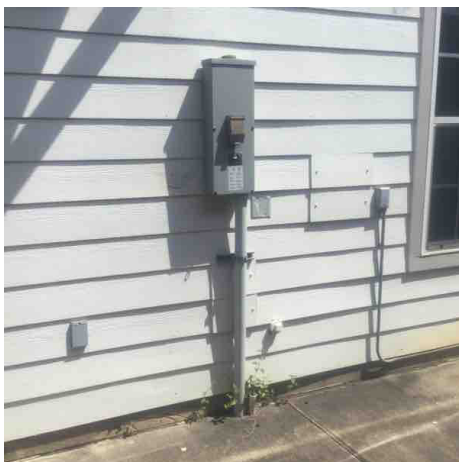
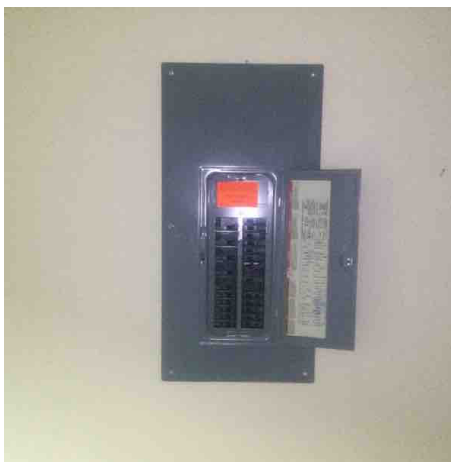
*Comments:*  
 • MAIN BREAKER PANEL  
 NAME: SQUARE D  
 LOCATION : GARAGE  
 The main beaker distribution panel has the service entrance wires routed underground, 110-220 volt service with copper conductors using breakers.  
 MAIN SHUT OFF DISCONNECT : 200Amps  
 LOCATION : OUTSIDE  
 At the time of the inspection the breaker distribution box was observed but could not be properly inspected or tested since the electrical utility was not connected.

The following conditions were observed.  
 Observed a 6 awg. copper grounding conductor to connected to the grounding rod.  
 Acorn clamp was secured on the grounding electrode.  
 Grounding rod was visible.  
 Panel board dead front cover was labeled properly.  
 Anti-oxidant was not present along the main lug terminals.  
 Arc fault protection breakers were observed at the required locations including to the bedroom receptacles.

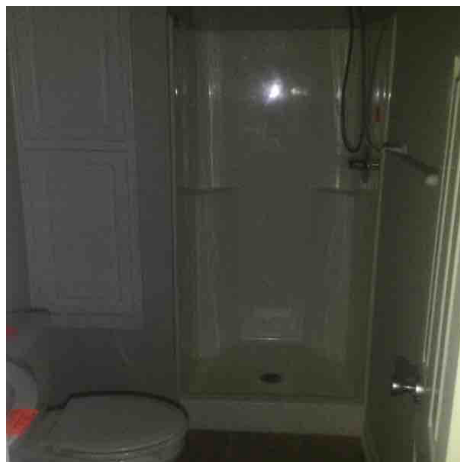
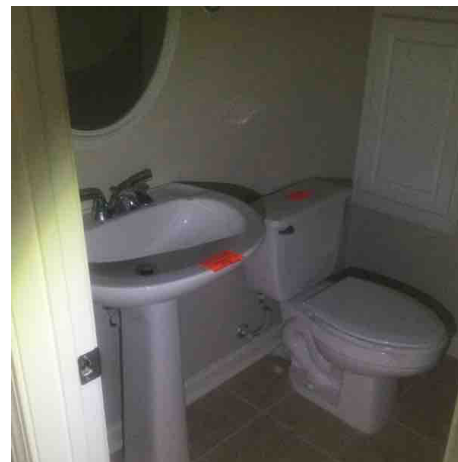
The bathroom fixtures appeared to be in satisfactory condition, but could not be tested as the water utility was not connected.

Further evaluation by a licensed specialist is required and advised.

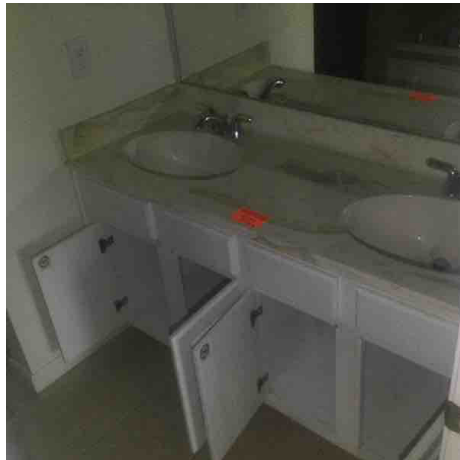
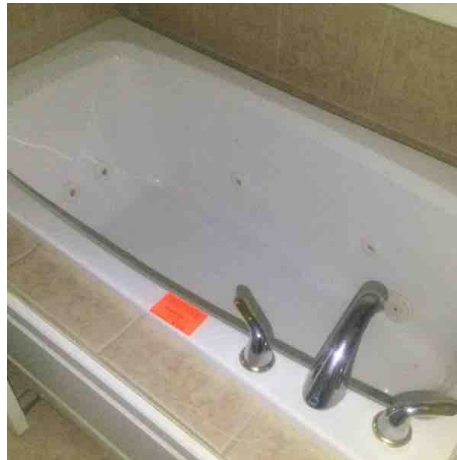
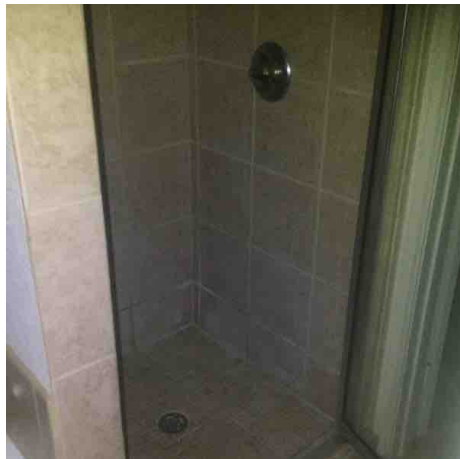
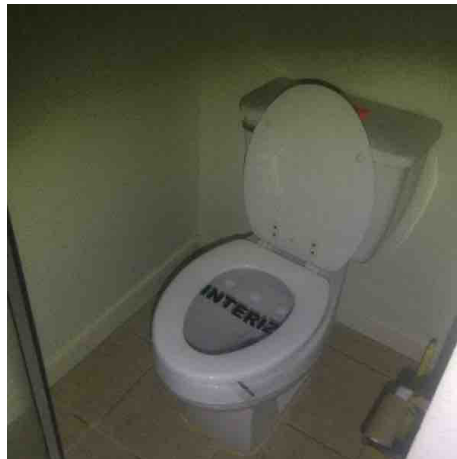
At the time of the inspection the plumbing fixtures appeared to be in satisfactory condition, but were not properly inspected or tested as the water utility was not connected.

Further evaluation is required by a licensed specialist.

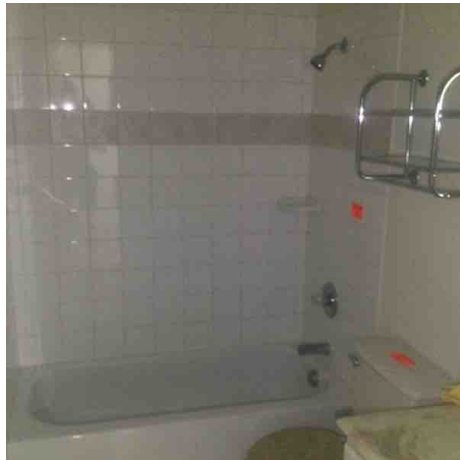
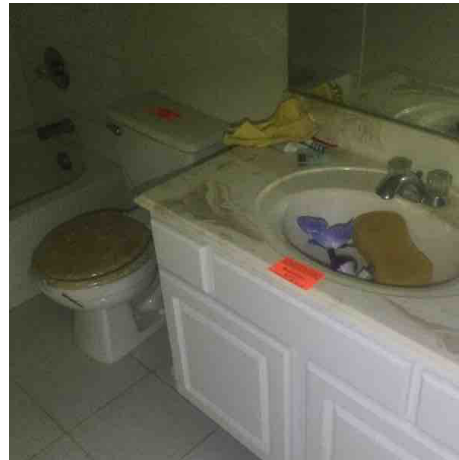
• **BACK BEDROOM BATH ROOM UPSTAIRS**

At the time of the inspection the plumbing fixtures appeared to be in satisfactory condition, but were not properly inspected or tested as the water utility was not connected.  
Further evaluation is required by a licensed specialist.

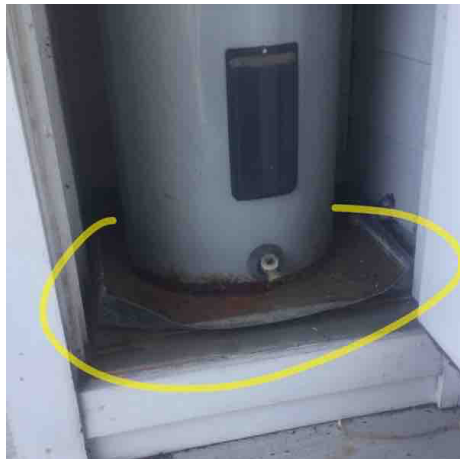
- Safety pan was present. Temperature pressure valve relief line, ( TPVR), was noted and terminated to the outside of the home.

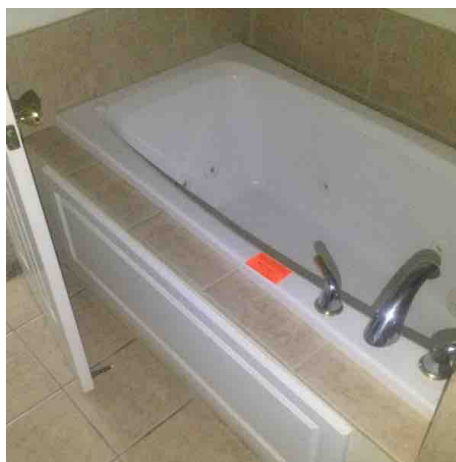
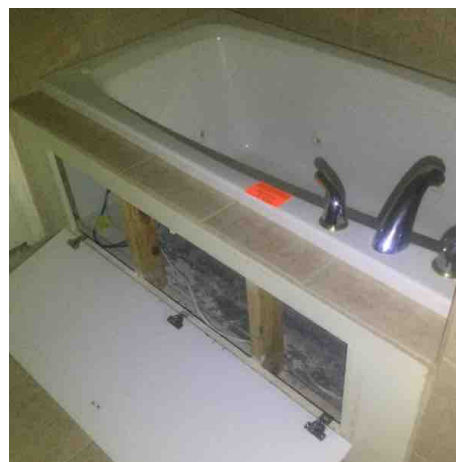
- At the time of the inspection the hydro therapy equipment appeared to be in satisfactory condition, but was not properly inspected or tested as the water utility was not connected. Further evaluation is required by a licensed specialist.
