PROPERTY INSPECTION REPORT

Concerning: 4515 Floyd Street unit E , Houston, TX 77007
(Address or Other Identification of Inspected Property)

By: Terrence Foster Lic.#: TREC #5182 07/24/2021
(Name and License Number of Inspector) (Date)

Home Inspection Report

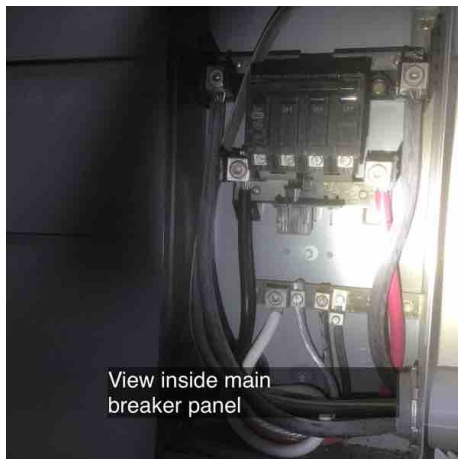
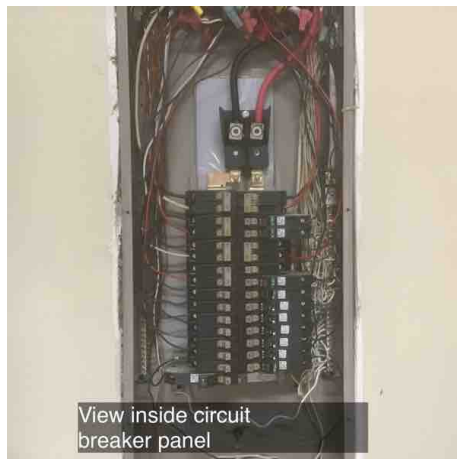
- Main service wire is aluminum. Main breaker is 150 amps, panel rating is 150 amps. Panel is located on the exterior west side of house, the circuit breaker panel is in the garage and is rated to 225 amps.
