HEDDERMAN SERVICES

MECHANICAL INSPECTION

11003 Riverview Dr
Houston, TX 77042

PROPERTY INSPECTION REPORT FORM

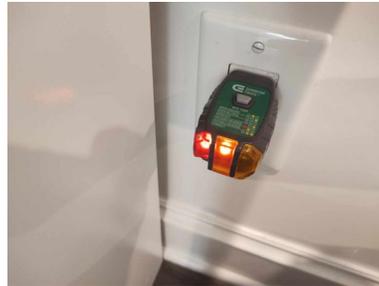
An outlet in which the hot and neutral (black and white) wires were reversed, causing reversed polarity.

Obtain Cost Estimate

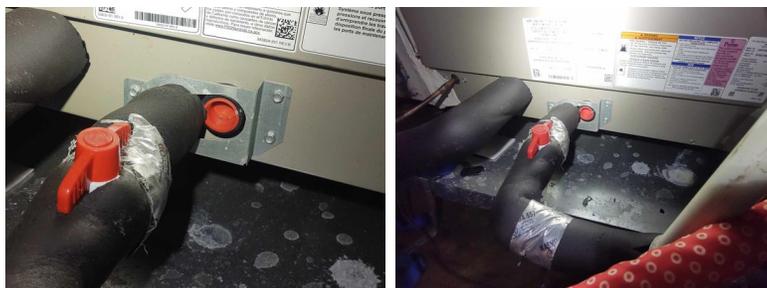
2: Coil - Leaking conditioned air repaired

The air conditioning system was leaking conditioned outside of the system at the coil. The coil need to be properly sealed.

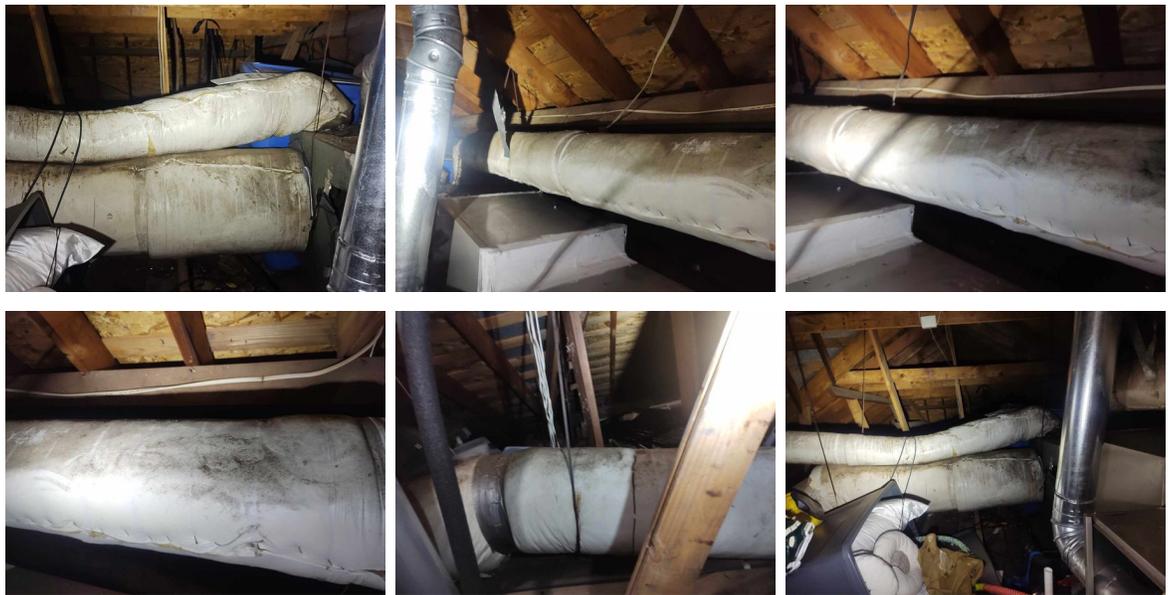
2: Registers - Dirty cleaned

The registers and adjacent ceiling areas were covered with debris that has passed through the air conditioning duct work. Have a service company check the inside of the duct work to determine if there is a build-up of debris, and to clean the ducts if necessary.

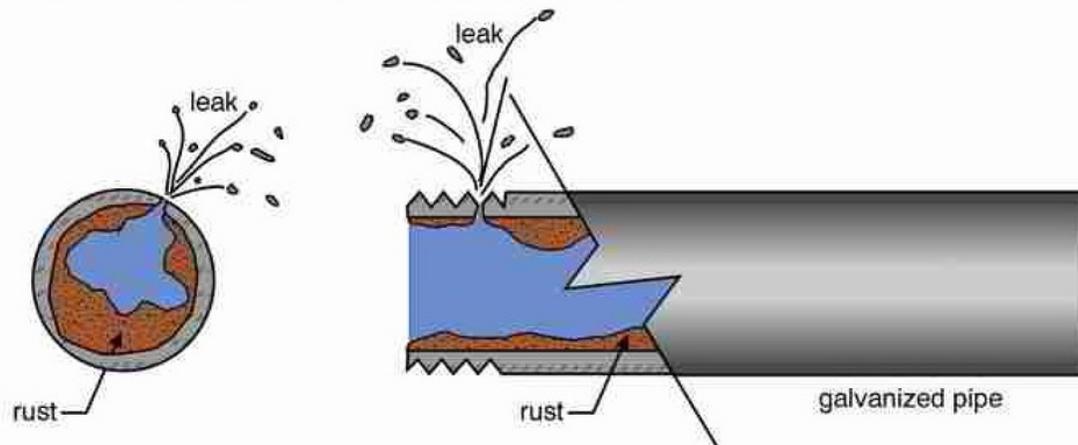
All or portions of the water piping for the property was observed to be the original galvanized piping. It is pointed out that the galvanized piping will deteriorate with time, and will corrode on the inside of the piping, thereby reducing the inside diameter of the pipe, and restricting the flow of the water through the pipe. In addition, the piping will corrode through to the outside of the pipe and will eventually deteriorate to where the pipe will start leaking. It can be anticipated that the galvanized water piping throughout the house will need to be replaced when it is causing reduced water pressure or is corroded enough to start leaking.

rusting of galvanized pipe can greatly reduce water pressure and will eventually cause leaks as rust creates holes in the pipe walls

problems are likely to occur soonest on pipes carrying hot water, horizontal pipes and at threaded (thinner) sections

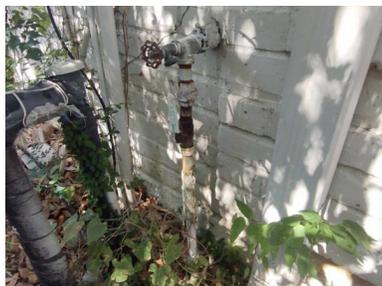
2: Vacuum Breaker - Missing

The atmospheric vacuum breaker devices were missing at one or more of the hose bibbs, and it is recommended that they be installed to prevent cross connections, which can allow contaminated water to enter the potable water supply.

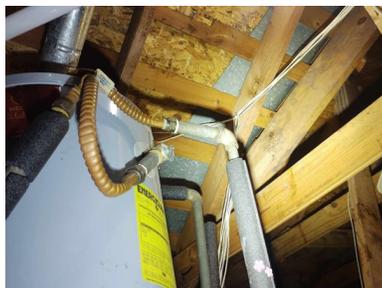
2: Tank - Gurgling noise

The tank was observed to be gurgling while it was heating, indicating a buildup of scale and other deposits inside the water heater. It can be anticipated that the condition will continue to worsen until the water heater is replaced. It is recommended that a plumber be contacted for further investigation and a cost estimate for any needed repairs.
