STRUCTURAL INSPECTION

11003 Riverview Dr
Houston, TX 77042

JULY 6, 2022

REF: CONDITION OF PROPERTY SURVEY

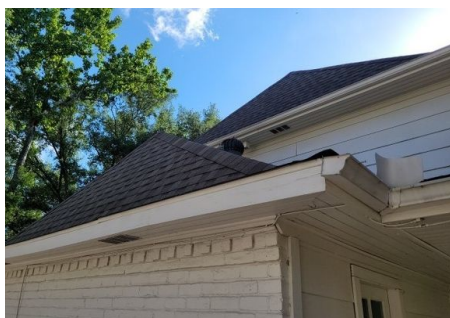
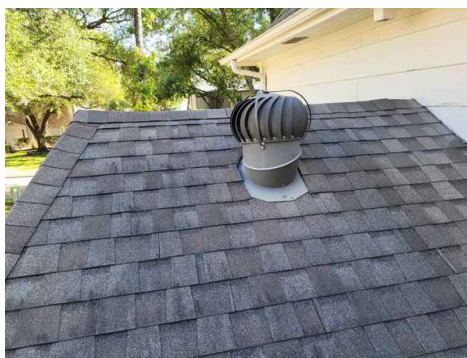
Wear and Deterioration: Composition - Some

Discolored, Nail Heads not Sealed, Rusted flashing details

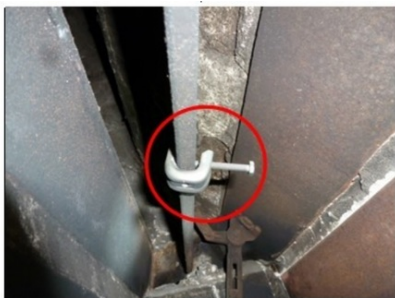
HEI file photo showing c-clamp in masonry fireplace

It is pointed out that the damper was not equipped with a spacer device to prevent the damper from closing completely. This device keeps the damper open slightly, even when it is in the closed position, to prevent combustion gases from building up in the living space should the gas log be operated when the damper is closed. It is recommended that the clamp be installed for safety purposes.

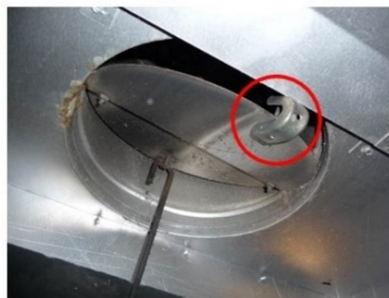
HEI file photo showing c-clamp in metal fireplace

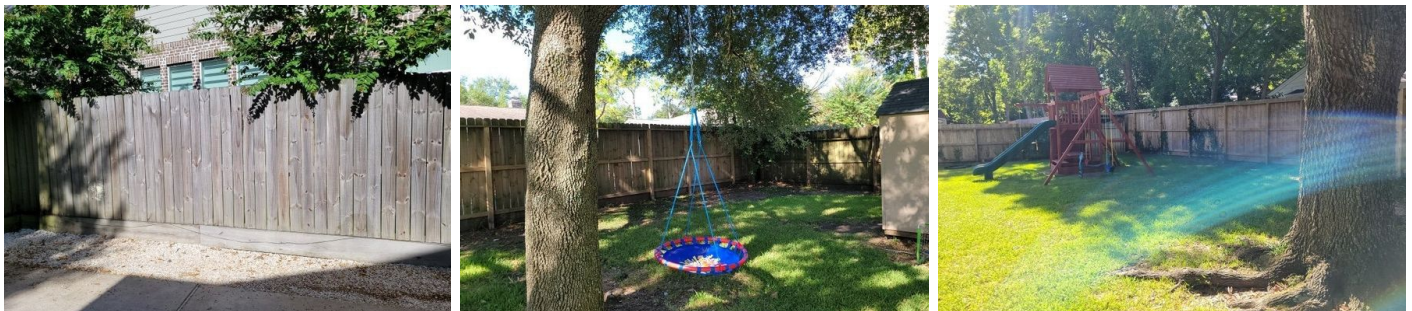
Gates and Fences: Gates and Fences - Some Repairs

The gates and fences were in generally good condition at the time of the inspection with some repairs observed to be needed as shown below under Recommendations/Repairs.
