# **Inspection Report**

Property Address: 6315 Settlers Square Lane Katy TX 77449

# **PROPERTY INSPECTION REPORT FORM**

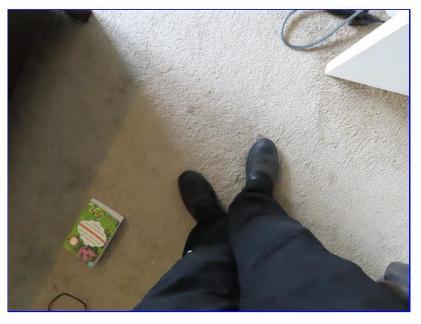
F. Item 3(Picture)

(2) Upstairs subfloor in several areas have soft spots and make noise when walked on. Should have a professional secure subfloor properly.

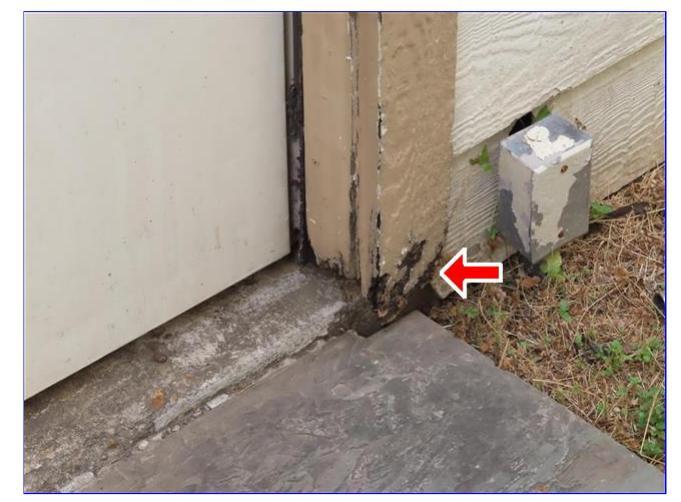
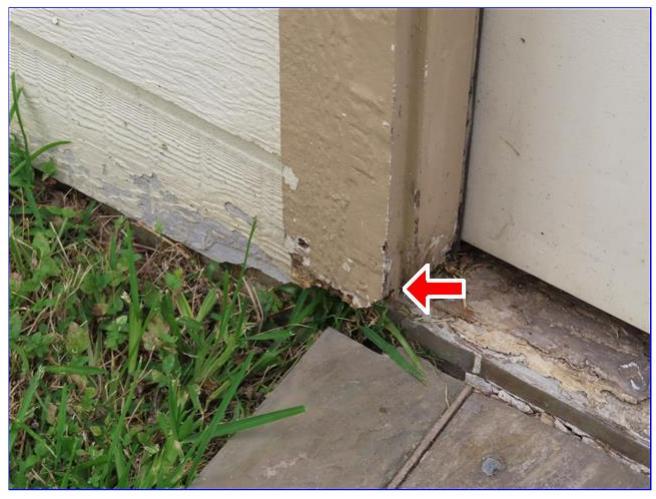
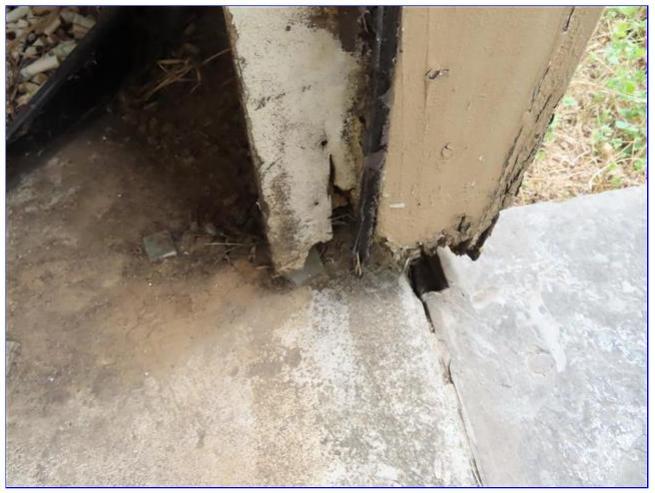
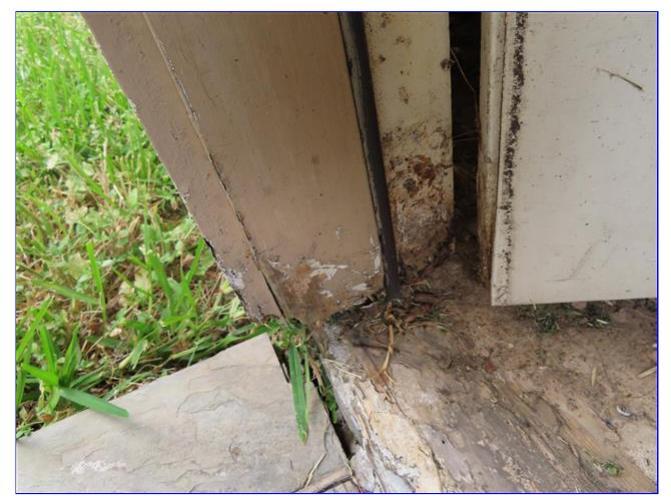
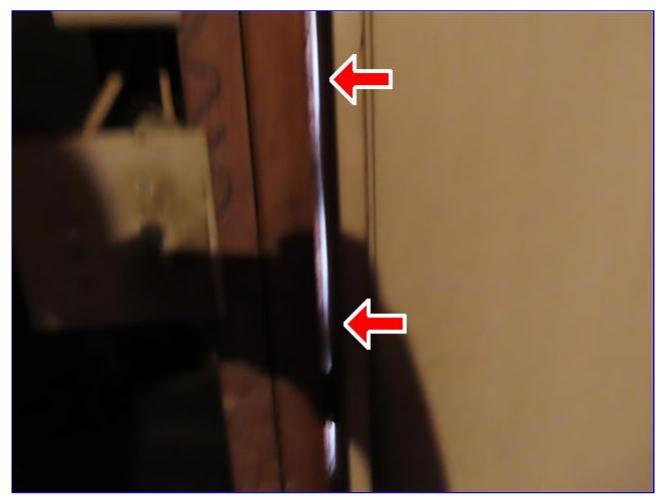
(1) Rear garage door frame has moisture damage and rot at time of inspection. Door frame was leaking daylight into the interior of garage at time of inspection. Should have a professional correct and seal properly. Conducive to moisture intrusion and causing possible damage.

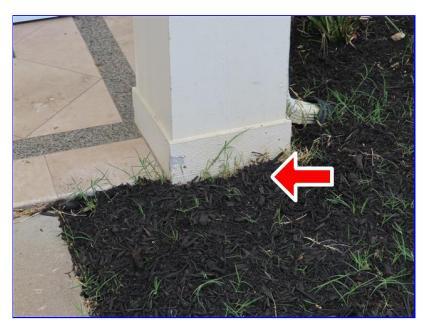
K. Item 1(Picture)

| I. Stairways (Interior and Exterior)<br>Comments: |
|---|
| <ul> <li>K. Porches, Balconies, Decks and Carports</li> <li>Appurtenance: Porch, Sidewalk, Patio</li> <li>Driveway: Concrete</li> <li>Comments: <ul> <li>(1) Front porch columns were touching soil at time of inspection. This is conducive to possible moisture, reand WDI (Wood Destroying Insect).</li> </ul> </li> </ul> |

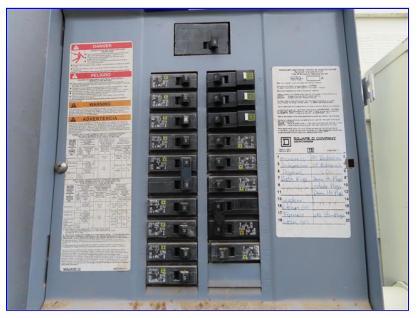
A. Item 3(Picture)

# ININPD I. Electrical Systems I. Electrical Service Conductors: Below ground Panel Capacity: 100 AMP Panel Type: Circuit breakers, AFCI Breakers Electric Panel Manufacturer: SQUARE D Comments: Square D breaker box and electric meter. Boxes should be sealed properly to siding. Dead front cover was missing fastener at time of inspection. Should have a professional electrician correct properly. Image: Contract of the part of the part

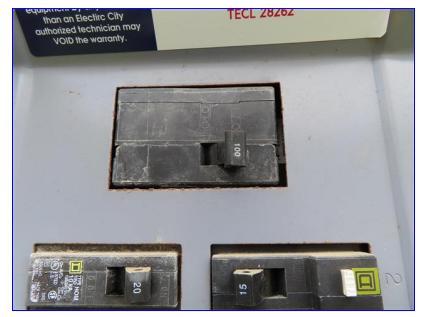
B. Item 3(Picture)

(3) All wire sheathing in the breaker box should go all the way to the breaker. No bare wires should be showing. Should have a professional electrician correct.

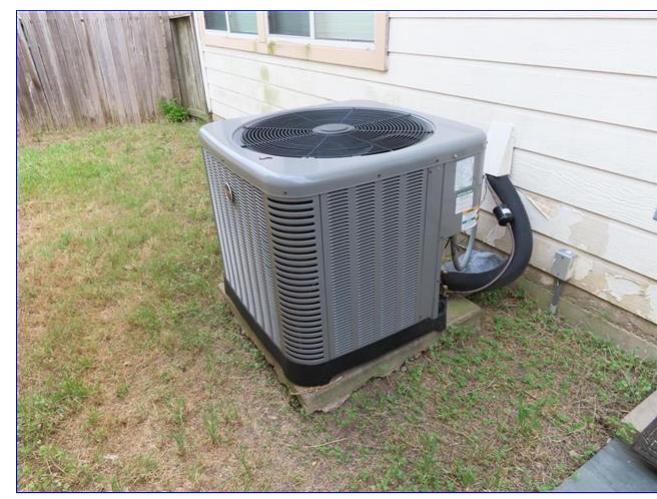
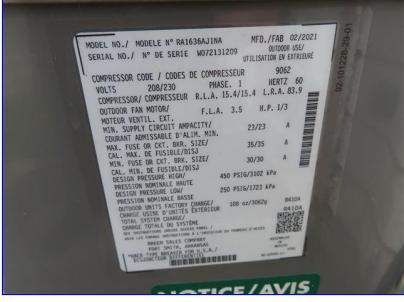
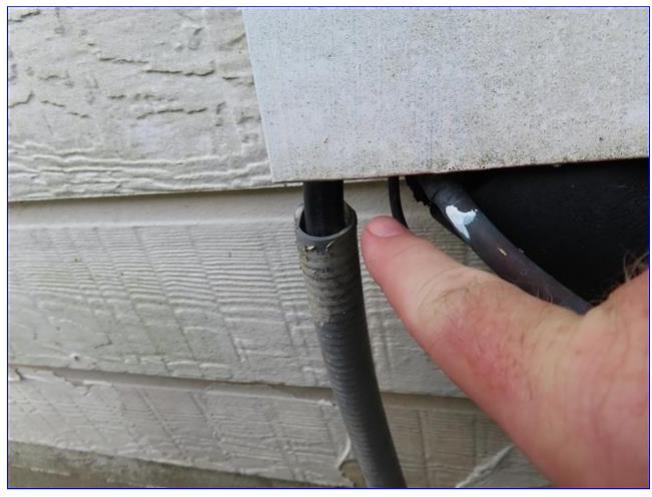
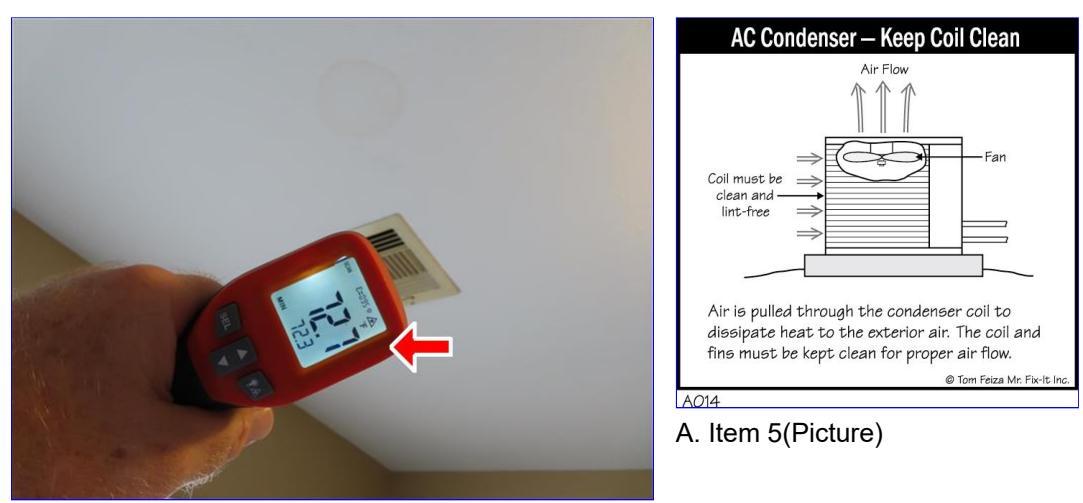
| I NINP D | |
|---|---|
| | AC Tech inspect and service unit properly. |

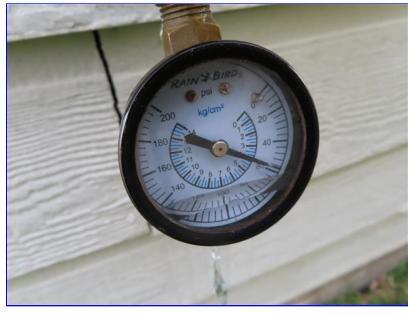
A. Item 1(Picture)

(1) Static water pressure was 58 psi at time of inspection. (This is for informational purposes only)

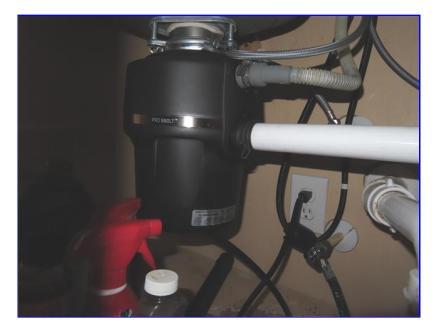
B. Item 1(Picture)

InSinkErator disposal was working properly at time of inspection.

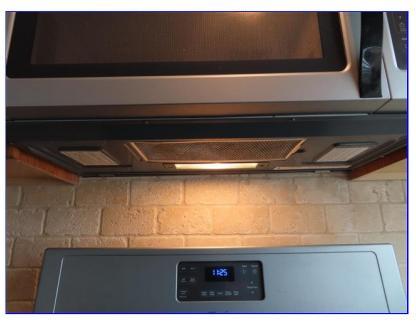
C. Item 1(Picture)

Whirlpool built in microwave exhaust fan and light was working properly at time of inspection.

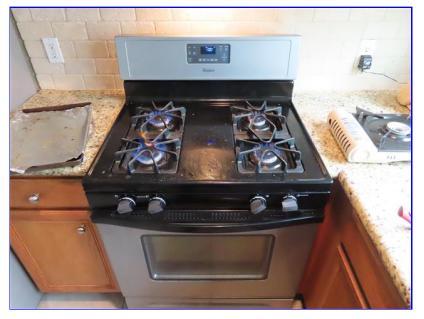
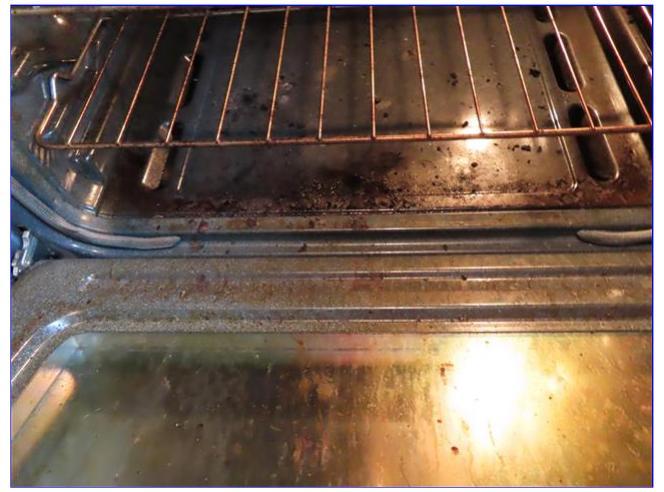
Whirlpool gas cooktop and oven was working properly at time of inspection. Oven is dirty and should be cleaned properly.
