PROPERTY INSPECTION REPORT

Concerning: 5007 Cedar Creek Drive, Dickinson, Texas 77539

By: Harold K. Randle License # 10237

April 17, 2020

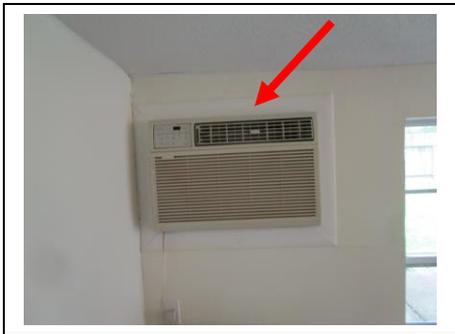
Thru Wall Unit

2. Thru-wall air conditioner operated as intended.

Recommend having licensed heating and air conditioning specialist further evaluate air conditioning system.
