Baker Real Estate Inspections

Property Inspection Report
Exclusively Prepared For
Theresa Nguyen

2606 Silent Springs Creek Dr.
Katy, TX 77450

PROPERTY INSPECTION REPORT

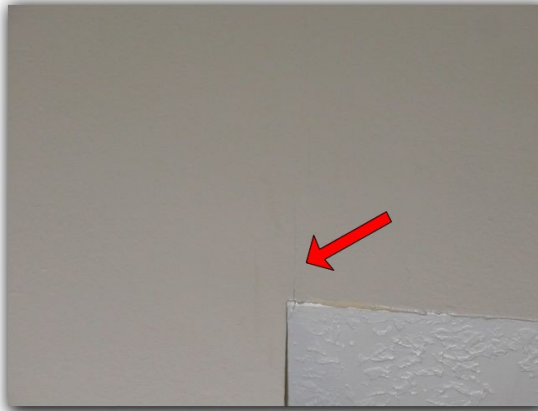
Movement: Interior Wall Cracks

A drywall crack was noted on the north wall of the southeast bedroom. This implies that some structural movement of the building has occurred.

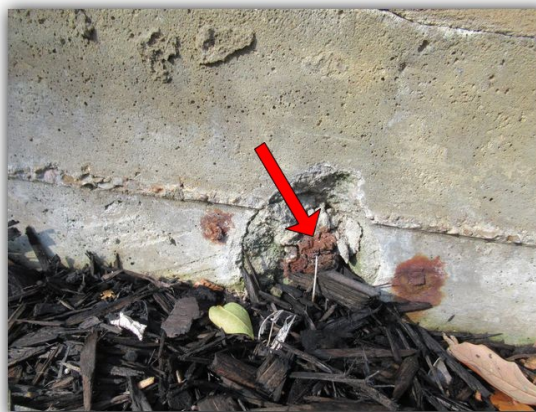
Cable Ends Visible

Post tension cable ends were observed on the exterior of the foundation. This should be repaired to prevent corrosion. All exposed steel cable ends should be properly covered to avoid corrosion of the exposed steel. Recommend repair before more extensive repairs become necessary.

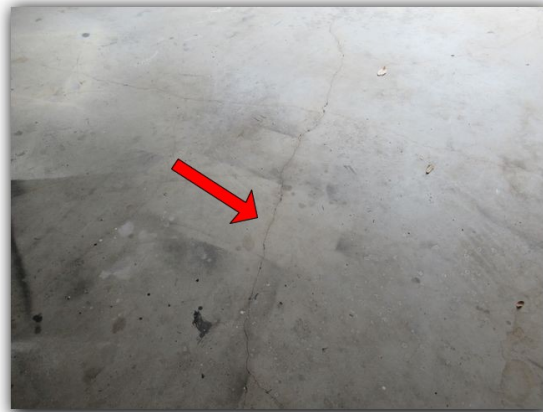
Foundation Elevation Readings taken with a Zip Level

(adjustments were made fro differing floor covering heights)

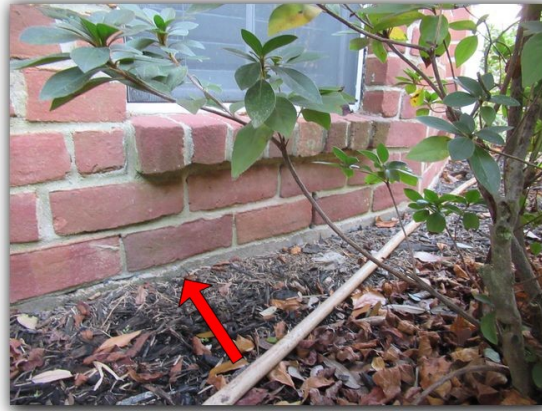
Soil Level

The soil level is high on the brick wall. Weep holes are near or below ground level. As a result, splash back (during rain storms) and upward migration of water from adjacent ground can lead to decay and facilitate insect intrusion in this area. Ideally, at least four(4) inches of clearance should be maintained between the soil level and the bottom of the first course of brick.

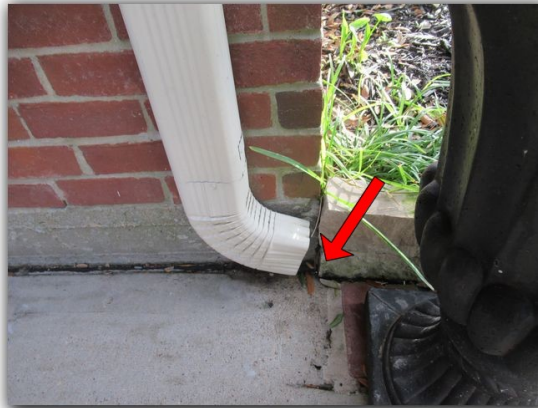
Downspout Discharge Near Foundation

The downspout(s) should discharge water at least five (5) feet from the foundation. Corrections to discharge the water away from the foundation should be made for proper foundation maintenance.

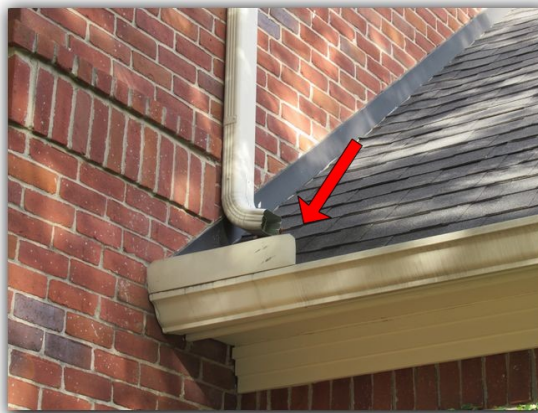
Downspout Discharge on Roof

Downspout(s) that discharge onto the roof should be extended to discharge directly into the gutters below. This condition, if left unattended, can result in premature deterioration of the roofing under the end of the downspouts.

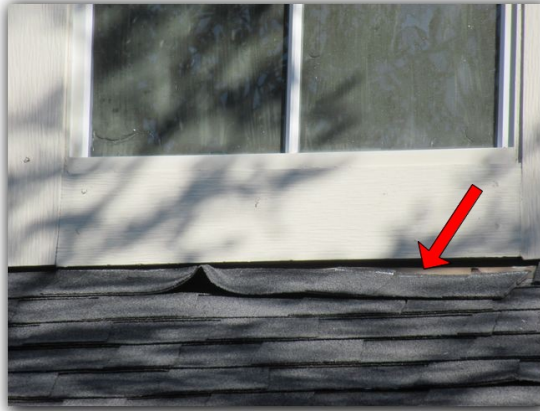
Loose Shingle

A loose shingle was noted just below the front dormer.

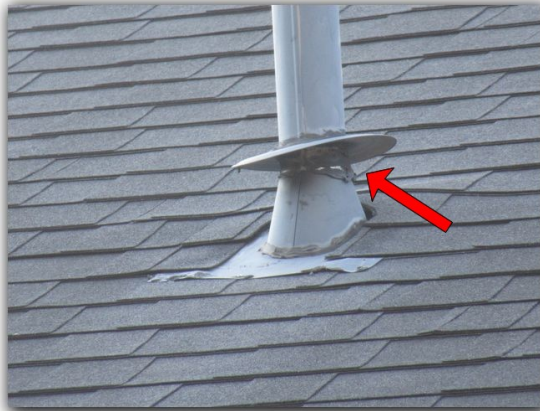
Flue Storm Collar not Properly Positioned

Two roof level flue storm collars are not properly installed and/or positioned over the roof jack. The storm collar needs to be properly positioned over the roof jack and sealed to prevent water intrusion into the structure.

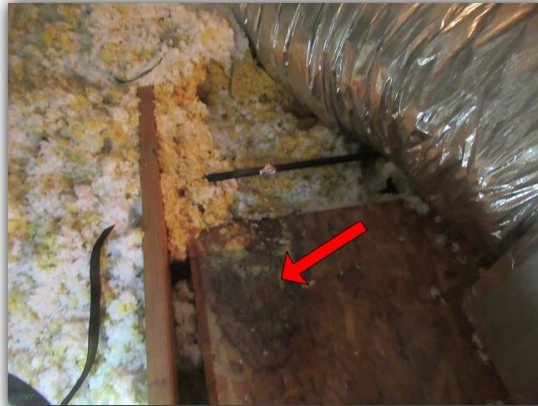
Evidence of Roof Leak

Evidence of a possible roof leak was noted below the upstairs furnace vent.

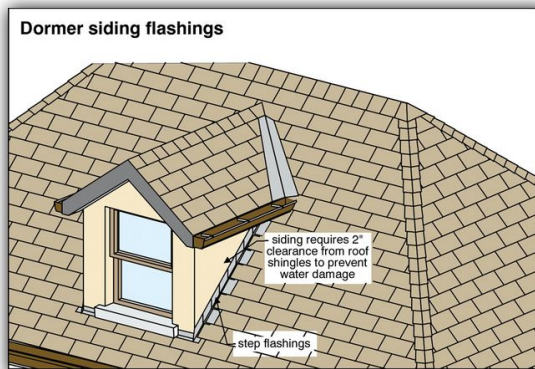
Lack of Clearance Between Siding and Flashing

The clearance of the siding at the flashing is insufficient at least one to two inches of clearance should be provided. This condition leaves the siding vulnerable to rot as moisture and debris can become trapped between the flashing and the siding.

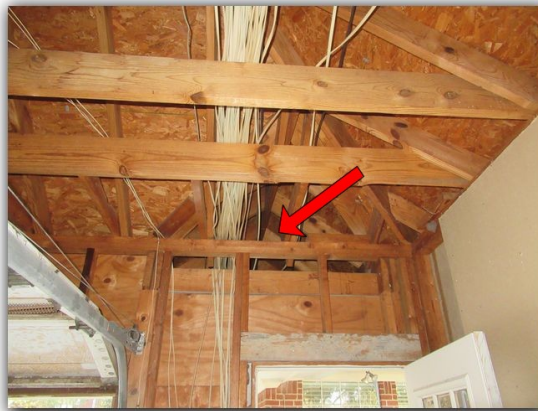
Garage: Lack of Separation

There is a lack of proper separation between the garage and the attached breezeway attic space. A number of potential hazards exist within garages as occupants tend to store hazardous materials in the garage. Along with the hazardous materials the potential for carbon monoxide build-up within the garage exist. Thus a fire separation of the garage attic space from the attached breezeway attic space is recommended at the garage roof structure.

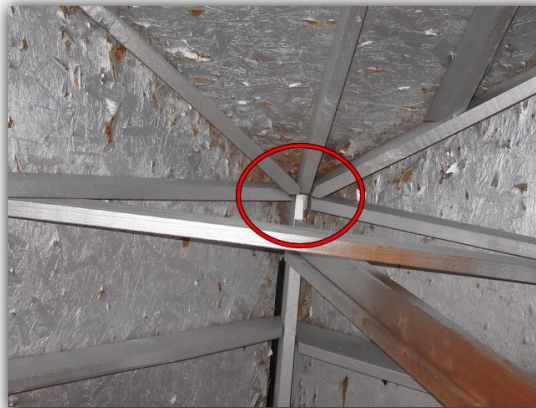
Lack of Palm Bracing

There is a lack of a palm brace to provide vertical support at the intersections of the hip rafters to the main ridge board in the garage and house. A palm brace in this location provides a load path to the foundation as required from the main ridge and attached hip rafters.

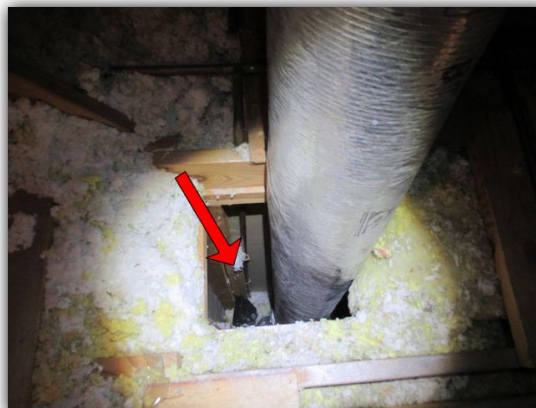
Lack of Fire Blocking

An open chase extends through the attic space with no fire blocking. Recommend sealing/fire stopping all open chases in attic down to the living area.

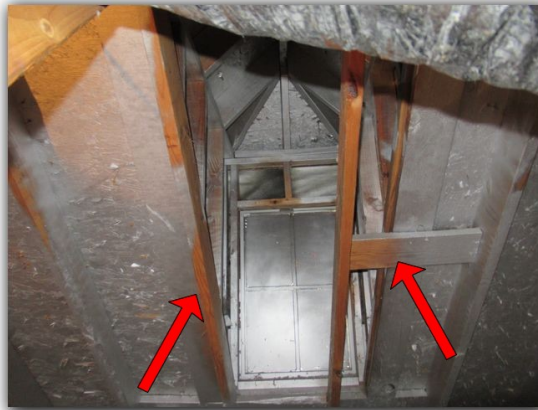
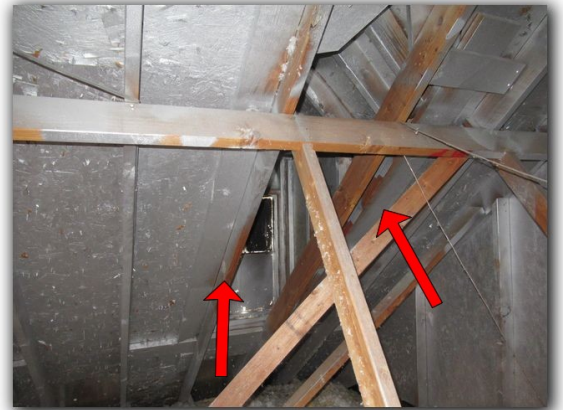
Lack of Support Under Dormers

Dormers should be supported on top of double roof rafters to properly support the additional weight of the dormer.

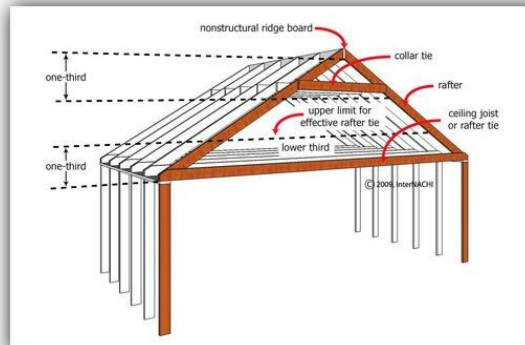
Insufficient Collar Ties

Lack of collar ties were noted in both dormers. Ideally, collar ties, (horizontal members running between each rafter, near their mid-span to upper 1/3) should be provided for all rafters. Collar ties help to resist rafter sag. Installation is usually very simple.

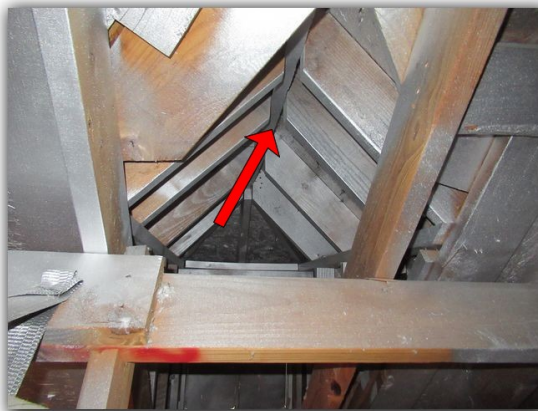
Undersized Ridge Board

The heels of the rafters hang below the ridge board in both dormers. The cut end of the rafters should be in full contact with the ridge board, therefore the ridge board should be no smaller than the cut end of the rafters. A structural engineer or qualified professional framer should be consulted to determine the need for correction.

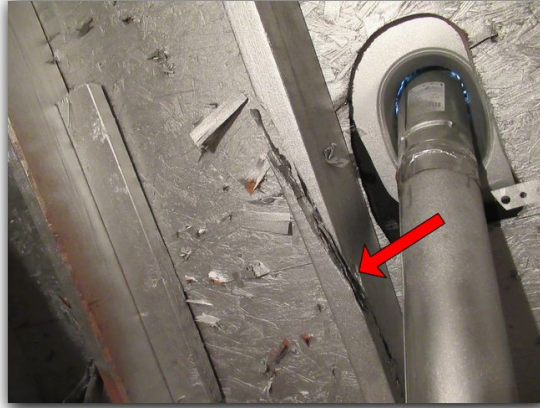
Cracked Rafter

A cracked rafter was noted in the attic space on the east slope. Support is considered compromised in this area.

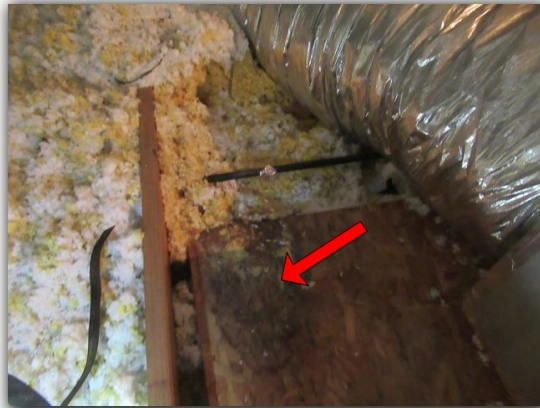
Evidence of Roof Leak

Evidence of a roof leak was noted below the upstairs furnace vent.

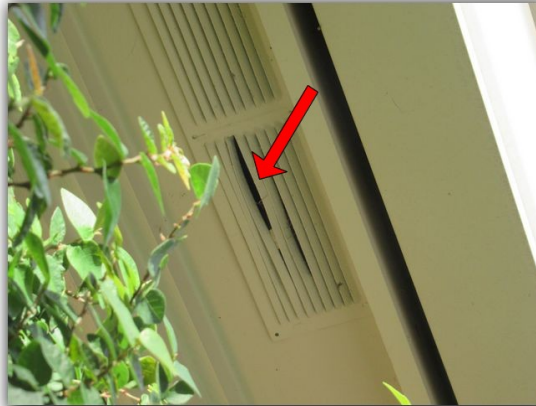
Damaged Louvers on Vents

Damaged louvers on vents should be repaired to prevent insect and vermin entry.

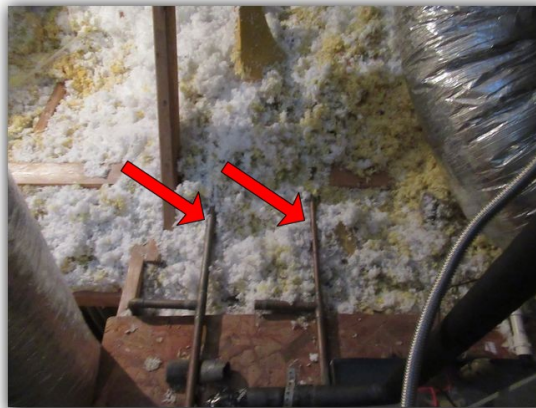
Lack of Insulation on Water Supply Lines

There is a lack of insulation on the water supply lines within the attic space. Improvements should be undertaken to avoid damage to the pipes in freezing weather, which can also result in interior water damage to the home as well.

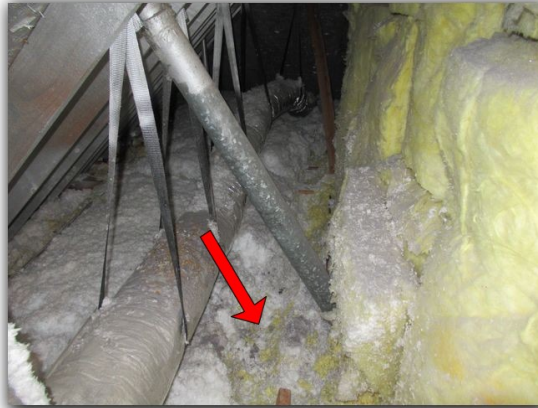
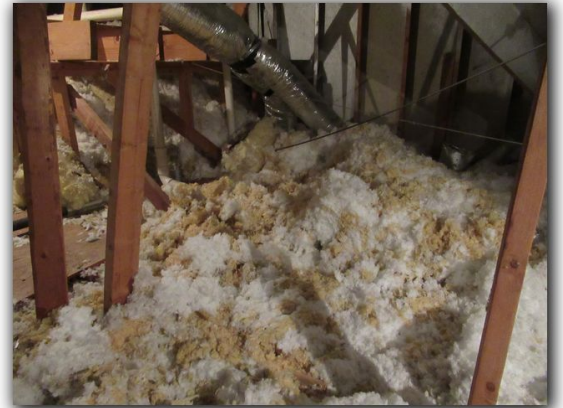
Even Out Insulation

Insulation should be evened out.

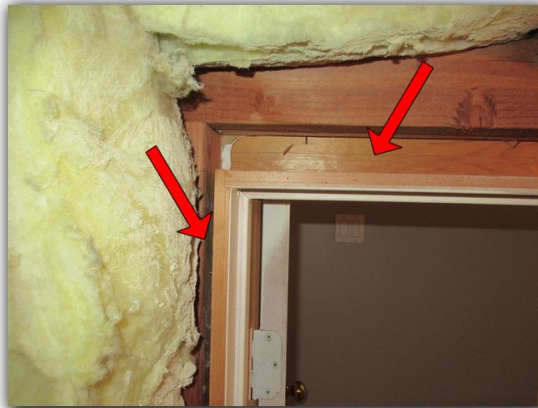
Lack of Insulation- Around Door Frame

There us a lack of insulation around the attic access door frame and the wall framing.

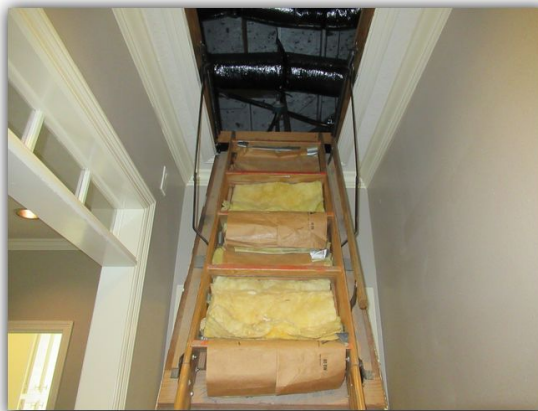
Access Hatch Needs Insulation

Ideally, the attic access hatch should be insulated and weather stripped.

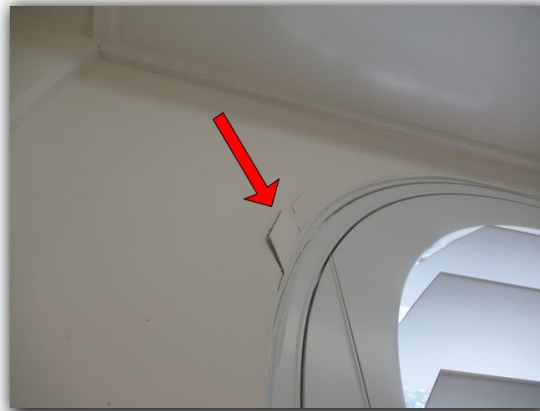
Damage Noted

Damage was noted to the interior finish was observed in the following listed locations.
garage
at master bedroom window

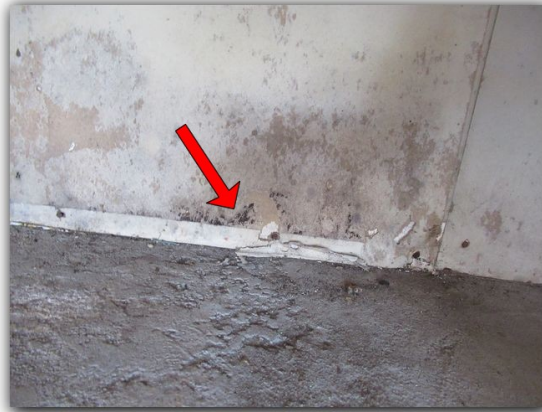
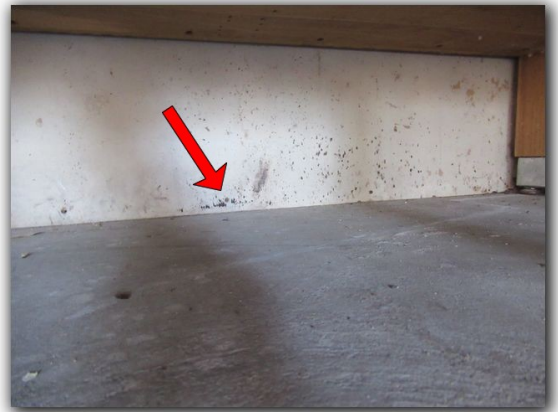
Mold/Mildew Type Substance Present

Signs of a mold/mildew type substance was observed in the following listed room(s).
The cause should be investigated and/or repaired to prevent further damage.
Recommend further investigation and testing by a licensed professional mold inspector.
garage

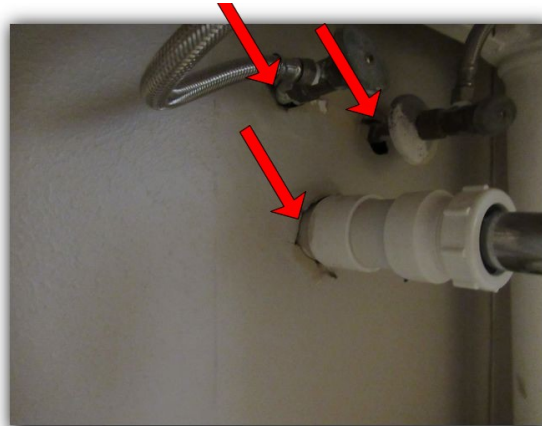
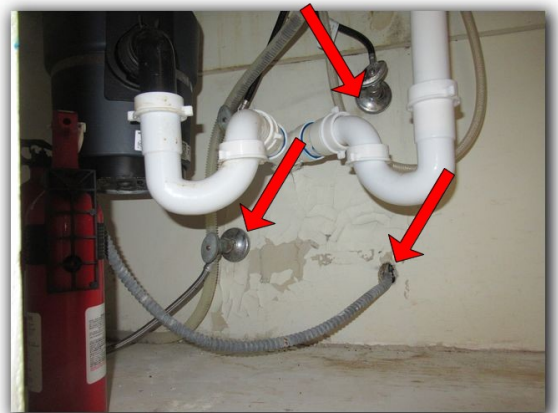
Seal Escutcheon

All escutcheon around at the plumbing penetration should be properly sealed to the wall under the kitchen sink and all bath vanities.

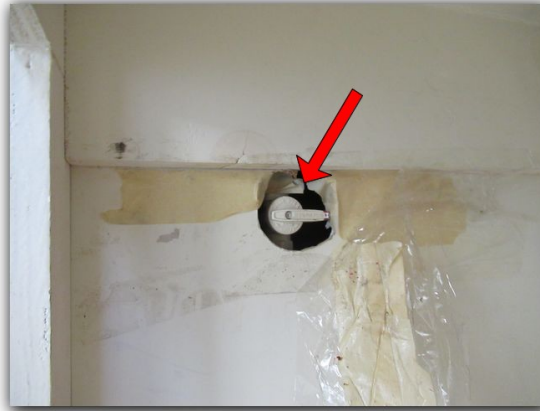
Wall Opening

A wall opening exist around the gas valve for the fireplace. This resulting in the movement of unconditioned air into the living space.

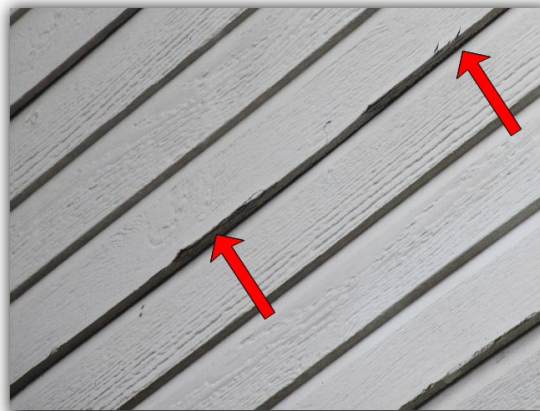
Hardboard/Composite Type Siding

The siding on the house is hardbaord/composite type of material. The siding is known for premature failure. Decayed material was noted on the north and the east sides of te house. This material requires a great deal of maintenance to prolong it's life, it is necessary to maintain complete sealing of all penetrations and joints as well as solid paint coverage on the face and edging paying close attention to all bottom rows of material above the ground and roof surface. Replacement maybe necessary in te near future.

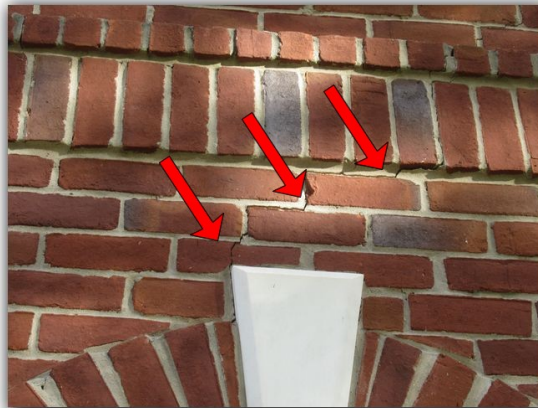
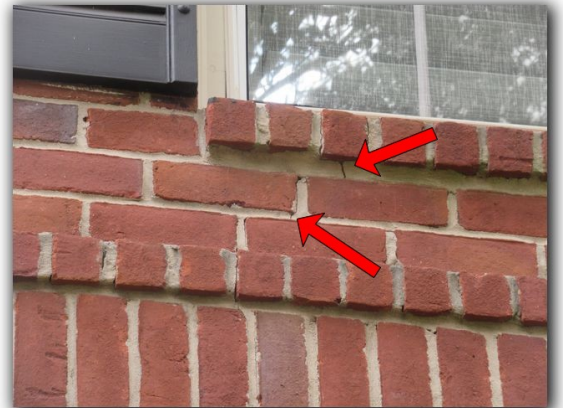
Brick veneer cracks were observed on the exterior walls of the house. This implies that structural movement of the building has occurred.

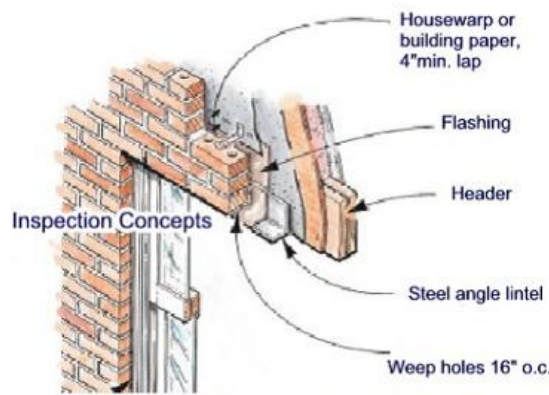
Lintels: Lack of Flashing

There does not appear to be any required flashing above the lintels as required for proper drainage. This can result in deterioration of the lintels as moisture comes in contact with the metal lintel.

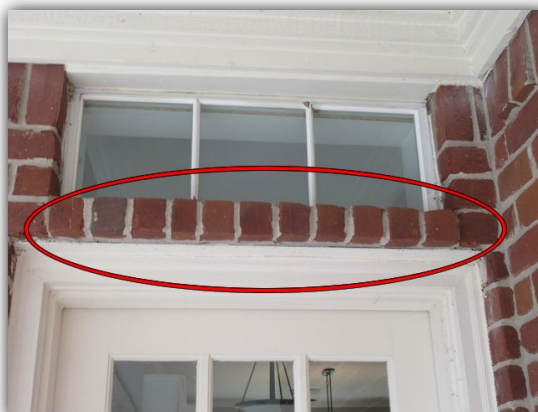
Rusted Lintels

Corrosion is present in the form of rust on the lintels. It is recommended to have rust removed and paint lintels to avoid further corrosion of the lintel.

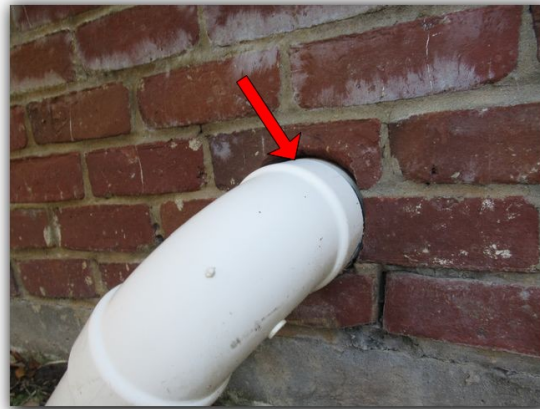
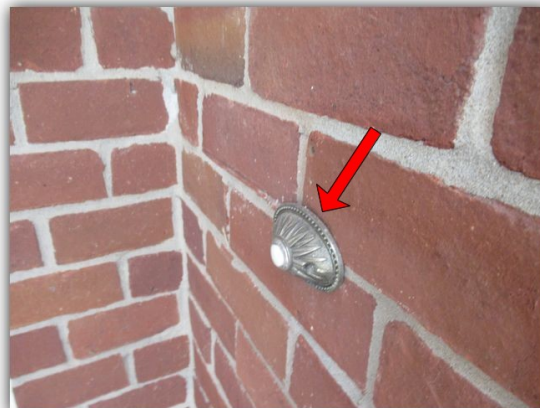
Deteriorated Sealant/Caulk: Various Locations

All deteriorated sealant/caulk should be replaced around windows, doors, vents, wall penetrations, exterior lights, ect.

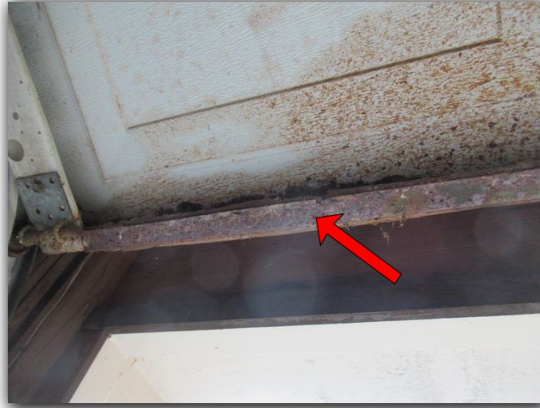
Overhead Garage Door Corrosion

Corrosion was noted to the bottom of the single car garage door.

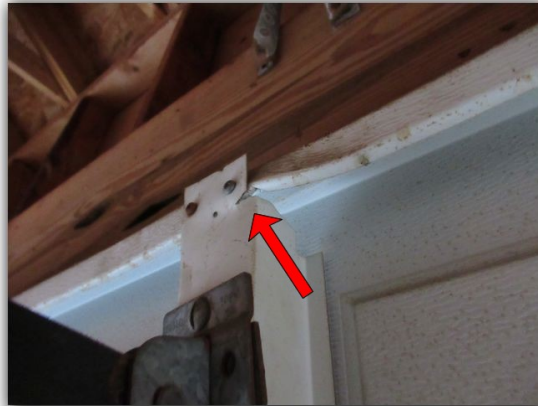
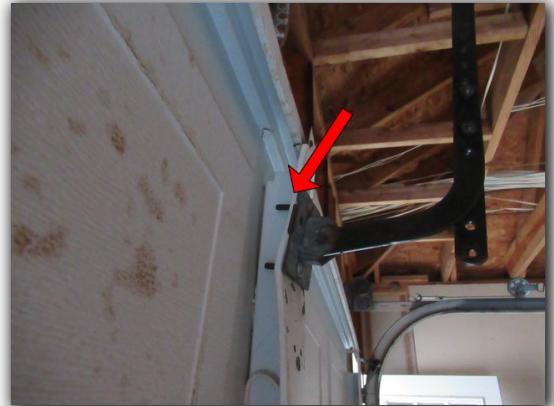
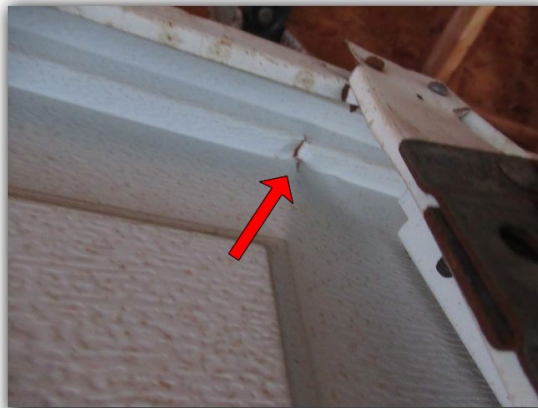
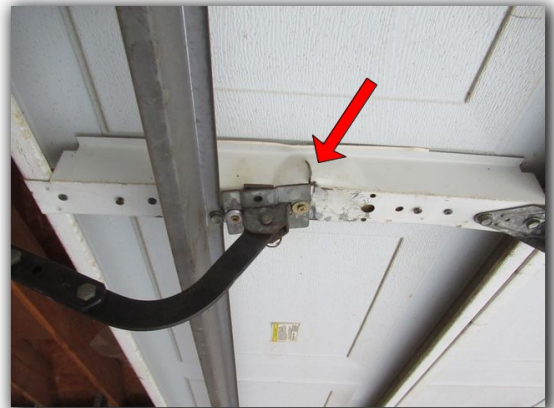
Garage Door Damage

Damage was noted to both overhead garage doors.

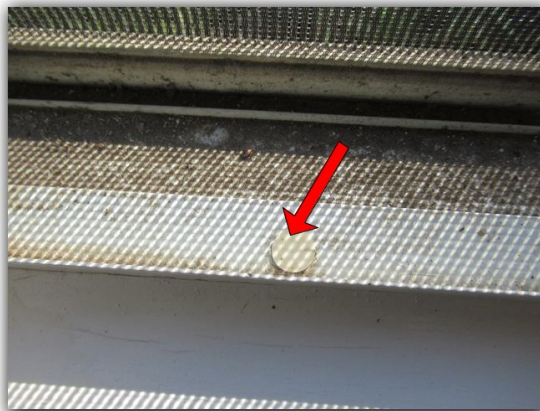
Penetration of Window Weeping System

The installation of the alarm contacts penetrates the windows weeping system. This can result in the entry of water into the wall cavity if the contacts are not sealed or the sealant fails. While most contacts are sealed some of the seals have failed and should be re-sealed. The drilling of the weeping system of the window system also voids most manufacture warranties.

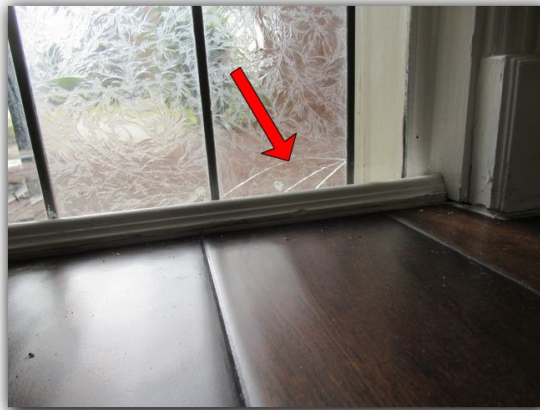
Window Cracked

The window adjacent to the front door is cracked.

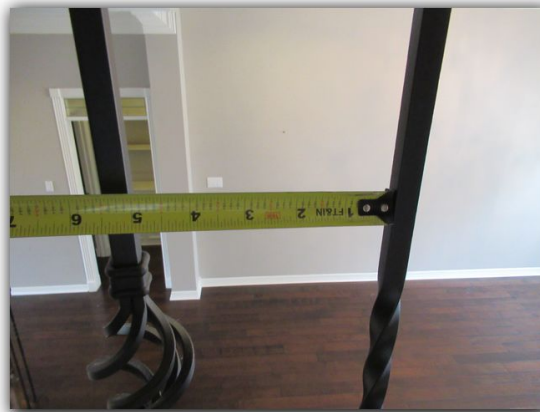
Railing Openings

The openings in the railings are large enough to allow an object larger than four inches to fall through. It is recommended that this condition be repaired for improved safety.

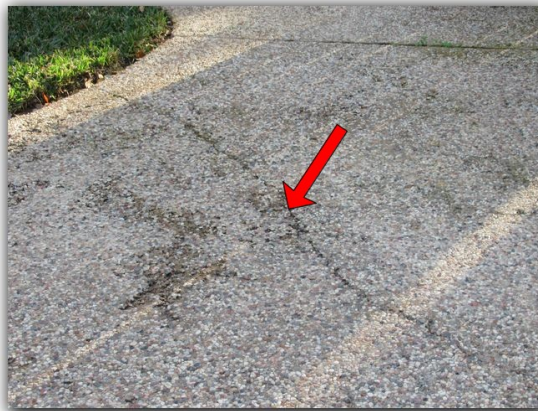
Patio: Larger Cracks

Larger than typical cracks and/or deficiencies were observed in the back patio.

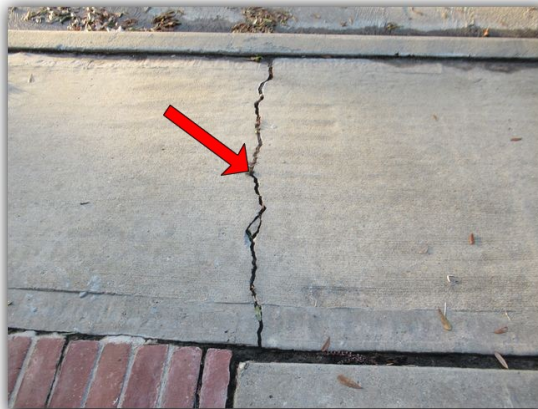
Sidewalks: Larger Cracks

Larger than typical cracks and/or deficiencies were observed in the sidewalk.

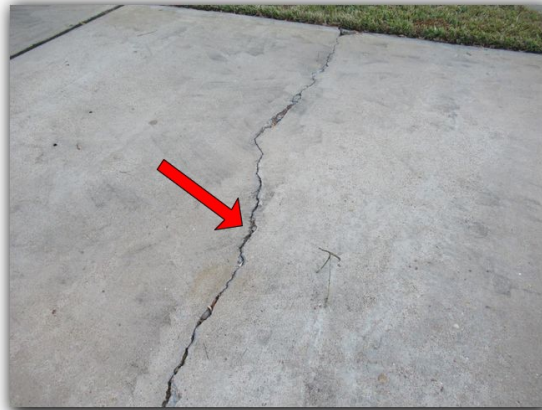
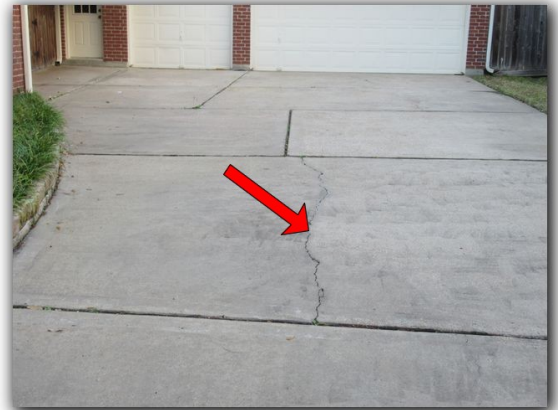
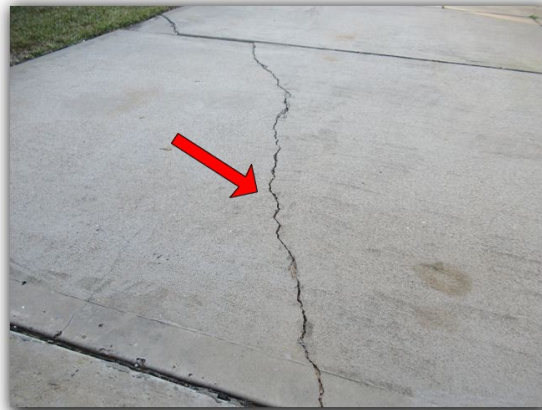
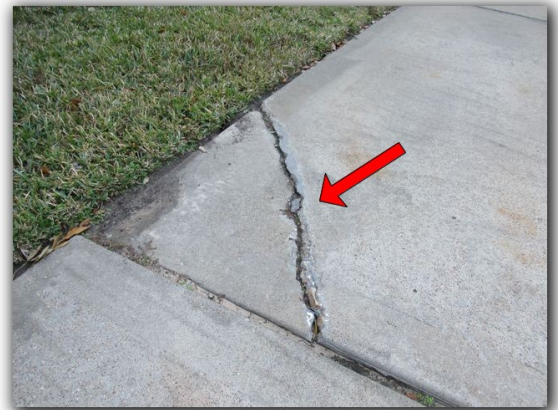
Driveway: Larger Cracks

Larger than typical cracks and/or deficiencies were observed in the driveway.

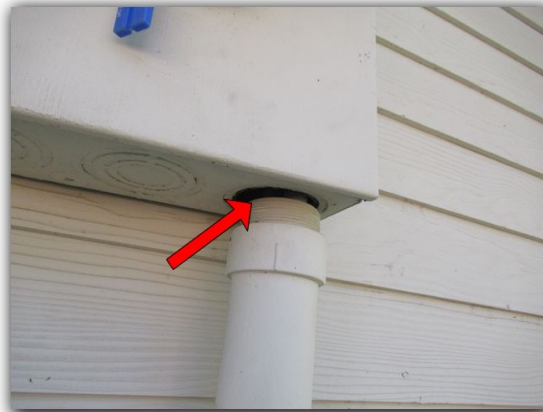
Conduit Pulled Loose Meter Housing

The conduit protecting the service wires under the electrical meter cabinet has pulled loose and needs to be re-secured for reasons of safety and wiring protection.

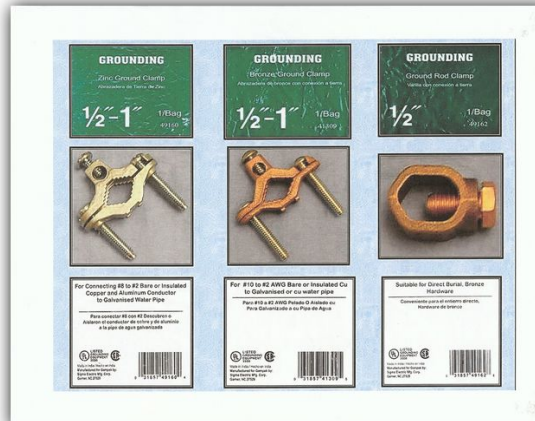
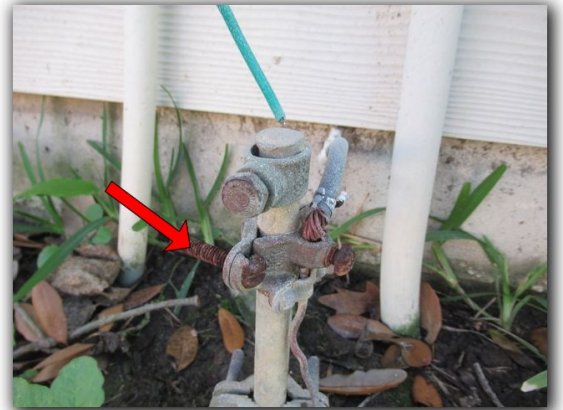
Breakers Not Marked

Not all breakers are properly identified.

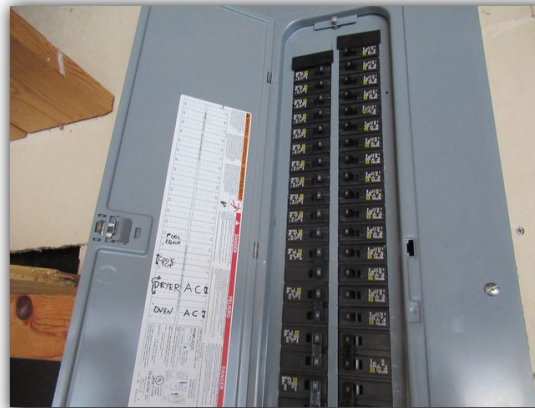
Combustible Debris

Combustible debris was noted in the bottom of the panel. The combustible debris should be removed for fire safety reasons.

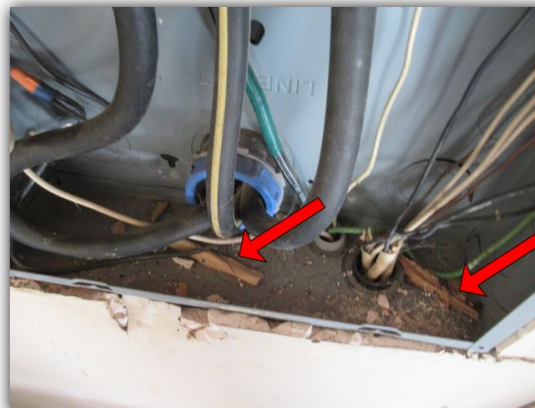
Cables Improperly Secured

The main rule of the National Electrical Code 312.5 (C) prohibits the installation of several cables bunched together and run through a knockout or chase nipples. Individual cable clamps or connectors are required to be used with only one cable per

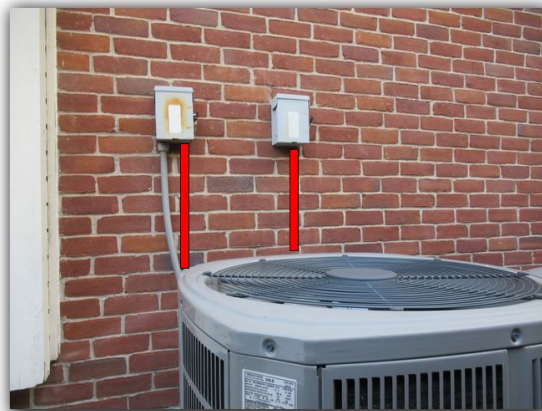
Electric Cooktop: Wiring Conduit Not Secured

The wiring leading to the cooktop is not properly secured to the unit to protect the wiring.

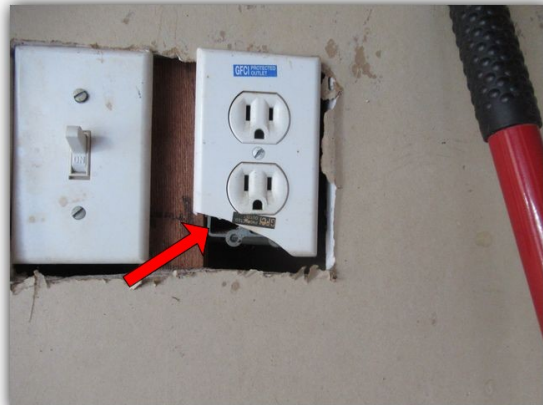
Receptacle(s): Damaged

The following listed receptacle(s) were observed to be damaged. All damaged receptacles be replaced for personal and fire safety.
southwest bedroom (ground slot blocked)

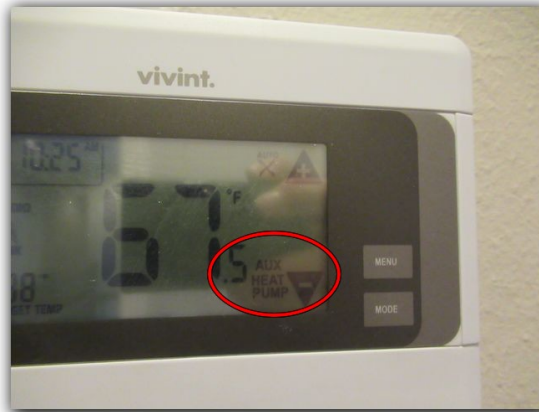
Improper Thermostat

It appears the thermostat for unit is improper. As thermostat is displaying "heat pump" but none of the equipment data plates indicate the equipment is a heat pump. Was never able to get the unit to heat properly.

A qualified heating and cooling technician should be consulted to further evaluate the system and make necessary repairs.

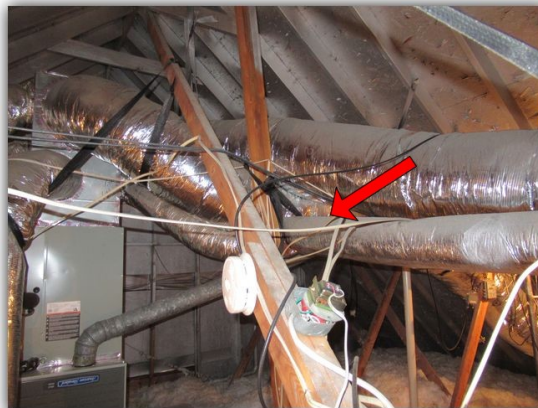
Improperly Supported Ducts

The supply ducts do not appear to be properly supported at 5-foot intervals with 1 1/2 - inch wide straps with no more than 1/2 - inch of sag per foot. Corrections should be undertaken to avoid restrictions in air flow.

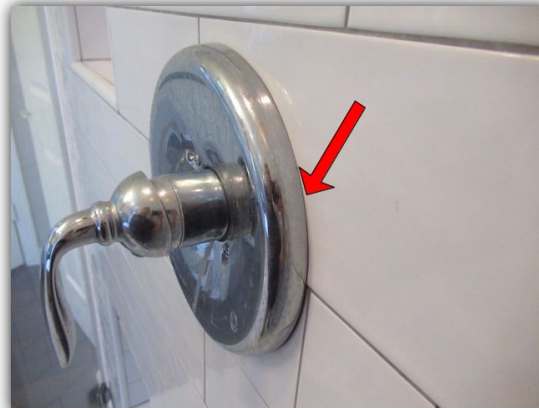
Shower: Seal Shower Fixtures

The master bath shower fixtures are not sealed to the shower surround tile. It is recommended these fixtures be sealed to the shower surround/tile to avoid water intrusion into the wall cavity.

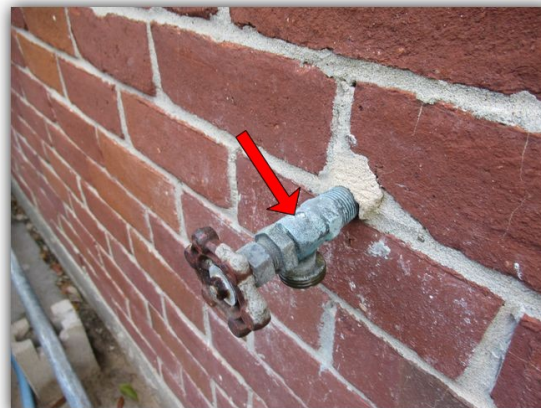
Exterior Faucet: Lack of Anti Siphon

There is no anti siphon device installed on the exterior faucets.

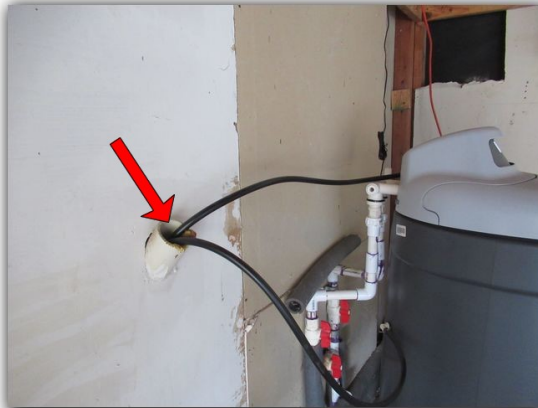
Lack of Air Gap: Possible Cross Contamination

There is a lack of an air gap on the drain line from the water softener equipment. This can result in cross contamination of the water supply.

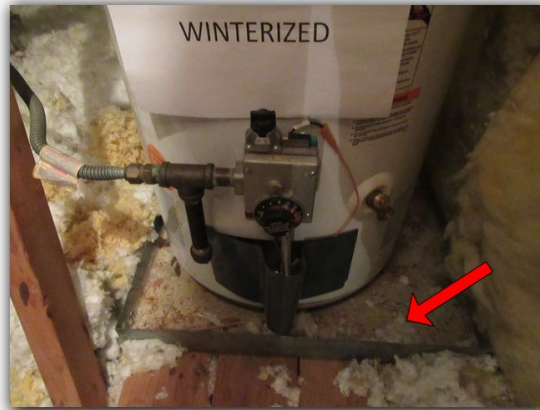
Disconnected Plumbing Strap

The plumbing strap is disconnected. A plumbing strap needs secure the vent properly to the structure as required.

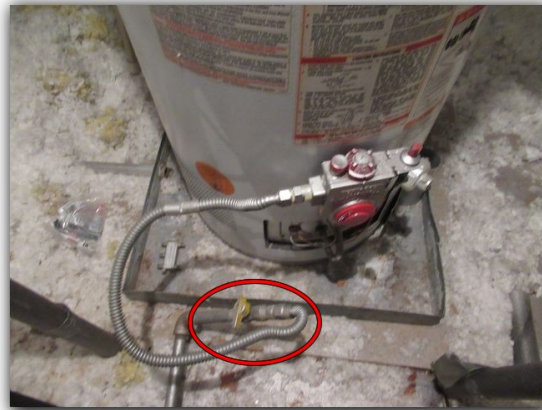
Lack of Sediment Trap On Gas Line

There was no sediment trap found on the gas line servicing the water heating equipment. The trap is intended to catch foreign material before it gets into gas valves, burners, etc. Implications include equipment malfunction because of foreign material entering the equipment. There is also a safety issue, as foreign material could block a valve, preventing it from closing completely.

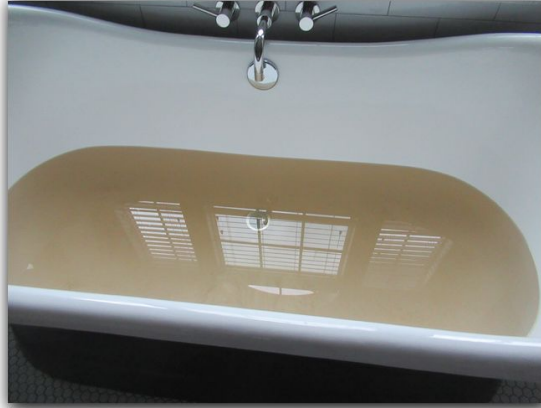
Brown Water at Fixtures

Brown water was observed at the fixtures when the water was operated. This is good indicator that the water heater is near end of its life expectancy.

A qualified professional licensed plumber should be consulted to further evaluate the hot water heater and make necessary repairs and/or replace the unit.

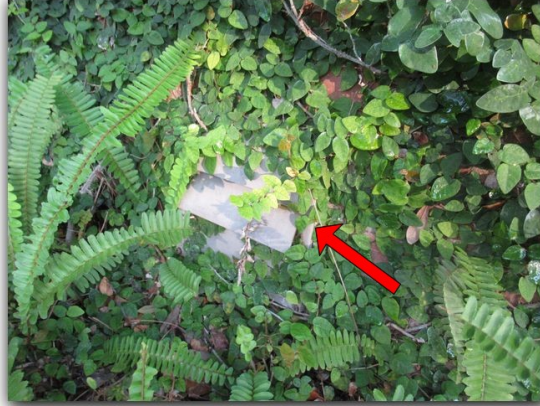
Back Draft Blocked

The back draft damper is blocked by vines. As a result the back draft damper can not fully open.

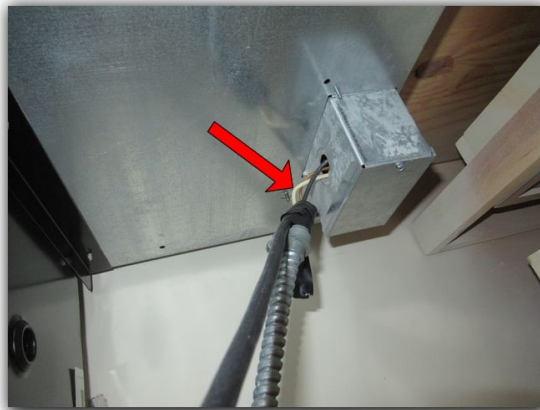
Electric Cooktop: Wiring Conduit Not Secured

The wiring leading to the cooktop is not properly secured to the unit to protect the wiring.

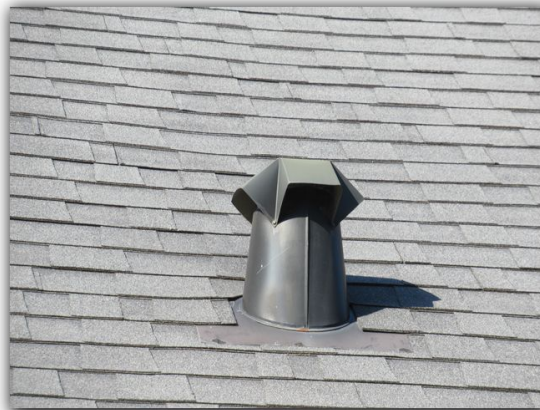
Lack of Back Draft Damper

There is no back draft damper on the vent termination as required. Back draft dampers should be installed to avoid outdoor air infiltration during periods when the dryer is not operating and prevent the entry of animals.

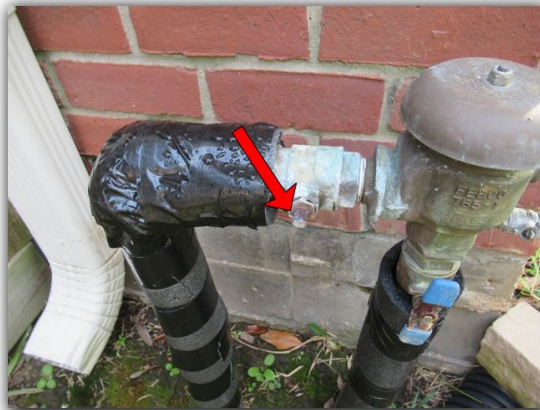
Anti-Siphon Improper Height

Anti-siphon valves are required to be 12" taller than any sprinkler head. Improvements should be undertaken.
