RESIDENTIAL INSPECTION REPORT

5947 Mockingbird Ln Sealy, TX 77474

By: Gonzales Dowdell - TREC #23532 06/19/2020 3:00 pm

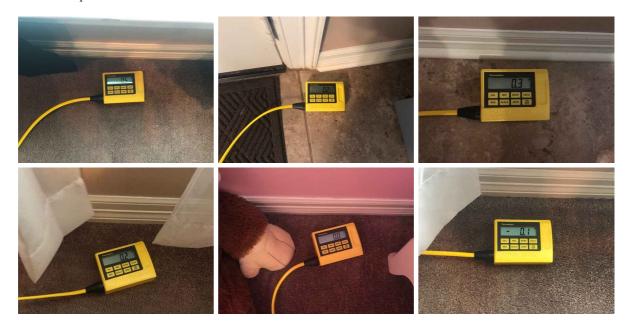
Foundation Inspected with Digital Level:

This foundation was measured with the use of an electronic digital measurement tool. Multiple elevation points were registered on the foundation throughout the property to determine if there were elevation variations that indicated excessive movement of the foundation. At the time of this inspection the measured areas did not indicate any variations that, in this inspector's OPINION, indicated any need for invasive repairs to the foundation.
