Inspection Report

Property Address:
3805 Shelby Circle
Houston Texas 77051

Shammah Inspection Group

Date: 8/10/2019	Time: 09:00 AM	Report ID: 156
Property: 3805 Shelby Circle Houston Texas 77051	Customer: Rahwa Baatai	Real Estate Professional: Saba Asfaha

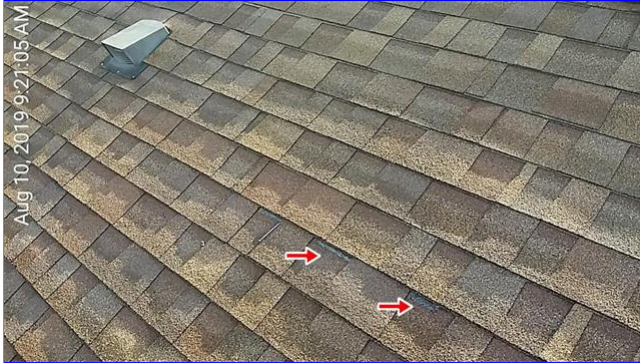
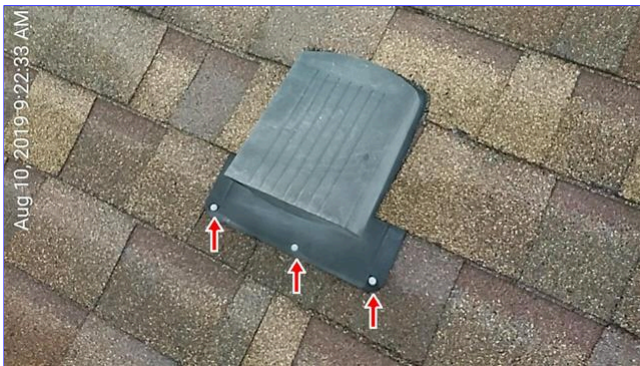
(7) Exterior Left Rear Roof - The exhaust vent flange nails were not sealed at the time of the inspection. Recommend sealing the nail heads to prevent deterioration.

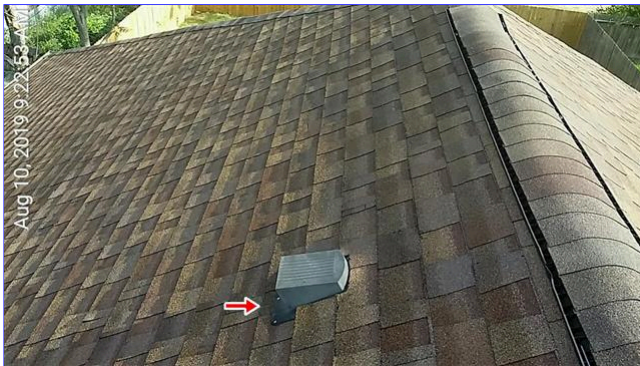
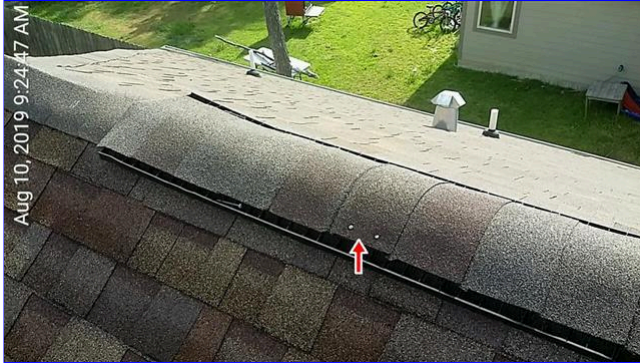
(8) Exterior Left Rear Roof Ridge - Observed exposed nails on the roof ridge vent at the time of the inspection. Recommend sealing the nail heads to prevent deterioration.

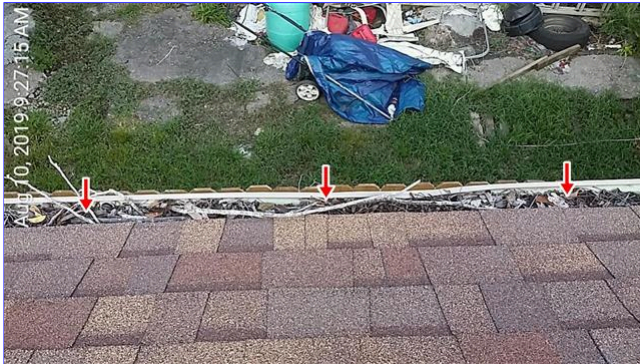
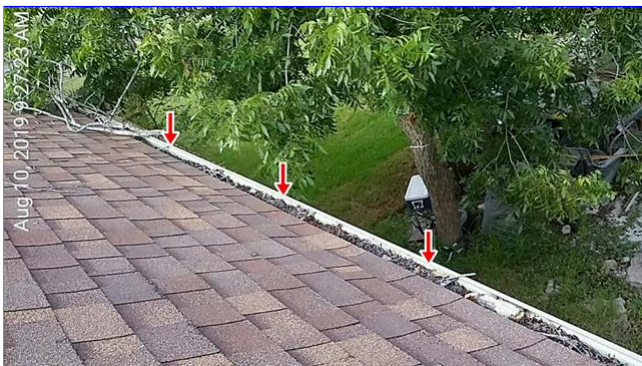
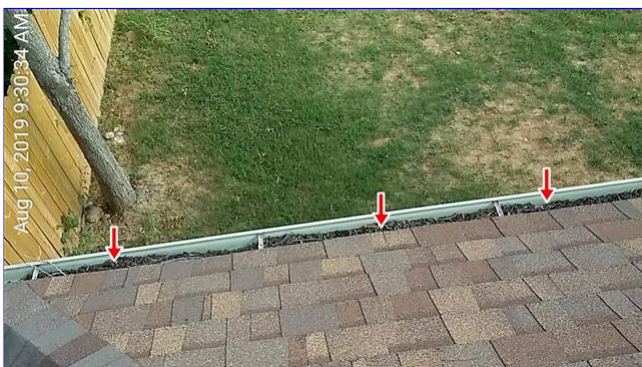
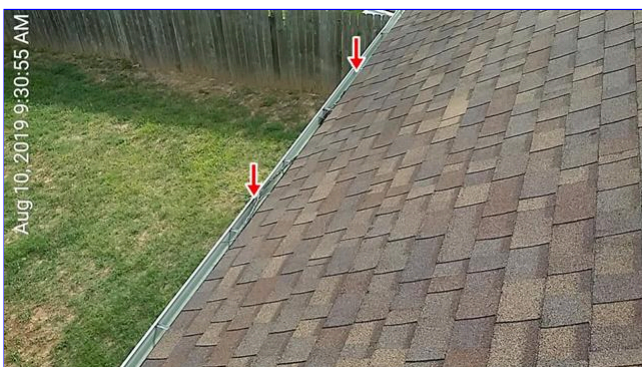
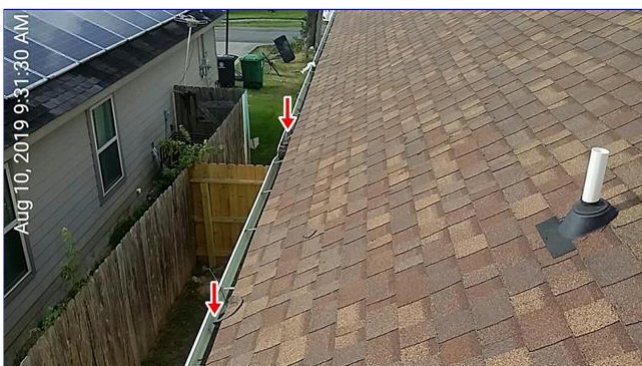
(9) Exterior Left Rear and Right - Recommend removing the debris from the gutters to allow proper water flow inside the gutters.

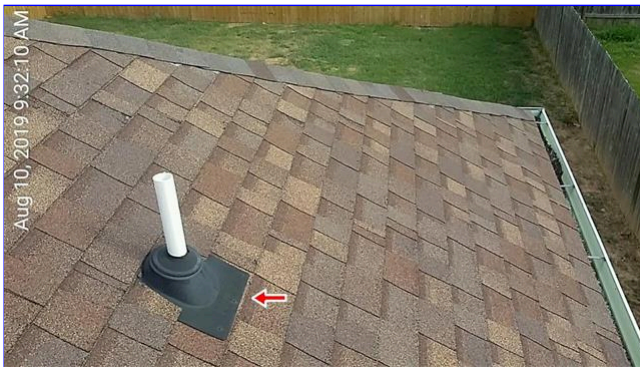
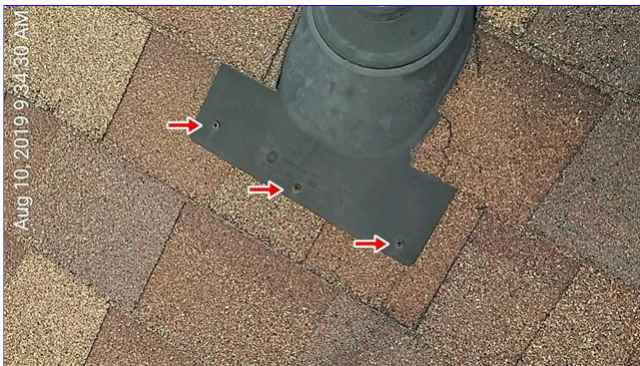
(10) Exterior Right Rear - The plumbing vent flange nails were not sealed at the time of the inspection.

Recommend sealing the nail heads to prevent deterioration.

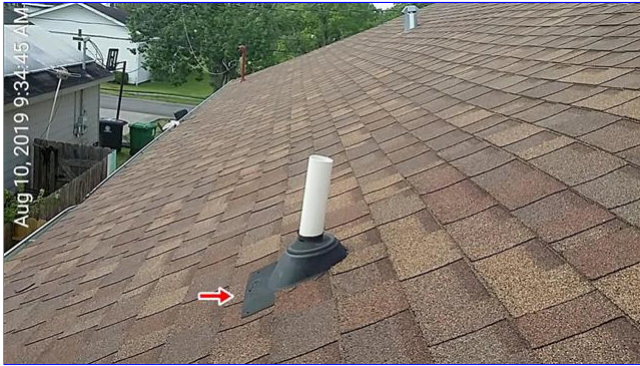
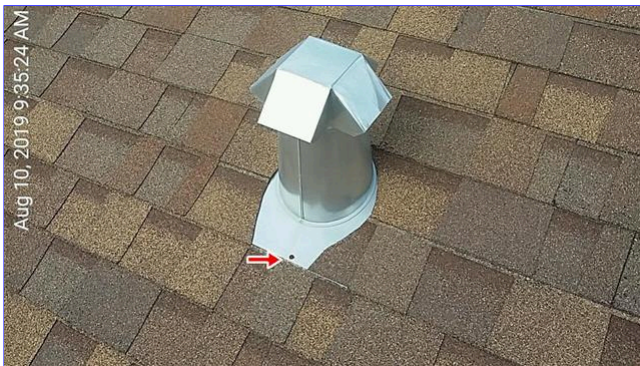
(11) Exterior Right Middle Roof - The plumbing vent flange nails were not sealed at the time of the inspection. Recommend sealing the nail heads to prevent deterioration.

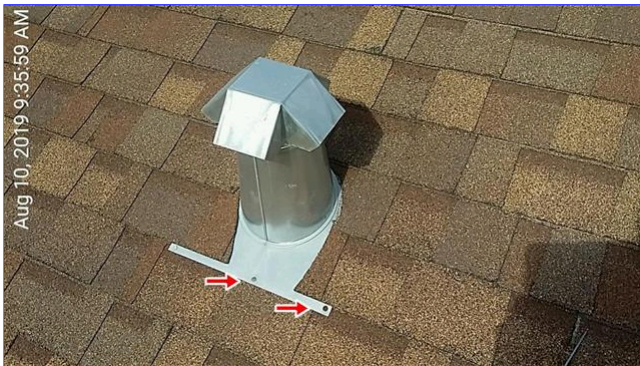
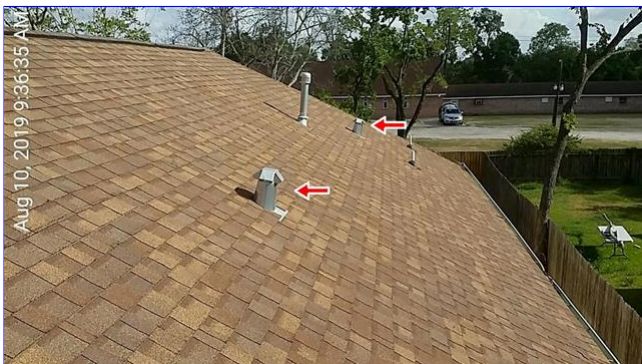
(12) Exterior Right Roof - The exhaust vent flange nails were not sealed at the time of the inspection. Recommend sealing the nail heads to prevent deterioration.

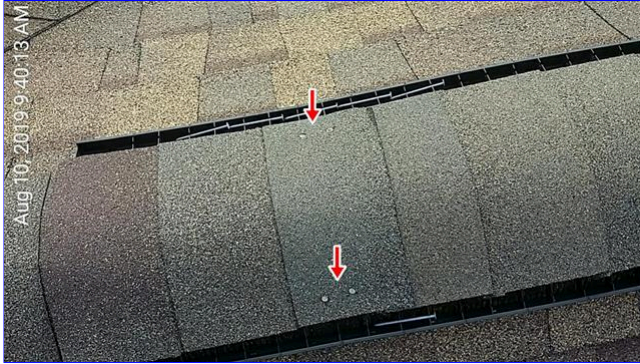
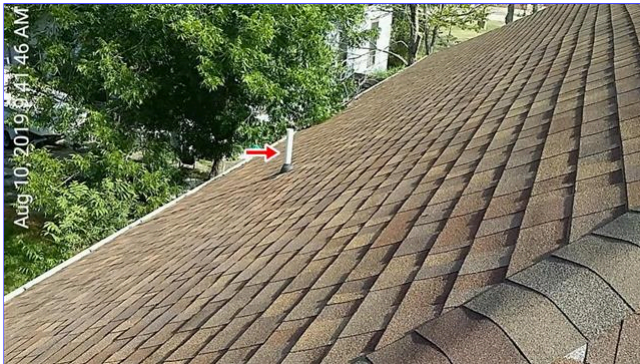
(15) Exterior Left Middle Roof - The plumbing vent was not painted at the time of the inspection. Recommend painting to prevent deterioration.

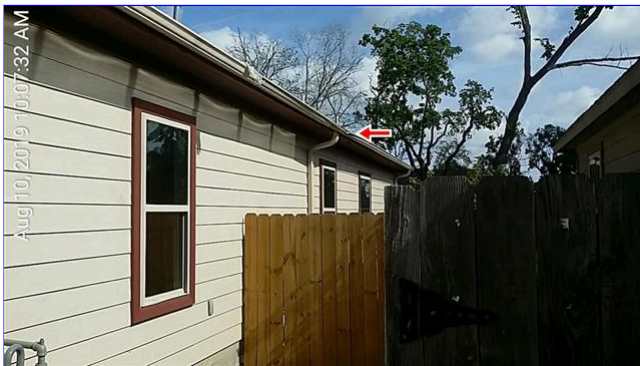
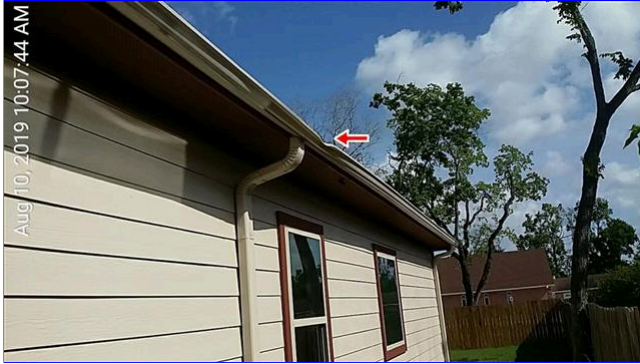
(16) Exterior Right Middle - Observed a damaged gutter at the time of the inspection.

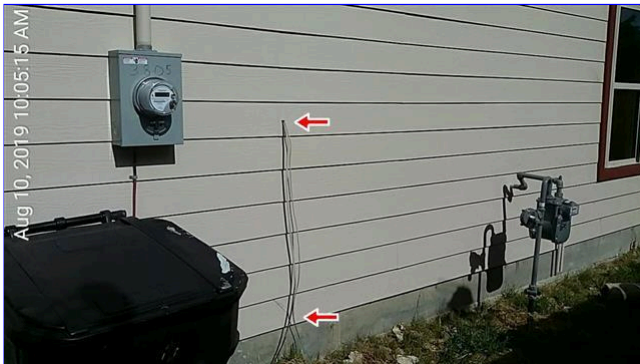
E. Item 1(Picture)

(1) Exterior Right Front - The exterior siding penetrations were not sealed at the time of the inspection.

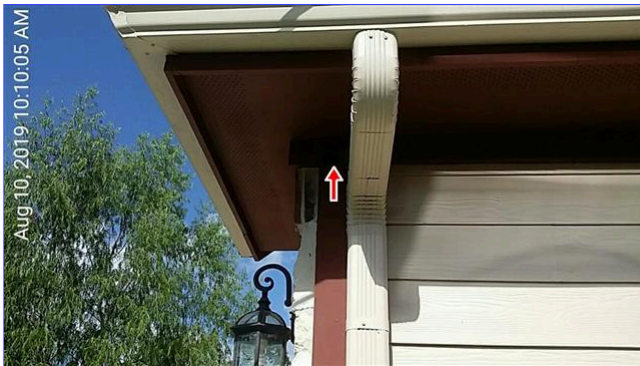
E. Item 5(Picture)

(2) Exterior Right Front - Observed a gap between the brick frieze trim joint at the time of the inspection. Recommend covering the area to prevent pest intrusion.

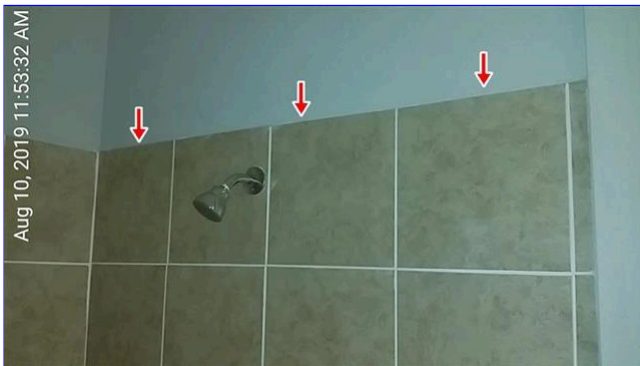
E. Item 8(Picture)

(4) Right Hallway Bathroom - The top of the shower tile wall was not sealed at the time of the inspection.

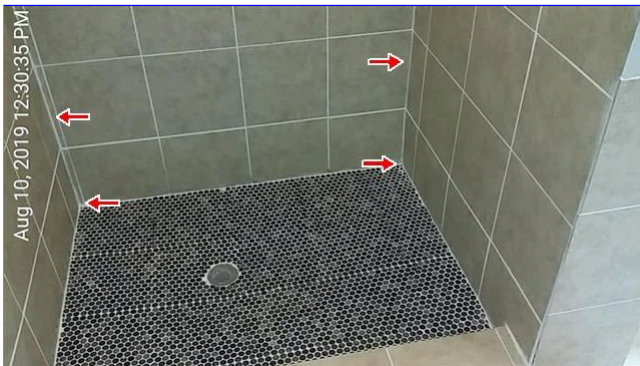
E. Item 11(Picture)

(6) Master Bathroom - The shower floor and wall tile joint were not properly sealed at the time of the inspection.

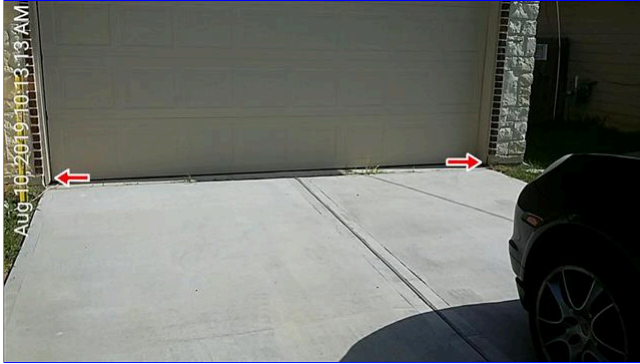
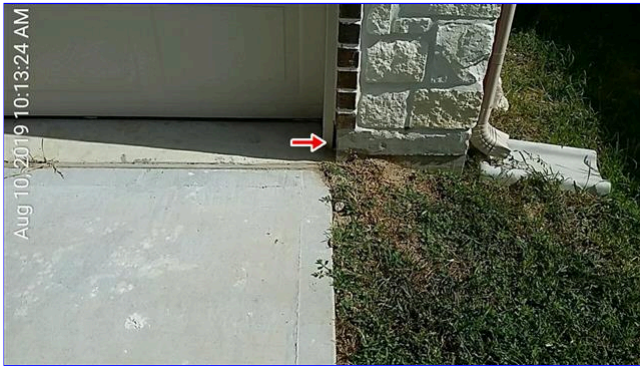
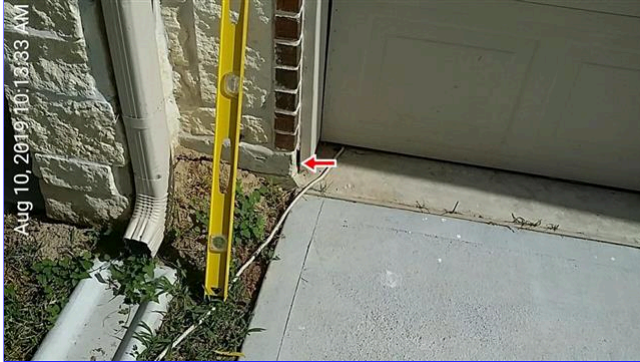
(1) Exterior Front Right - Observed gaps between the left and right garage door trimmers at the time of the inspection. Recommend sealing to prevent water and pest intrusion.

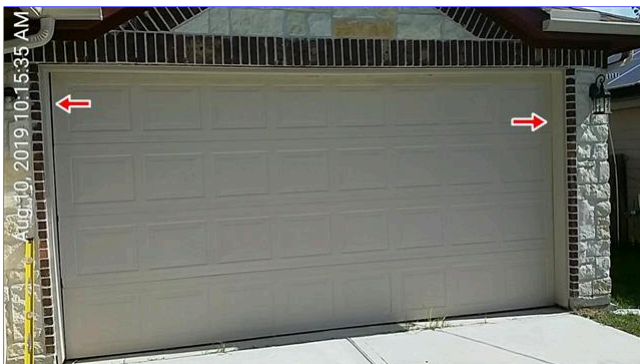
G. Item 4(Picture)

(2) Exterior Front Right - The vehicle garage door was not set properly at the time of the inspection.

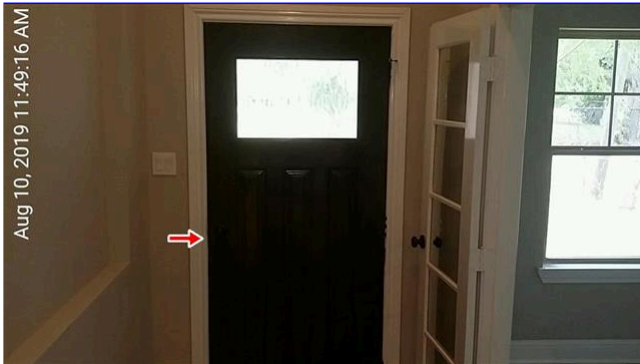
G. Item 5(Picture)

(3) Entry - The exterior front door did not latch properly at the time of the inspection.

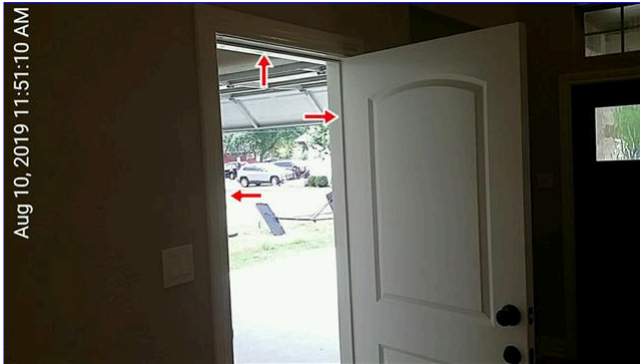
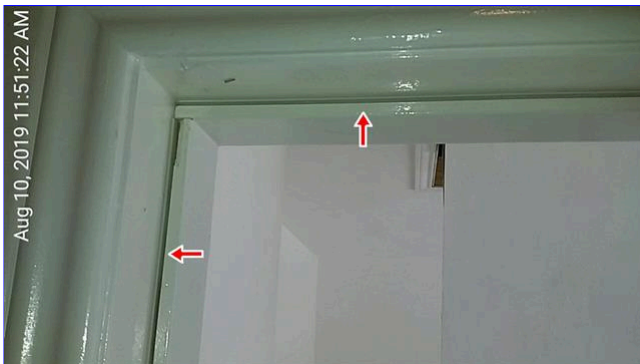
(4) Foyer Right - The garage pedestrian door was missing weather stripping at the time of the inspection.

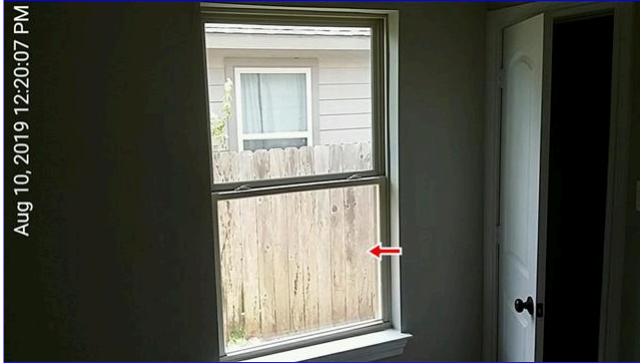
H. Item 5(Picture)

(2) Right Rear Bedroom - The window would not stay open at the time of the inspection.

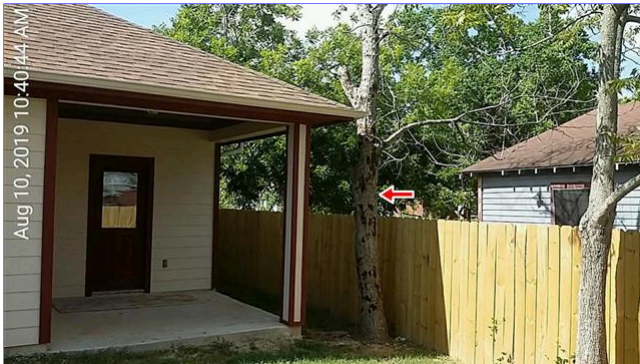
L. Item 1(Picture)

(1) Exterior Left Rear - Recommend removing the tree in the near future to prevent possible damage to the home during a strong storm event.

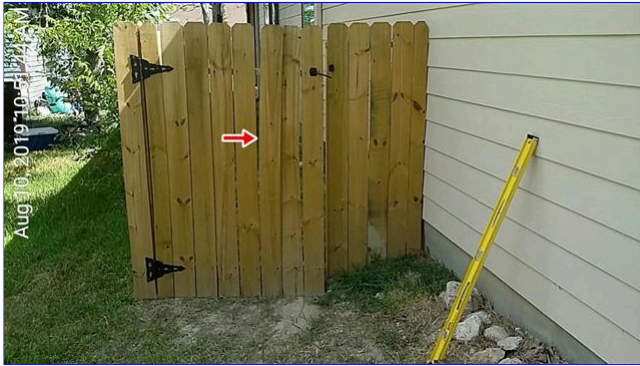
L. Item 2(Picture)

(2) Exterior Left Front - Observed loose pickets on the gate at the time of the inspection.

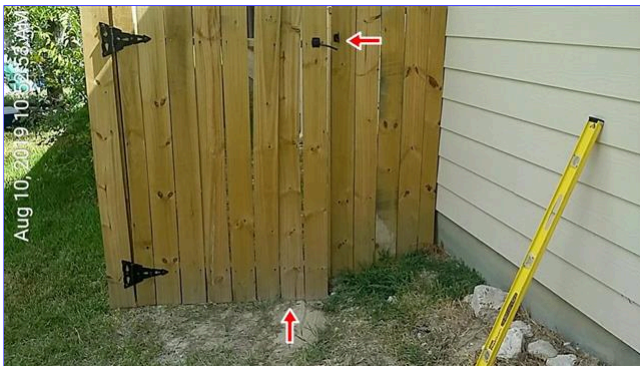
L. Item 3(Picture)

(3) Exterior Left Front - The gate was rubbing the ground and did not latch properly at the time of the inspection.

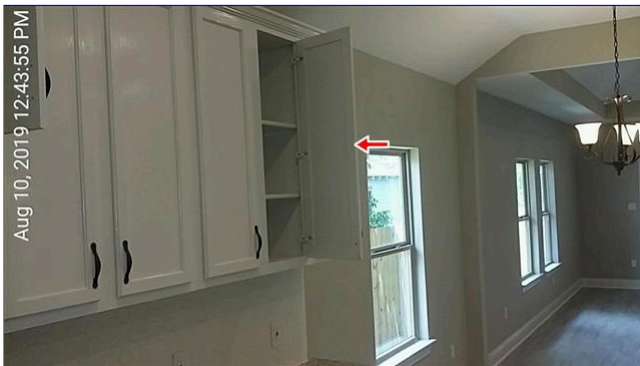
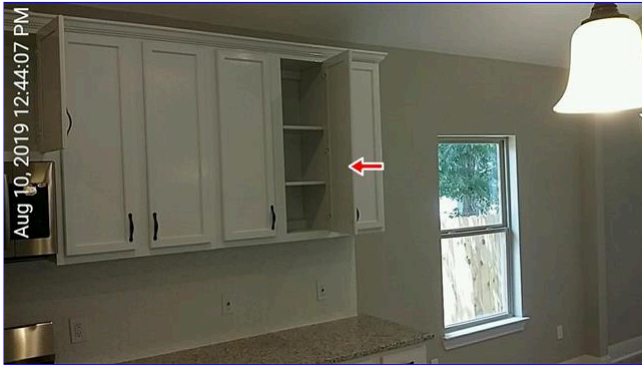
(4) Kitchen - The left rear upper cabinet door was loose at the hinges at the time of the inspection.

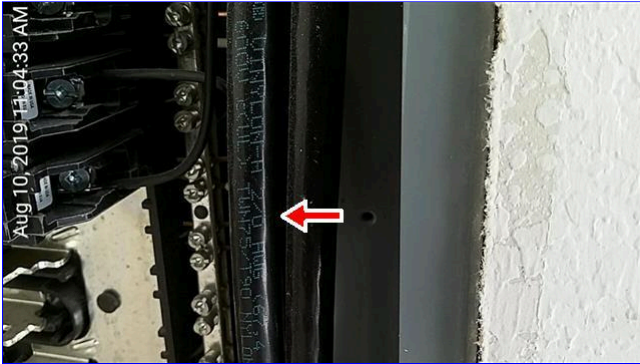
A. Item 8(Picture)

(2) Garage Right Wall - Electrical Panel - Observed a 2/0 AWG aluminum wire connected to a 200 AMP

breaker at the time of inspection. A 200 AMP breaker requires a 4/0 AWG aluminum wire for proper service. Recommend hiring a licensed and experienced electrician to switch the breaker or the service wiring.

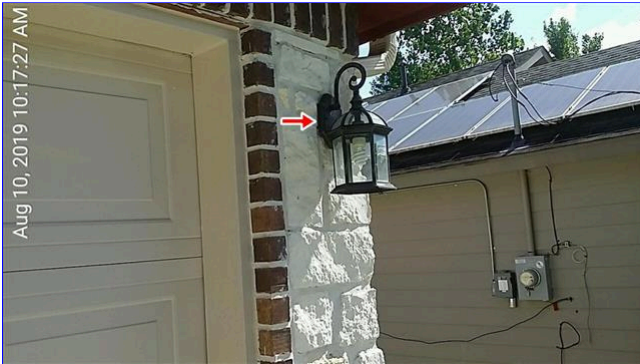
B. Item 1(Picture)

- (1) **Type of Wiring:** Observed type of branch wiring is copper.
- (2) Exterior Front Right - The coach lights were not sealed at the time of the inspection.

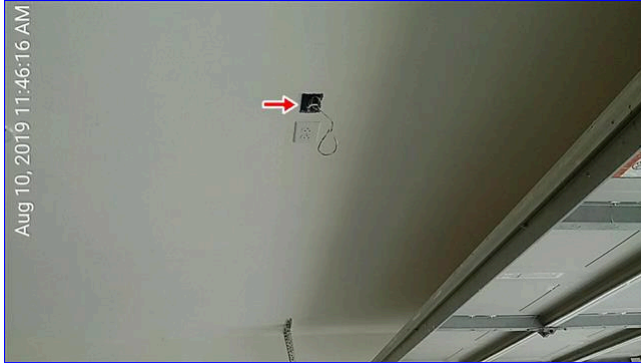
B. Item 3(Picture)

- (3) Garage - Observed a missing cover plate on the garage ceiling at the time of the inspection.

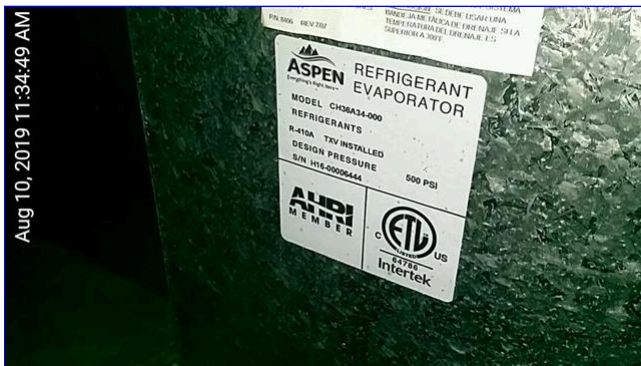
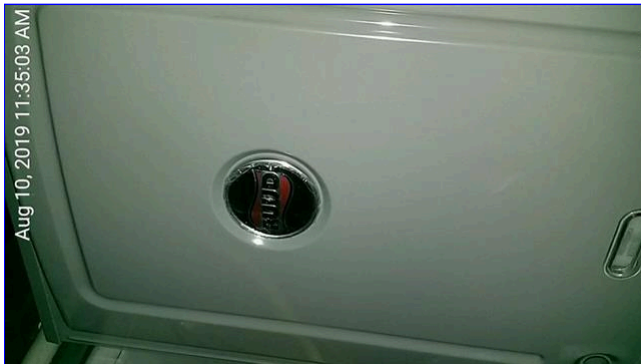
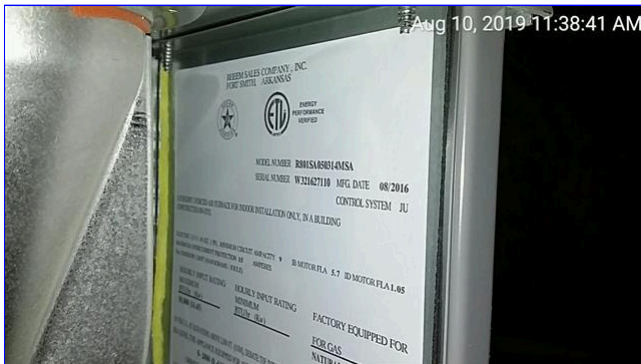
HEATING UNIT: The heater was inoperable at the time of the inspection. Recommend having a licensed HVAC technician examine and service the unit before normal use.

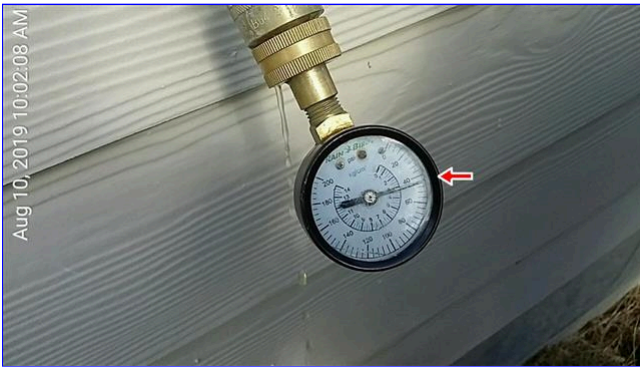
A. Item 2(Picture)

(2) Exterior Left Middle - Recommend adding insulation around the hose to prevent damage during a hard freeze.

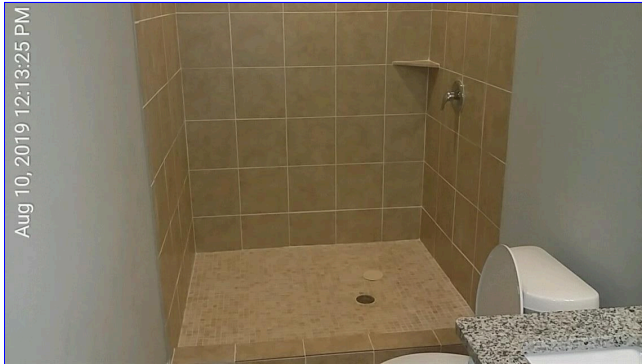
A. Item 4(Picture)

- (4) Kitchen Front Wall - The refrigerator water supply box was missing trim at the time of the inspection.
- (5) Master Bathroom - The shower was missing an enclosure at the time of the inspection.

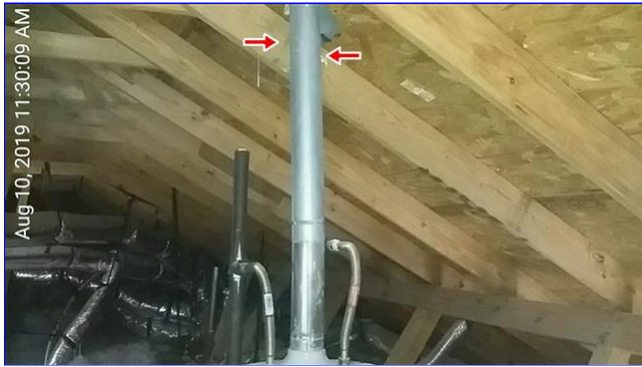
C. Item 1(Picture)

(2) Garage Attic Area - The water heater exhaust vent was not secured and supported properly at the time of the inspection.

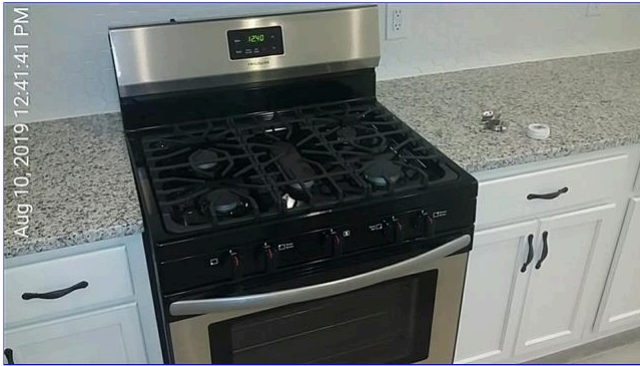
D. Item 1(Picture)

Kitchen - The stove was not connected to an anti-tipping device at the time of the inspection.

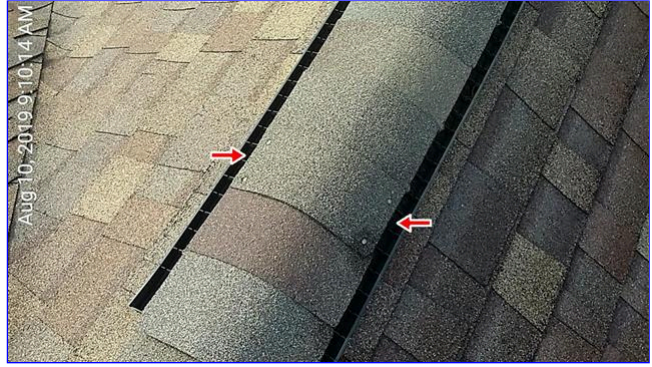
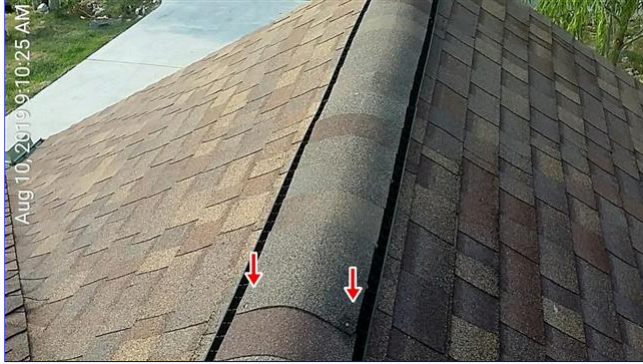
(2) Exterior Front Left Roof - Observed exposed nails on the ridge vent at the time of the inspection. Recommend sealing the nail heads to prevent deterioration.

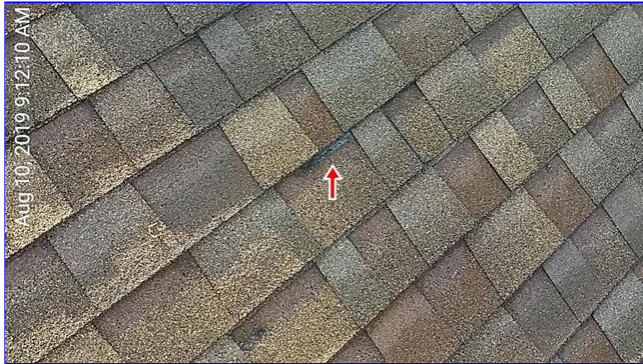
C. Item 14(Picture)

(3) Exterior Left Front Roof - Observed evidence of deteriorated shingles at the time of the inspection.

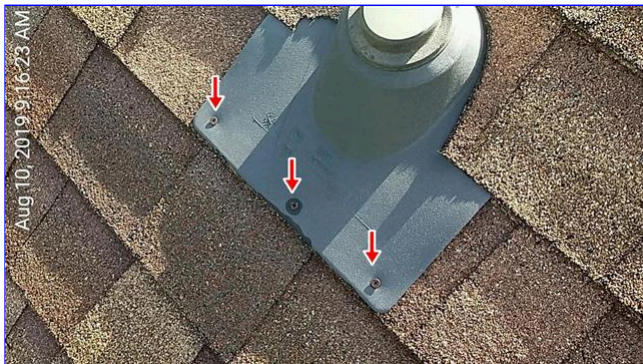
C. Item 16(Picture)

(4) Exterior Left Middle Roof - The plumbing vent flange fasteners were not sealed at the time of the inspection. Recommend sealing the nail heads to prevent deterioration.

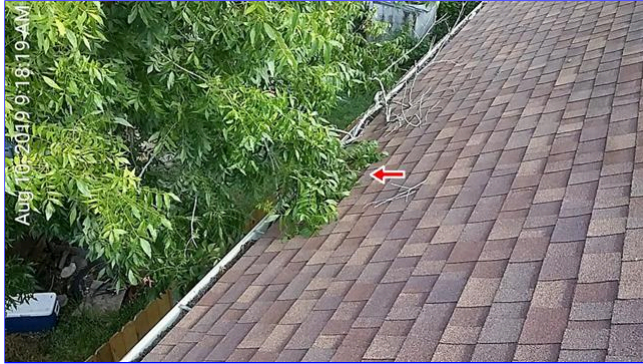
C. Item 18(Picture)

(5) Exterior Left Middle Roof - Observed tree branches rubbing the shingles at the time of the inspection. Recommend removing the tree branches to prevent shingle damage.

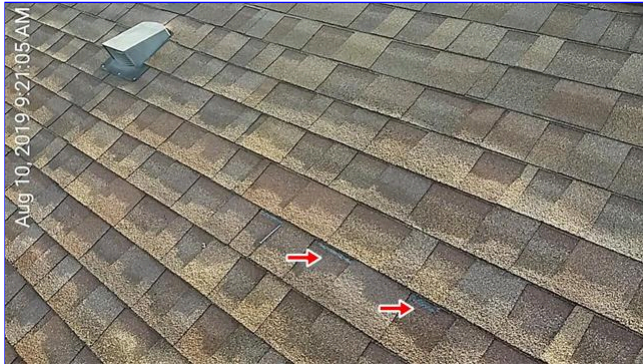
C. Item 20(Picture)

(6) Exterior Left Middle Roof - Observed evidence of deteriorated shingles at the time of the inspection.

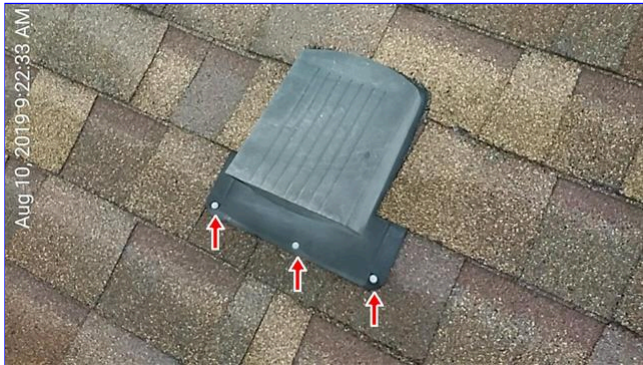
C. Item 21(Picture)

(7) Exterior Left Rear Roof - The exhaust vent flange nails were not sealed at the time of the inspection. Recommend sealing the nail heads to prevent deterioration.

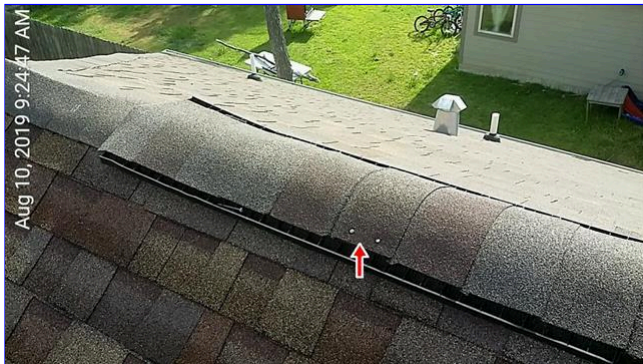
C. Item 22(Picture)

(8) Exterior Left Rear Roof Ridge - Observed exposed nails on the roof ridge vent at the time of the inspection. Recommend sealing the nail heads to prevent deterioration.

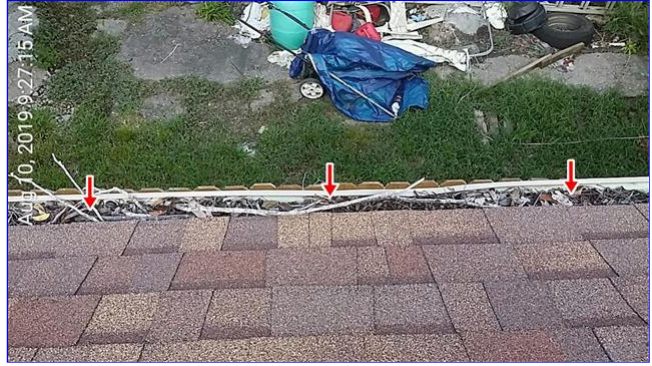
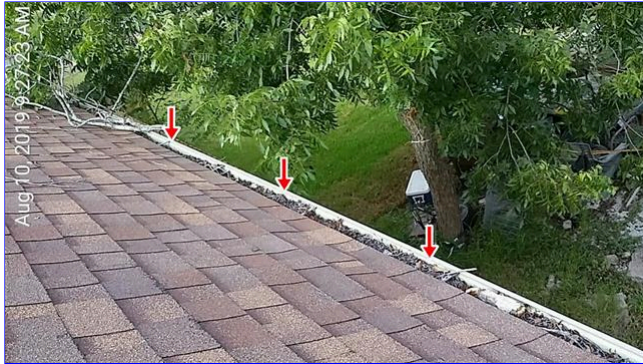
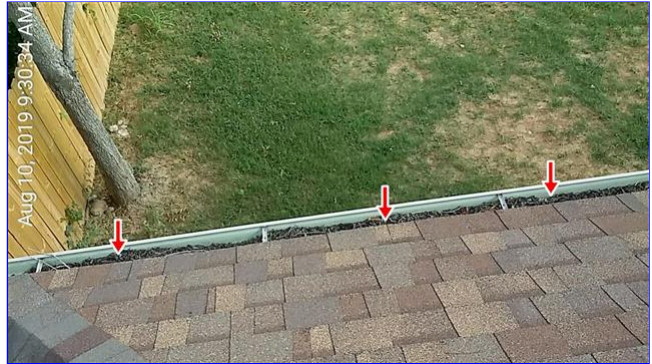
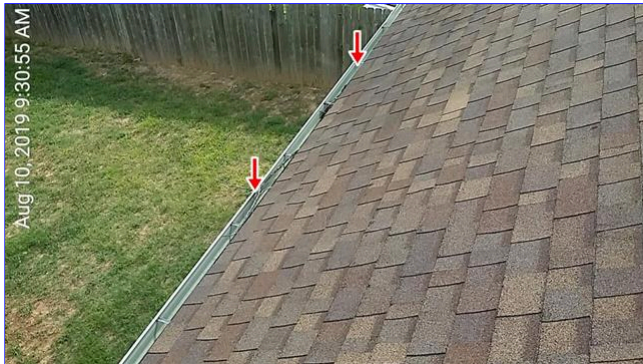
(9) Exterior Left Rear and Right - Recommend removing the debris from the gutters to allow proper water flow inside the gutters.

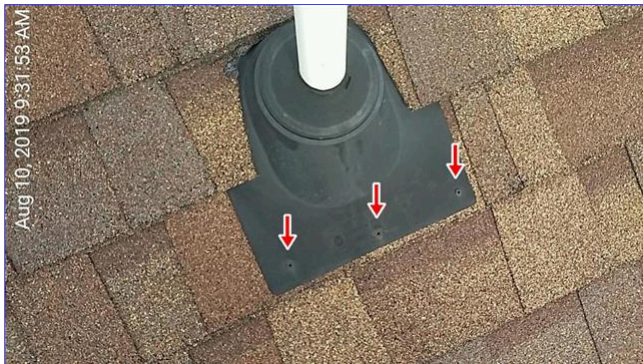
C. Item 29(Picture)

(10) Exterior Right Rear - The plumbing vent flange nails were not sealed at the time of the inspection. Recommend sealing the nail heads to prevent deterioration.

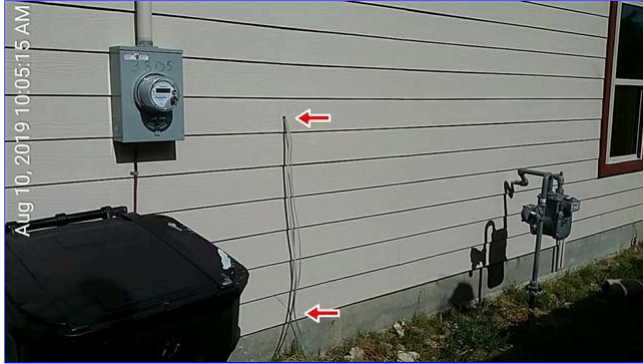
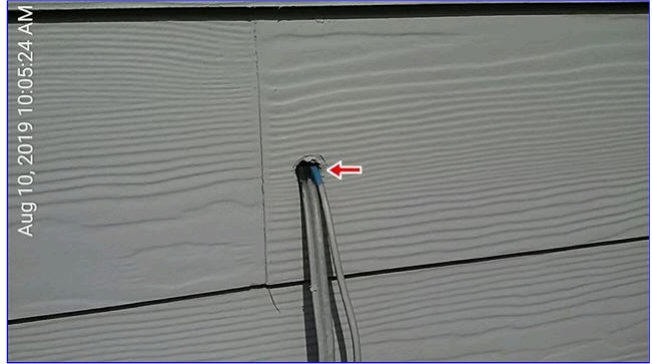
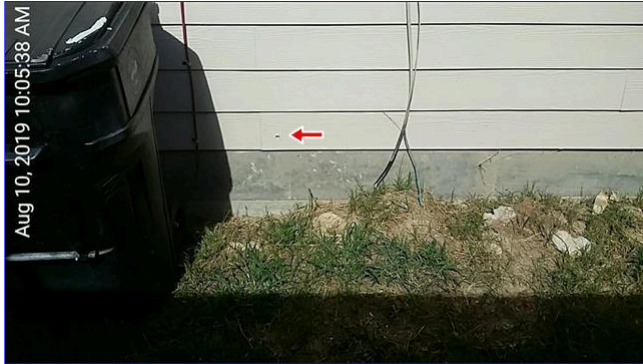
E. Item 1(Picture)

(1) Exterior Right Front - The exterior siding penetrations were not sealed at the time of the inspection.

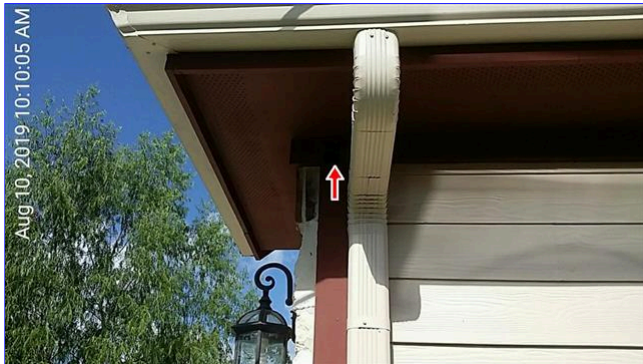
E. Item 5(Picture)

(2) Exterior Right Front - Observed a gap between the brick frieze trim joint at the time of the inspection. Recommend covering the area to prevent pest intrusion.

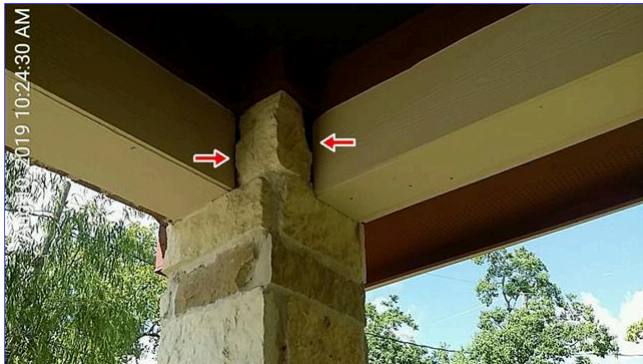
E. Item 7(Picture)

(3) Exterior Front Porch - Left Column - Observed a gap between the stone and cornice trim at the time of the inspection. Recommend pointing up to prevent pest intrusion.

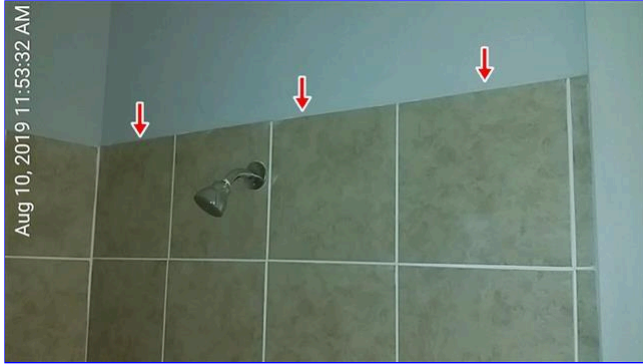
E. Item 8(Picture)

(4) Right Hallway Bathroom - The top of the shower tile wall was not sealed at the time of the inspection.

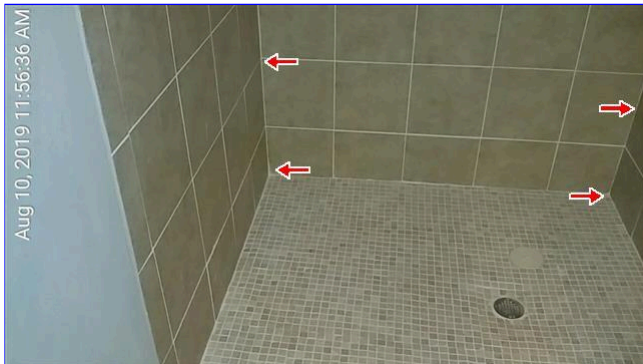
E. Item 10(Picture)

(5) Right Hallway Bathroom - Recommend sealing the shower tile joint to prevent water intrusion.

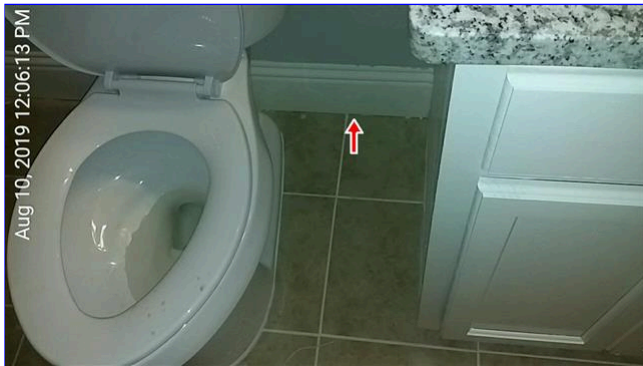
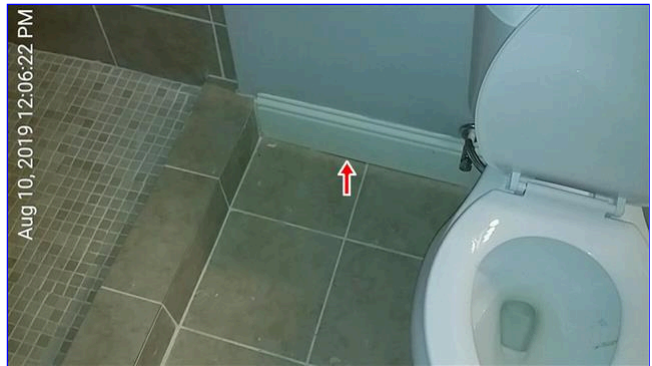
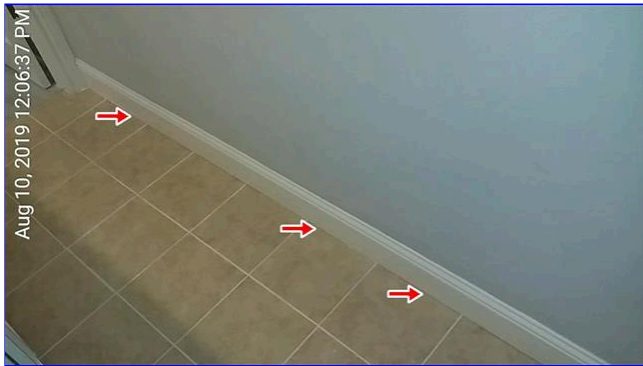
(2) Right Hallway Bathroom - The floor tile and floor base joints were not sealed at the time of the inspection.

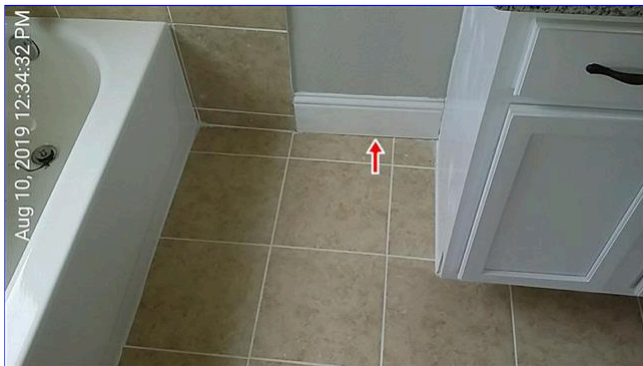
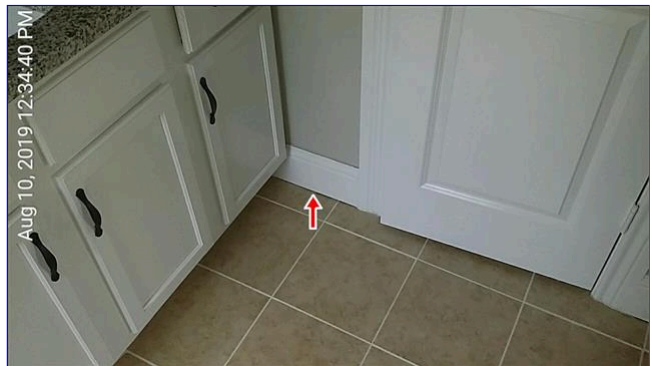
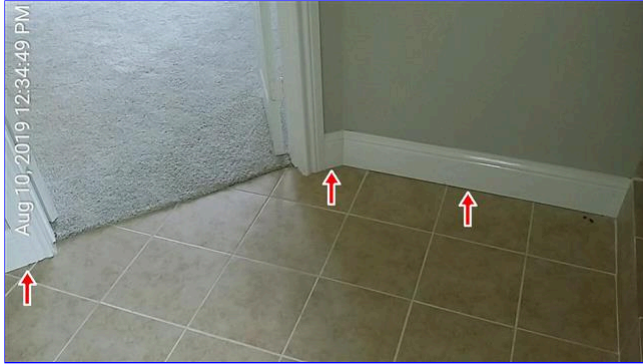
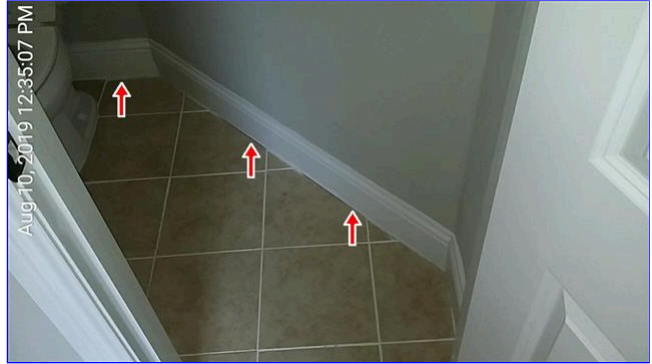
(3) Master Bathroom - The floor tile and floor base joints were not properly sealed at the time of the inspection.

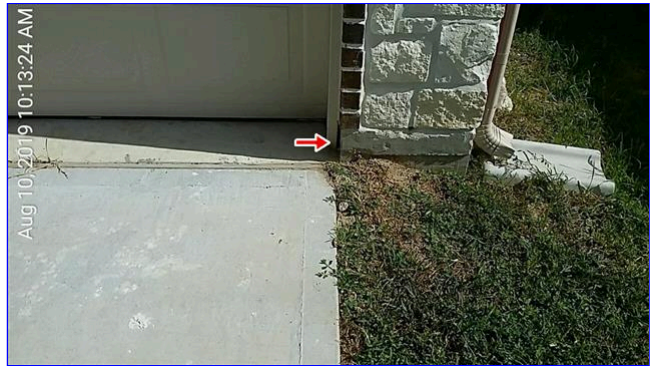
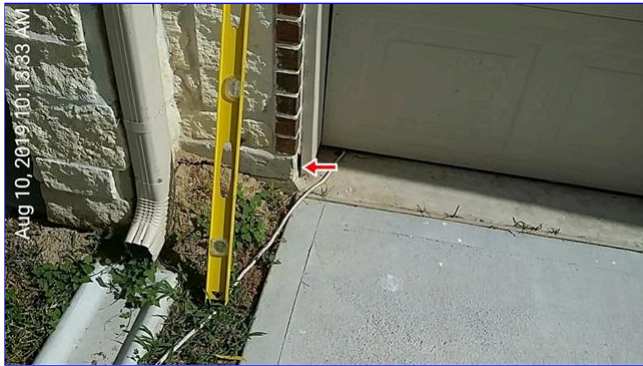
(1) Exterior Front Right - Observed gaps between the left and right garage door trimmers at the time of the inspection. Recommend sealing to prevent water and pest intrusion.

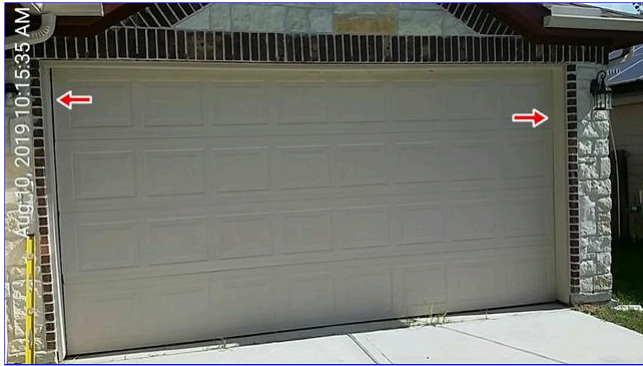
G. Item 4(Picture)

(2) Exterior Front Right - The vehicle garage door was not set properly at the time of the inspection.

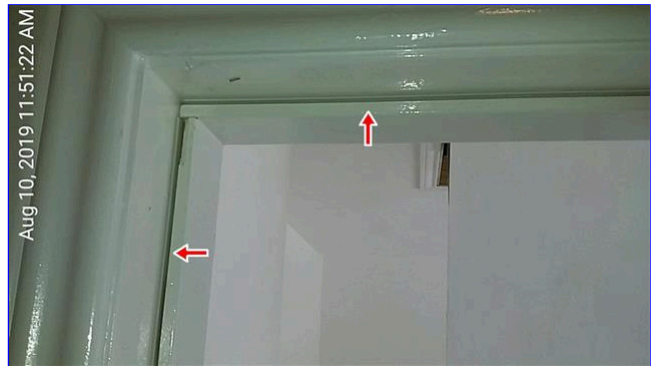
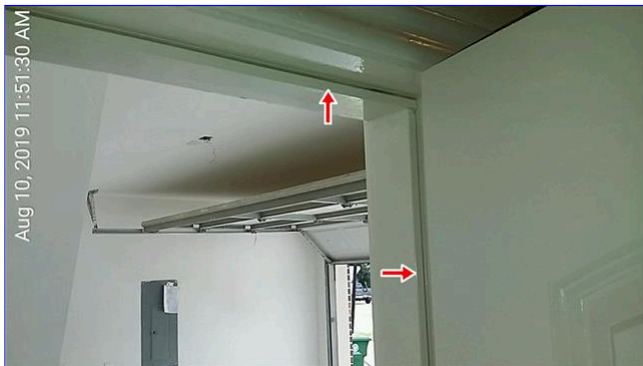
(4) Foyer Right - The garage pedestrian door was missing weather stripping at the time of the inspection.

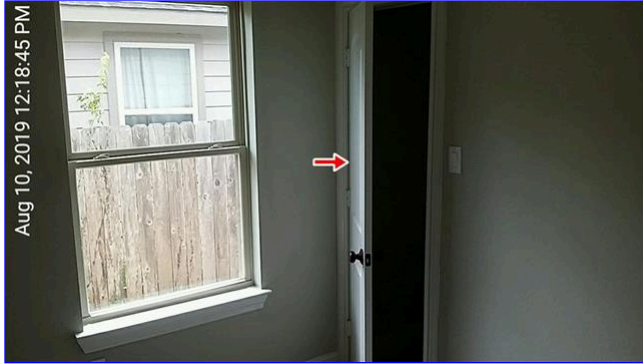
G. Item 9(Picture)

(5) Right Rear Bedroom Closet - The closet door did not latch properly at the time of the inspection.

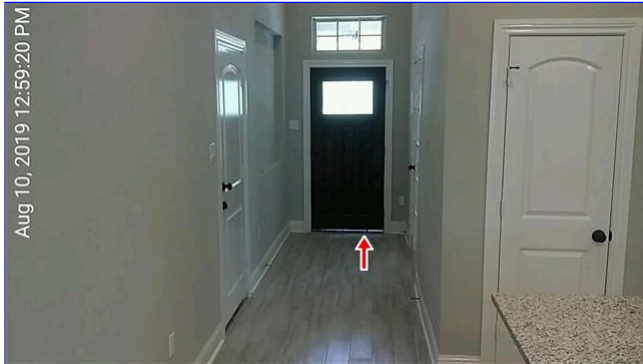
G. Item 10(Picture)

(6) Entry - Observed a gap under the exterior front door at the time of the inspection.

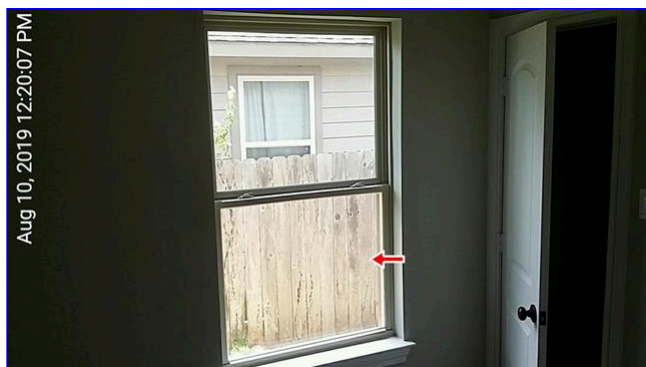
H. Item 5(Picture)

(2) Right Rear Bedroom - The window would not stay open at the time of the inspection.

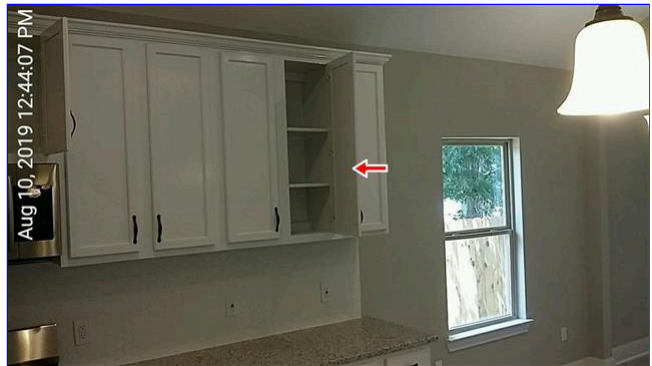
L. Item 5(Picture)

(4) Kitchen - The left rear upper cabinet door was loose at the hinges at the time of the inspection.

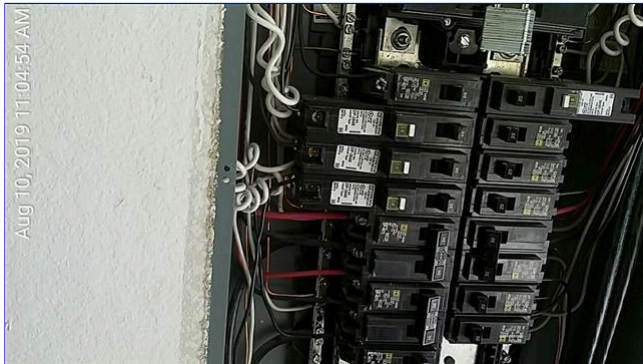
A. Item 7(Picture)

(2) Garage Right Wall - Electrical Panel - Observed a 2/0 AWG aluminum wire connected to a 200 AMP breaker at the time of inspection. A 200 AMP breaker requires a 4/0 AWG aluminum wire for proper service. Recommend hiring a licensed and experienced electrician to switch the breaker or the service wiring.

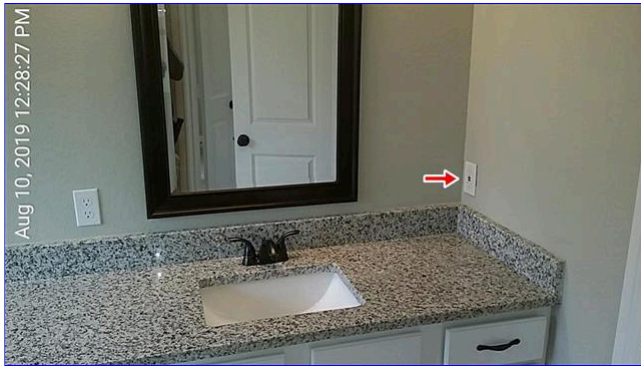
B. Item 6(Picture)

(6) Master Bathroom - The vanity left receptacle did not reset when tested at the time of the inspection.

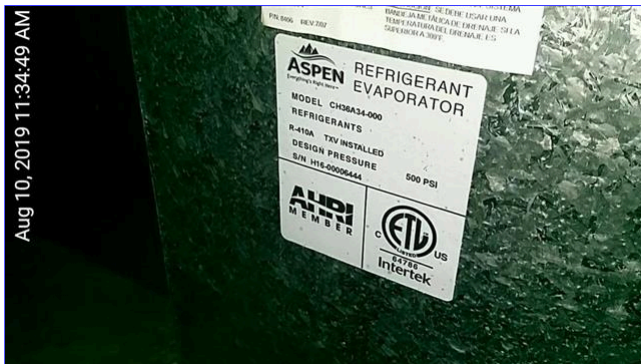
A. Item 1(Picture)

HEATING UNIT: The heater was inoperable at the time of the inspection. Recommend having a licensed HVAC technician examine and service the unit before normal use.

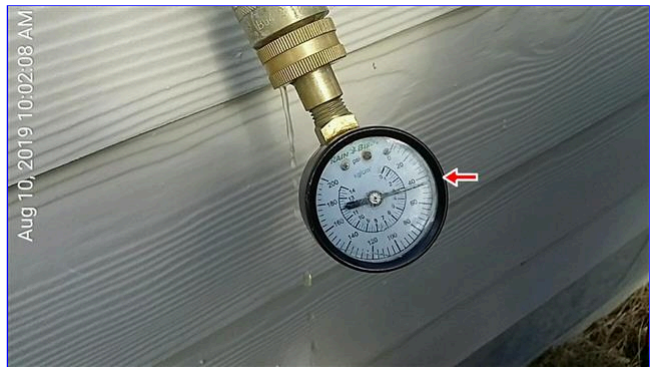
A. Item 2(Picture)

(2) Exterior Left Middle - Recommend adding insulation around the hose to prevent damage during a hard freeze.

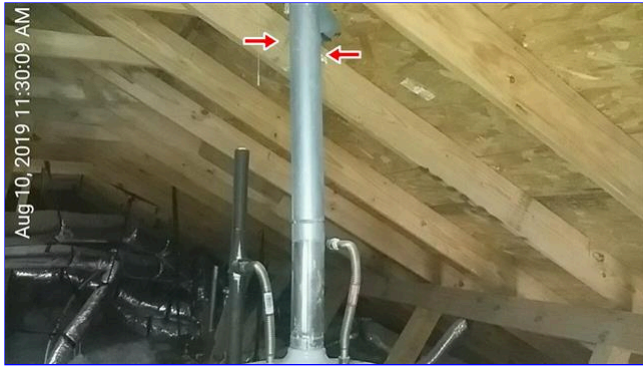
C. Item 1(Picture)

(2) Garage Attic Area - The water heater exhaust vent was not secured and supported properly at the time of the inspection.
