Inspection Report

Property Address:
13604 Starwreath Dr.
Pearland TX 77584

American Dream Inspections TX, llc

PROPERTY INSPECTION REPORT FORM

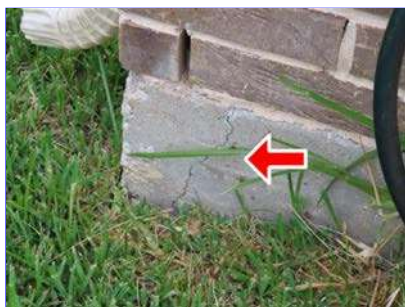
A. Item 1(Picture)

Foundation was working as intended at time of inspection. All foundation penetrations, gaps and cracks should be sealed properly. Conducive to moisture and WDI (Wood Destroying Insect) intrusion.

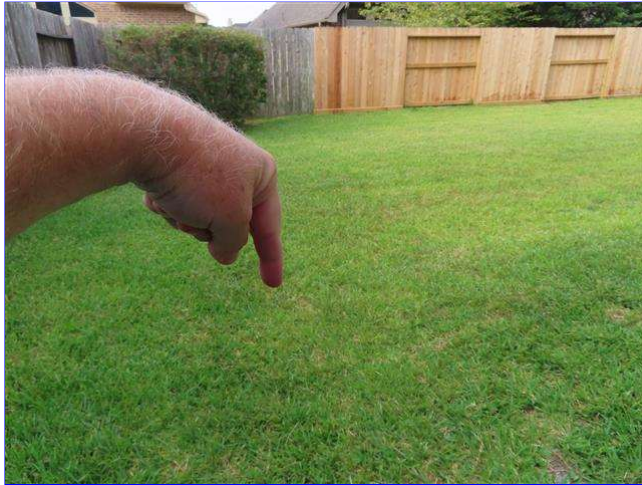
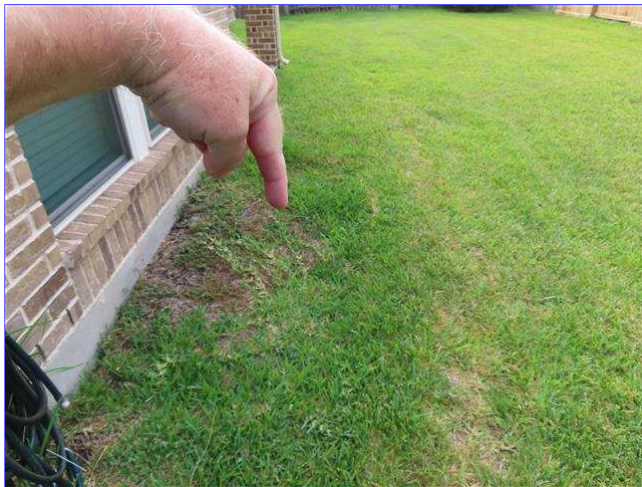
B. Item 1(Picture)

Rear yards have low spots in several areas at time of inspection. This is conducive to ponding. Should have a professional correct for proper drainage.

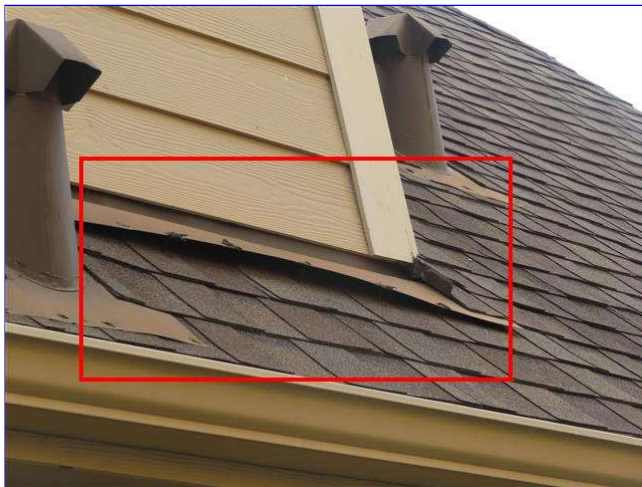
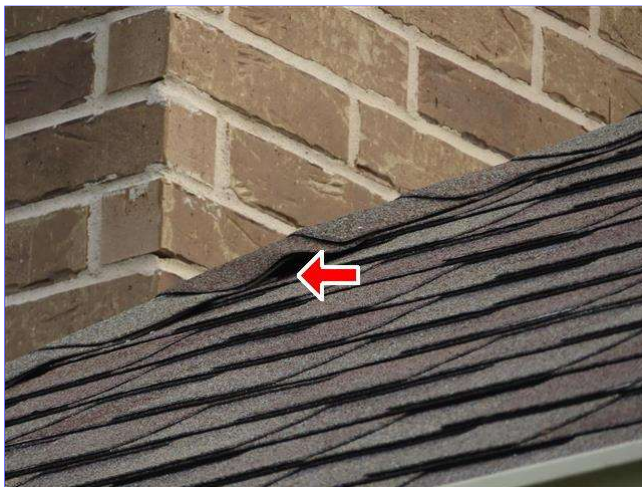
C. Item 2(Picture)

- 2) All lifted roof shingles and flashing should be corrected and sealed properly by a professional roofer. Conducive to moisture intrusion and causing possible damage. Should have a professional roofer inspect and evaluate roofing.

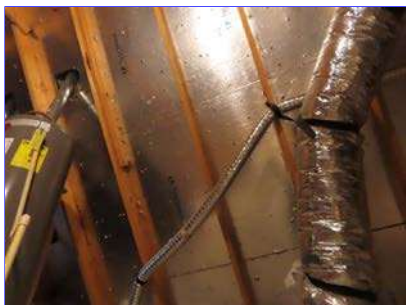
C. Item 4(Picture)

(2) Could not inspect roof sheathing in the attic due to being covered with TechShield at time of inspection.

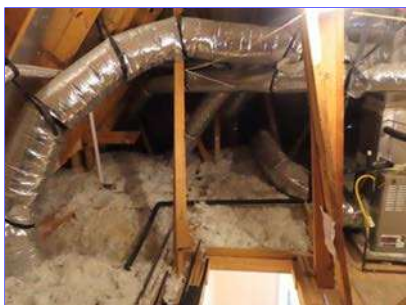
D. Item 1(Picture)

Areas of the attic was not accessible to inspect at time of inspection. These areas were not inspected for any defects or deficiencies at time of inspection.

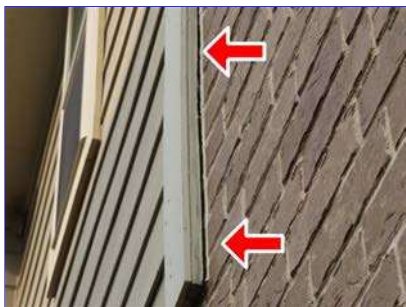
E. Item 3(Picture)

(3) Exterior wall trim is pulled away from the structure at time of inspection. Should have a professional correct and seal properly.

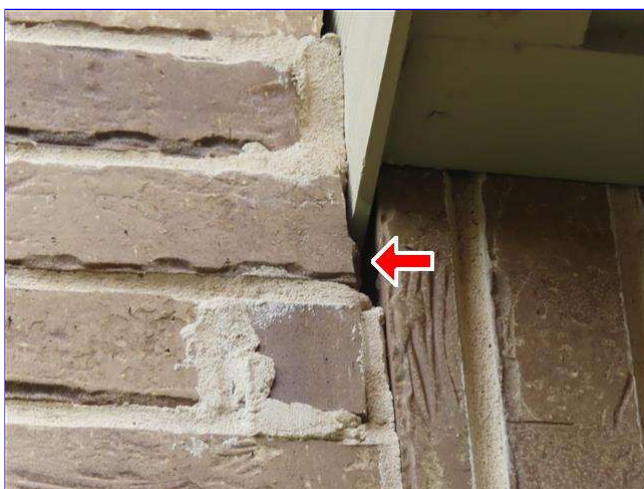
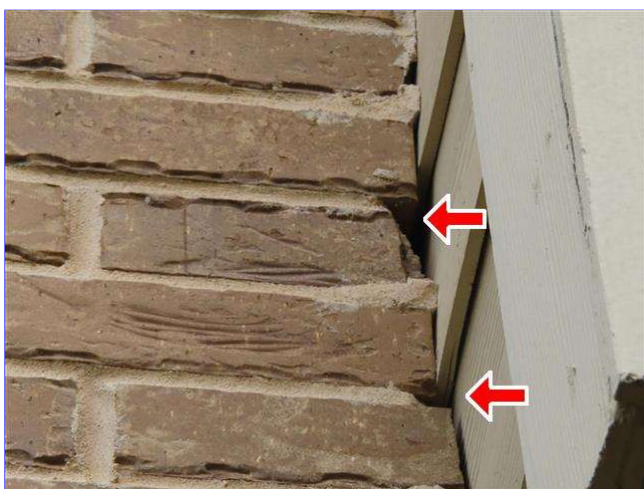
E. Item 5(Picture)

- 3) Side exterior window box has large gaps and penetrations in several areas at time of inspection. Should have a professional correct and seal properly. Conducive to moisture and vermin intrusion.

(4) Side exterior window box has large gaps and penetrations in several areas at time of inspection. Should have a professional correct and seal properly. Conducive to moisture and vermin intrusion.

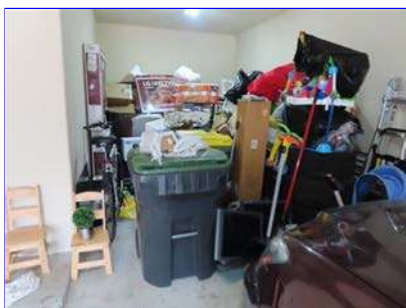
E. Item 8(Picture)

(6) Interior of the garage was not properly accessible and was not inspected at time of inspection.

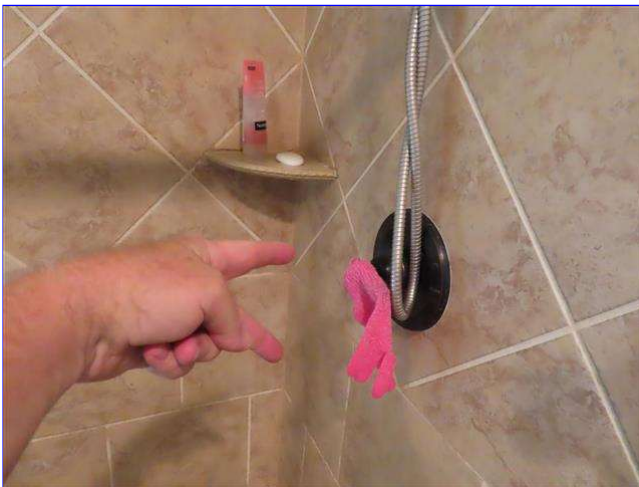
E. Item 10(Picture)

- 4) All exterior wall expansion joints should be sealed properly. Conducive to moisture and WDI (Wood Destroying Insect) intrusion.
- 5) All master shower tile wall penetrations and cracks should be sealed properly. Conducive to moisture intrusion and causing possible damage.

(7) All master shower tile wall penetrations and cracks should be sealed properly. Conducive to moisture intrusion and causing possible damage.

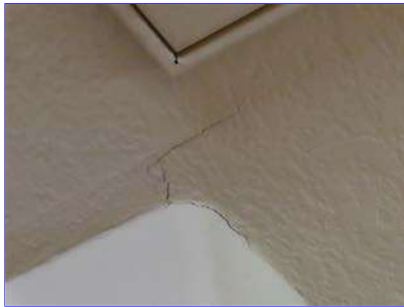
F. Item 3(Picture)

(2) Interior ceilings were cracked in several areas at time of inspection. This is possibly due from settling of the structure.

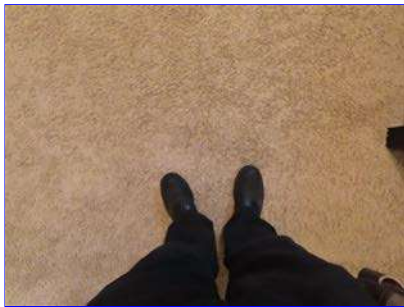
F. Item 4(Picture)

(3) Upstairs subfloor in several areas have soft spots and make noise when walked on. Should have a professional secure subfloor properly.

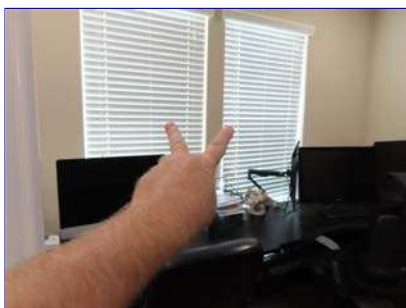
H. Item 20(Picture)

(3) Several windows were not properly accessible and were not inspected at time of inspection.

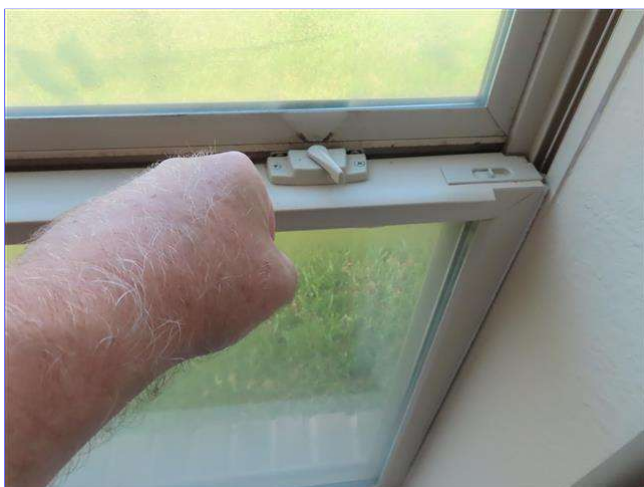
H. Item 21(Picture)

- 10) All exterior and interior window penetrations should be sealed properly. Conducive to moisture and WDI (Wood Destroying Insects) intrusion.
- 11) Master window was not operating and latching properly at time of inspection. Should have a professional correct properly.

(4) Master window was not operating and latching properly at time of inspection. Should have a professional correct properly.

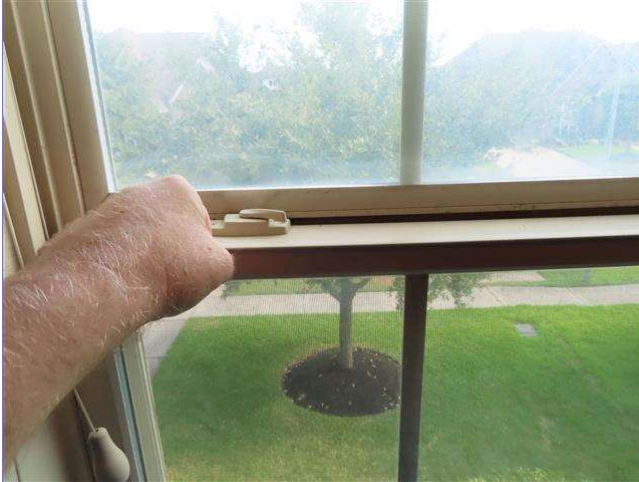
H. Item 22(Picture)

(5) Second floor front bedroom window was not operating and latching properly at time of inspection. Should have a professional correct properly.

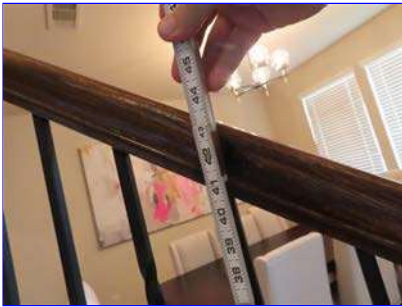
I. Item 1(Picture)

(1) Stair handrails should be between 34-38" in height per code.

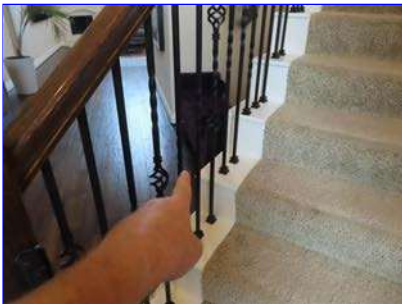
I. Item 2(Picture)

(2) Several stair handrail spindles were loose at time of inspection. Should have a professional correct properly.

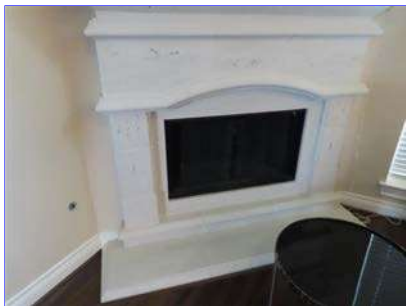
J. Item 1(Picture)

Gas fireplace. Fireplace was only visually inspected for defects or deficiencies at time of inspection. Did not inspect operation of fireplace at time of inspection. Fireplace did not have any visible defects at time of inspection. Inspection of fireplace is not part of home inspection per TREC Standards of Practice. Recommend having a professional Fireplace Tech further evaluate unit.

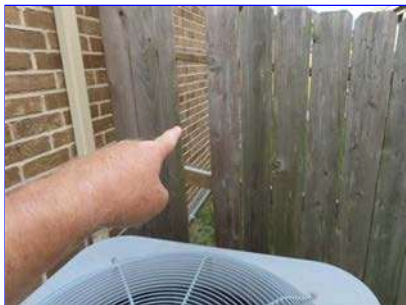
K. Item 1(Picture)

Woof fence picket was uninstalled at time of inspection. Should correct properly.

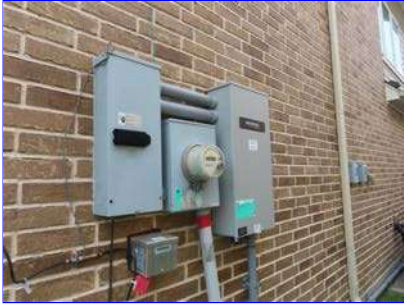
A. Item 1(Picture)

(1) Main electrical disconnect box and electric meter. (This is for informational purposes only)

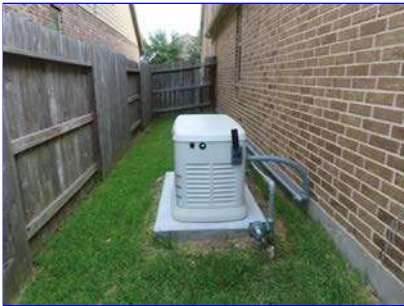
A. Item 2(Picture)

(2) Whole house generator was not part of the home inspection and was not inspected at time of inspection.

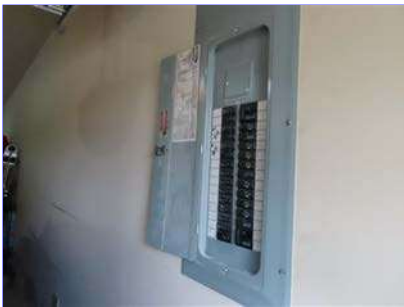
A. Item 3(Picture)

(3) Eaton breaker box in the garage. Breakers were labeled at time of inspection. (This is for informational purposes only)

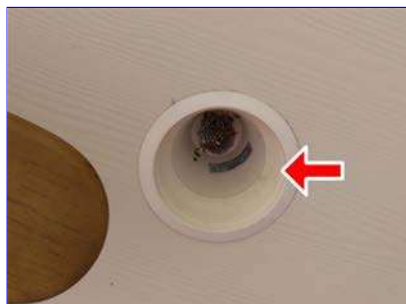
B. Item 4(Picture)

(3) Rear exterior light bulb was missing at time of inspection. Should correct properly.

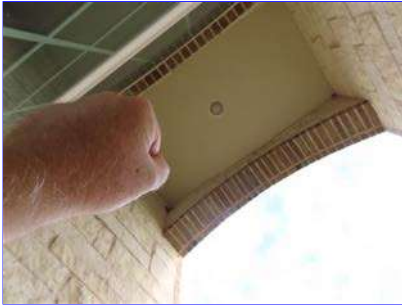
B. Item 5(Picture)

(4) Front porch light was not operating at time of inspection. Possible burnt bulb. Should correct properly.

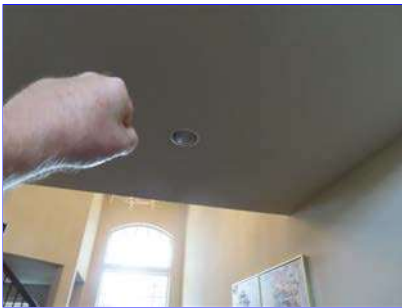
B. Item 6(Picture)

(5) Several interior bulbs were not operating at time of inspection. Possible burnt bulbs. Should correct properly.

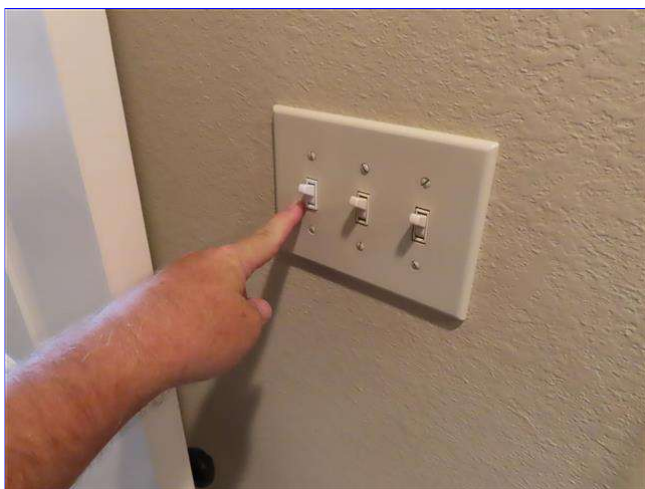
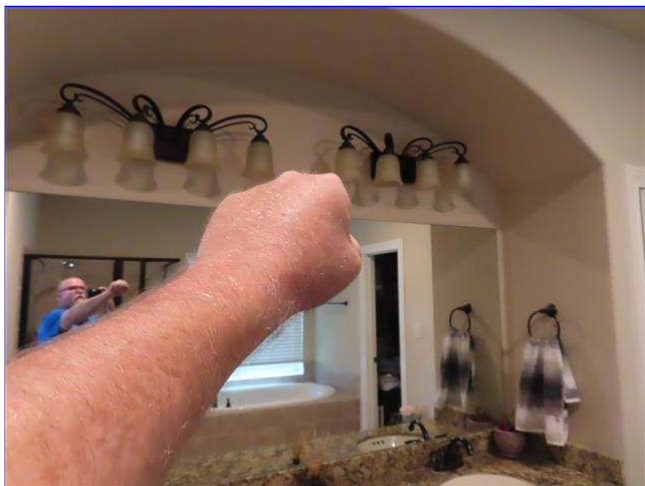
(8) Master bathroom electrical light switch was not operating properly at time of inspection. Should have a professional electrician inspect and correct properly.

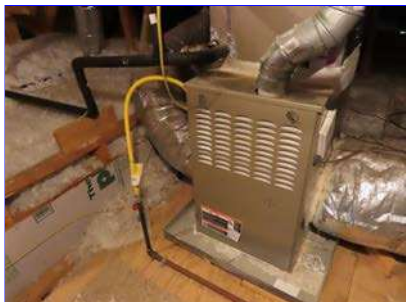
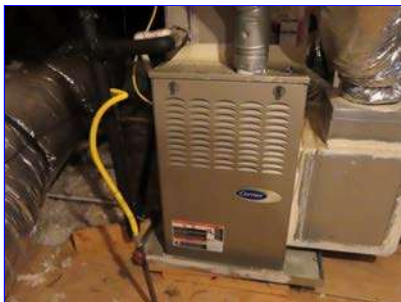
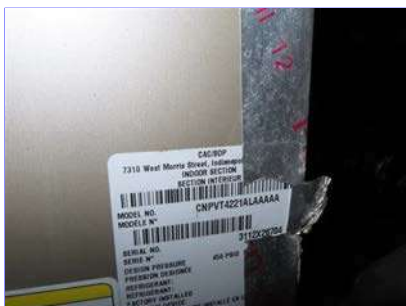
Two 2012 Carrier gas furnaces in the attic were working properly in Cool Mode at time of inspection. Did not test in Heat Mode since the outside temperature was over 60 degrees at time of inspection.

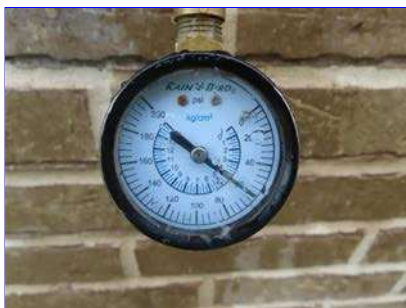
A. Item 1(Picture)

(1) Static wat pressure was 60 psi at time of inspection. (This is for informational purposes only)

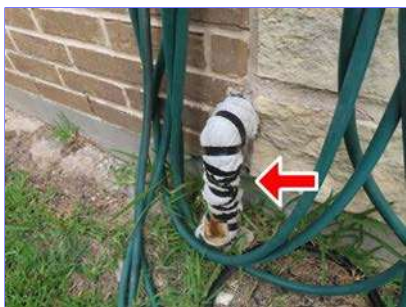
A. Item 2(Picture)

(2) Main water line and shut off valve to the structure. (This is for informational purposes only)

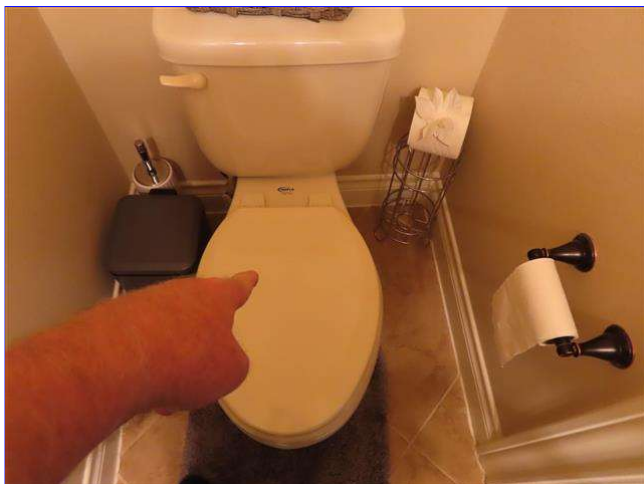
A. Item 3(Picture)

(3) Toilets were loose to the floor at time of inspection. Should be corrected by a professional plumber. Conducive to leaking and causing possible damage.

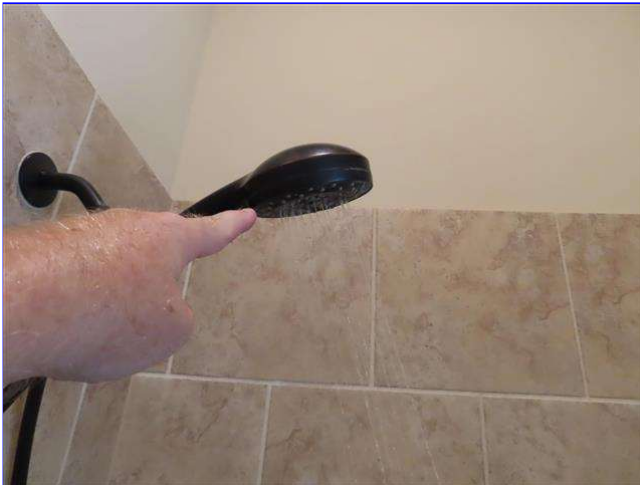
A. Item 11(Picture)

(10) Second floor bathroom showerhead was not flowing properly at time of inspection. Should have a professional plumber correct properly.

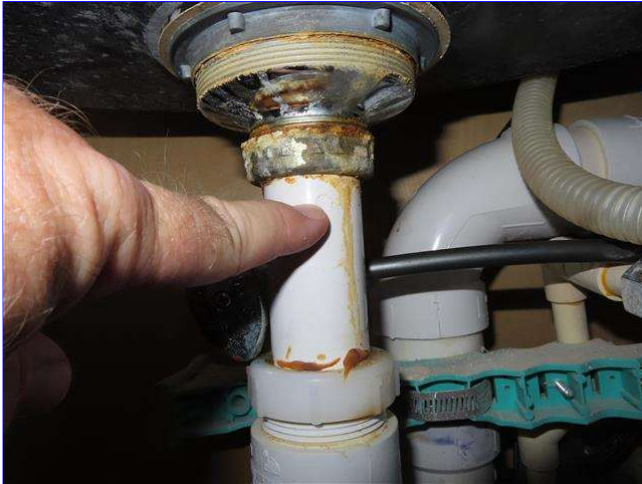
B. Item 1(Picture)

(1) Kitchen sink drain has signs of possibly leaking at time of inspection. Should have a professional plumber inspect and correct properly.

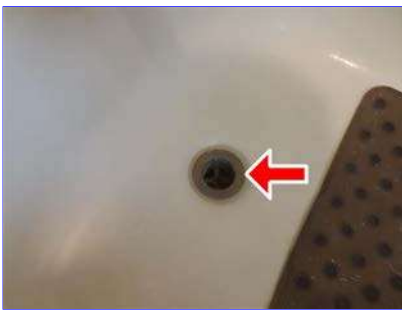
B. Item 2(Picture)

(2) Bathtub was missing drain stopper at time of inspection. Should have a professional plumber inspect and correct properly.

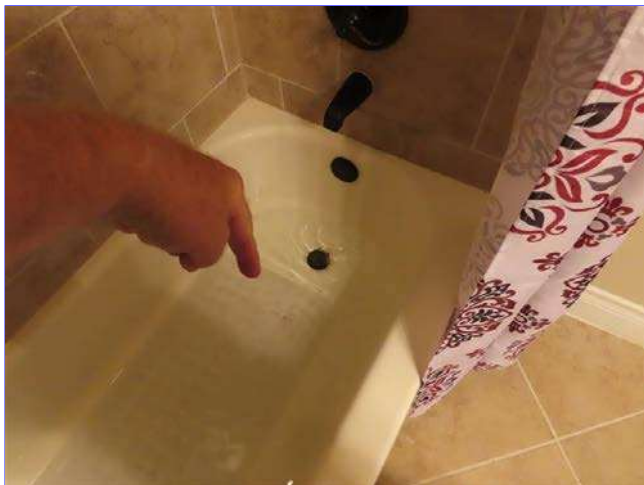
B. Item 4(Picture)

(4) Second floor bathtub was not draining properly at time of inspection. Should have a professional plumber inspect and correct properly.

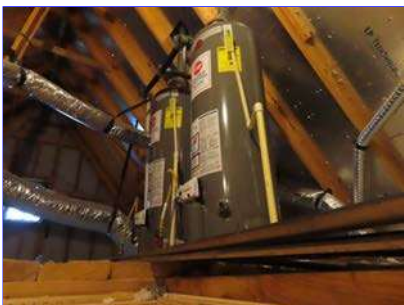
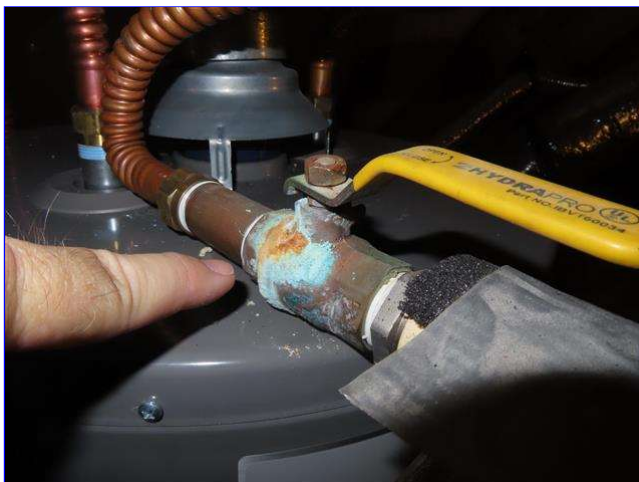
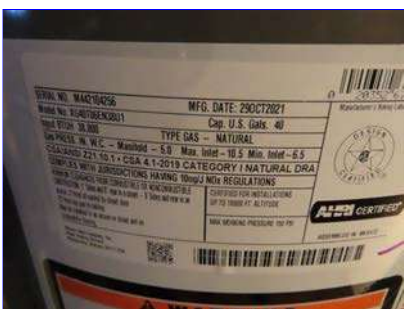
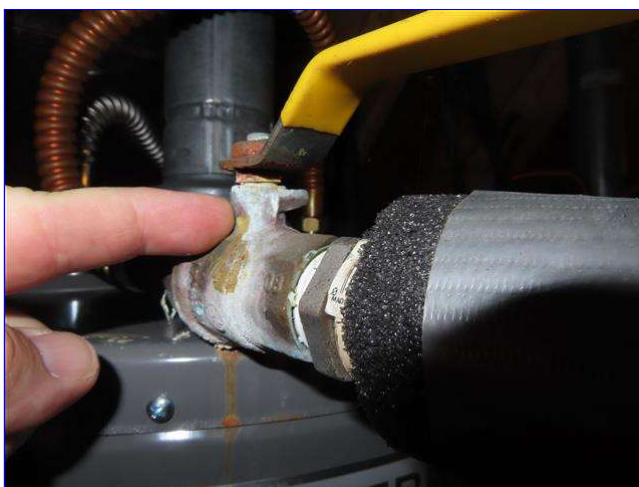
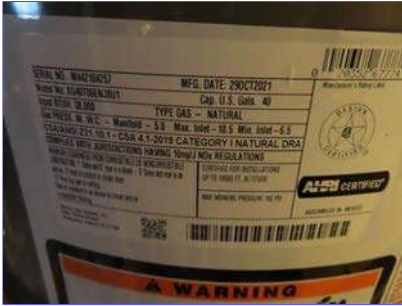
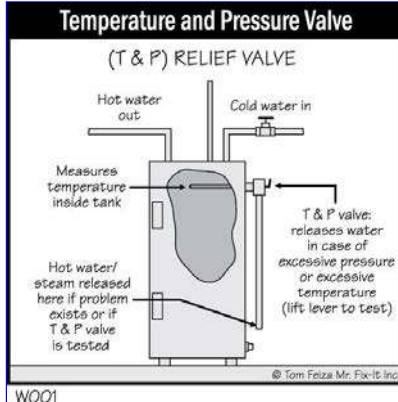
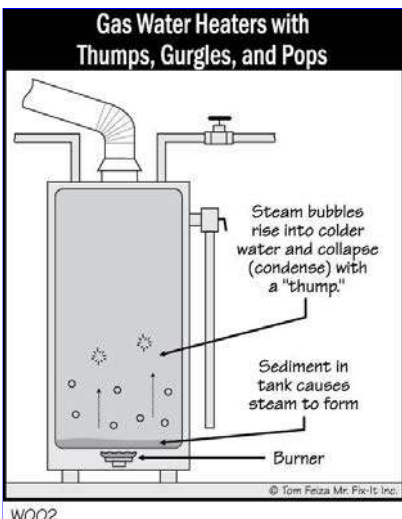
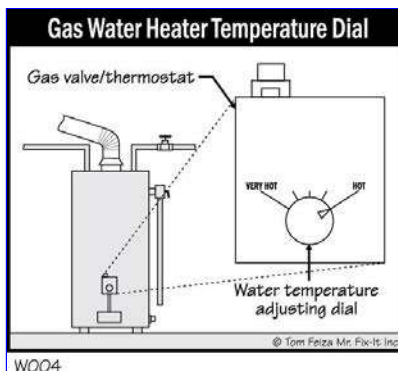
Two 2021 Rheem gas 40 gallons each hot water heater in the attic were operating properly at time of inspection. Both plumbing shut off valves to the units were rusting, corroding and has signs of possibly leaking at time of inspection. Should have a professional plumber inspect and correct properly.

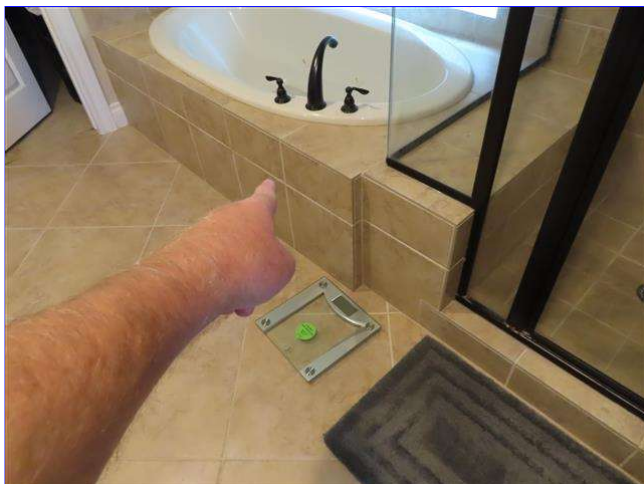
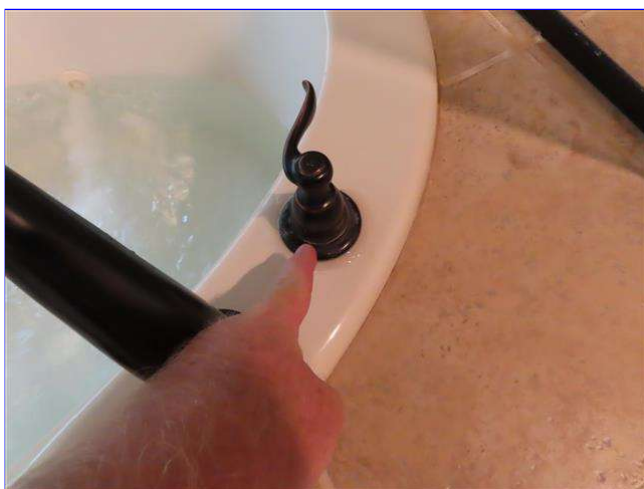
Master spa tub was working properly at time of inspection. Hot control valve was leaking at time of inspection. Tub was missing motor and plumbing access panel at time of inspection. Should have a professional plumber correct.

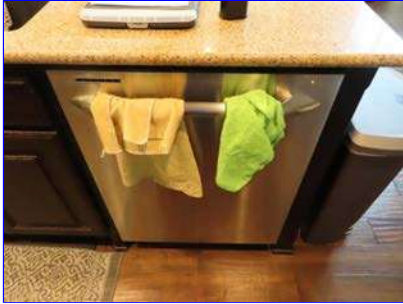
A. Item 1(Picture)

GE dishwasher was working properly at time of inspection.

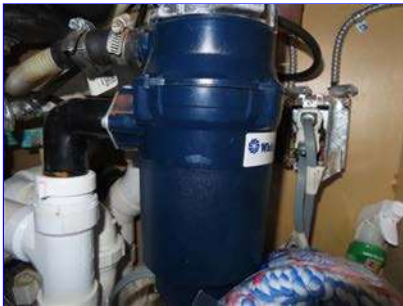
B. Item 1(Picture)

Whirlaway disposal was working properly at time of inspection.

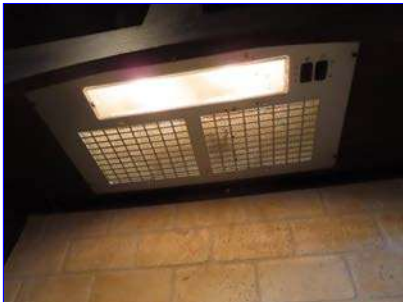
C. Item 1(Picture)

Cooktop exhaust fan and light was operating properly at time of inspection.

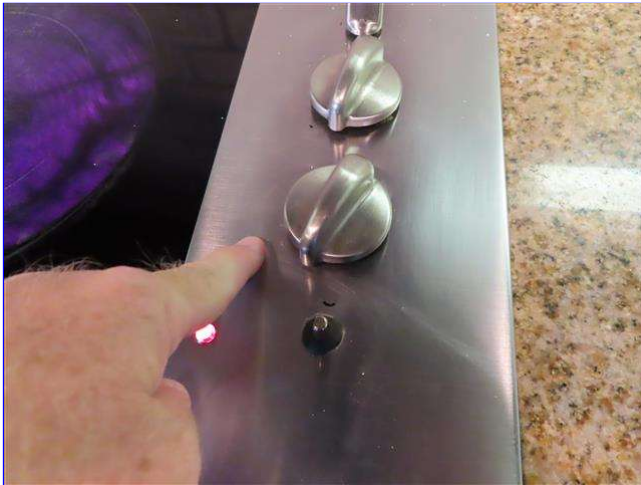
D. Item 2(Picture)

(1) GE electric cooktop was working properly at time of inspection. Cooktop has wear on several burners and control knob label was faded at time of inspection. Should have a professional correct properly.

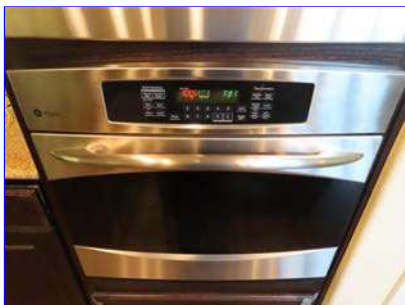
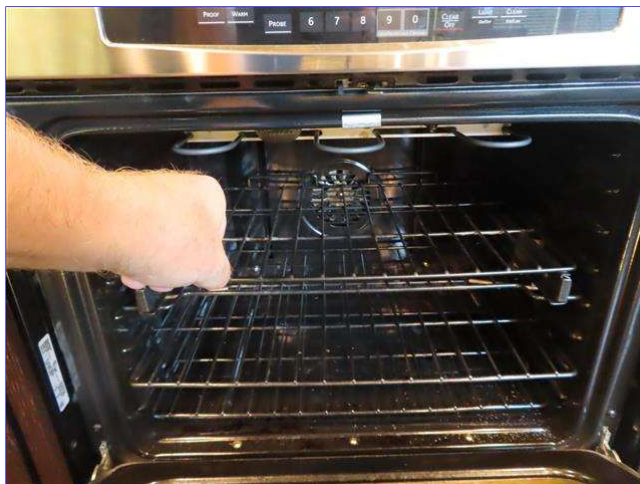
(2) GE built in gas oven was working properly at time of inspection. Oven light was not operating at time of inspection. Should correct properly.

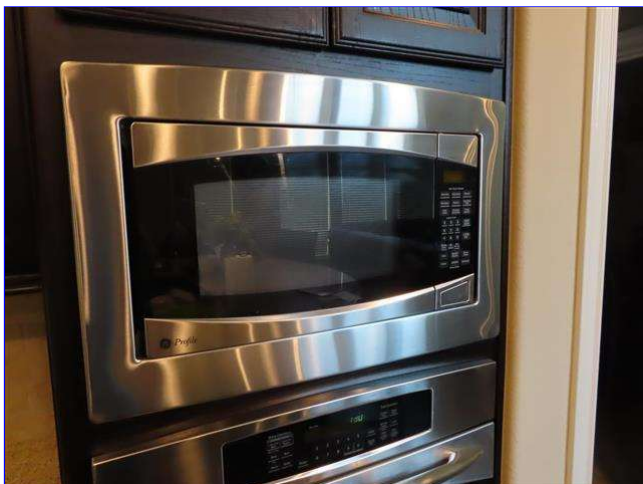
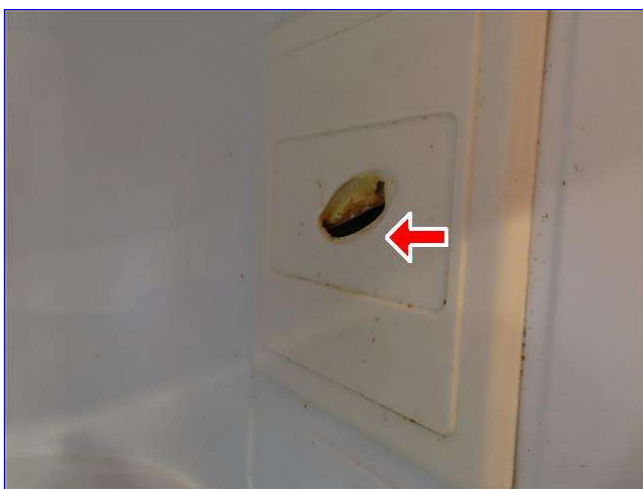
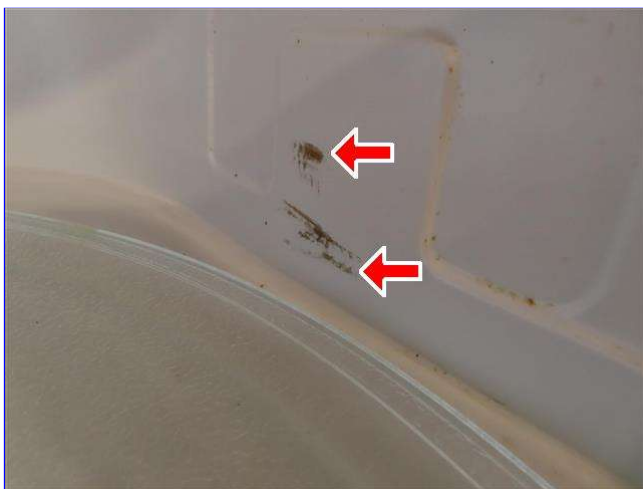
GE built in microwave was working properly at time of inspection. Interior has damage in several areas at time of inspection. Should have a professional replace unit properly.

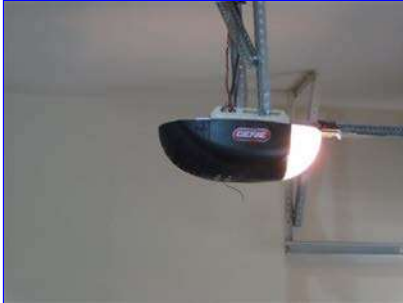
G. Item 1(Picture)

(1) Two Genie garage door openers were working properly at time of inspection.
