PROPERTY INSPECTION REPORT

Concerning: 3039 Thicket Path Way, Katy, TX 77493

By: David Wooley - TREC Professional Inspector License # 20722 02/21/2021 3:00 pm

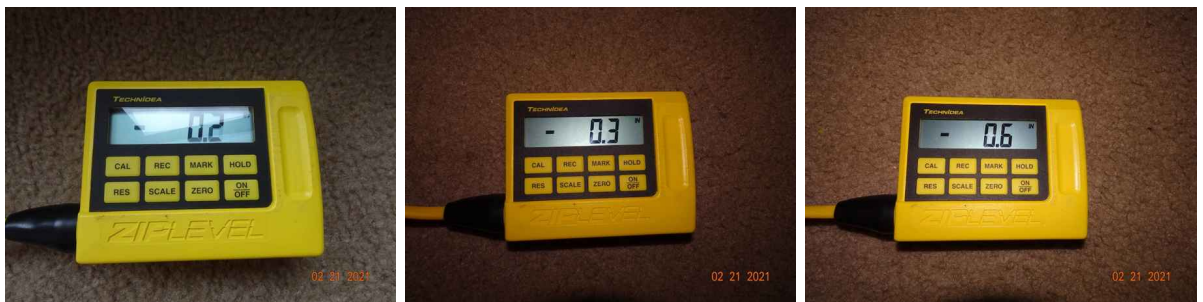
Photos of Digital Foundation Measurements:

Inspected with Zip Level - No Excessive Settlement Noted: **Note:** This foundation was measured with the use of an electronic digital measurement tool. Multiple elevation points are registered on the foundation throughout the property to determine if there are elevation variations that indicate excessive movement of the foundation. At the time of this inspection, the measured areas do not indicate any variations that, in this inspectors OPINION, indicate any need for invasive repairs to the foundation unless a Deficiency or Recommendation is noted in this report. If buyer desires a second opinion or further analysis, a foundation company or structural engineer should be contacted.

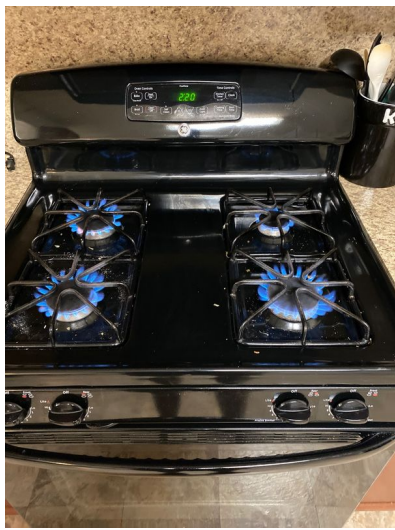
Oven Functioning: Note: The oven is functioning as intended. Unit is heating within the acceptable range of the temperature control setting.

Range Functioning: Note: The cooktop is functioning as intended.
