**BPG Inspection, LLC**

**19722 Rippling Brook Lane  
Tomball TX 77375**

Inspection Date: 8/23/2022

Inspector: Orlando Martinez , TREC 21694 (TX)

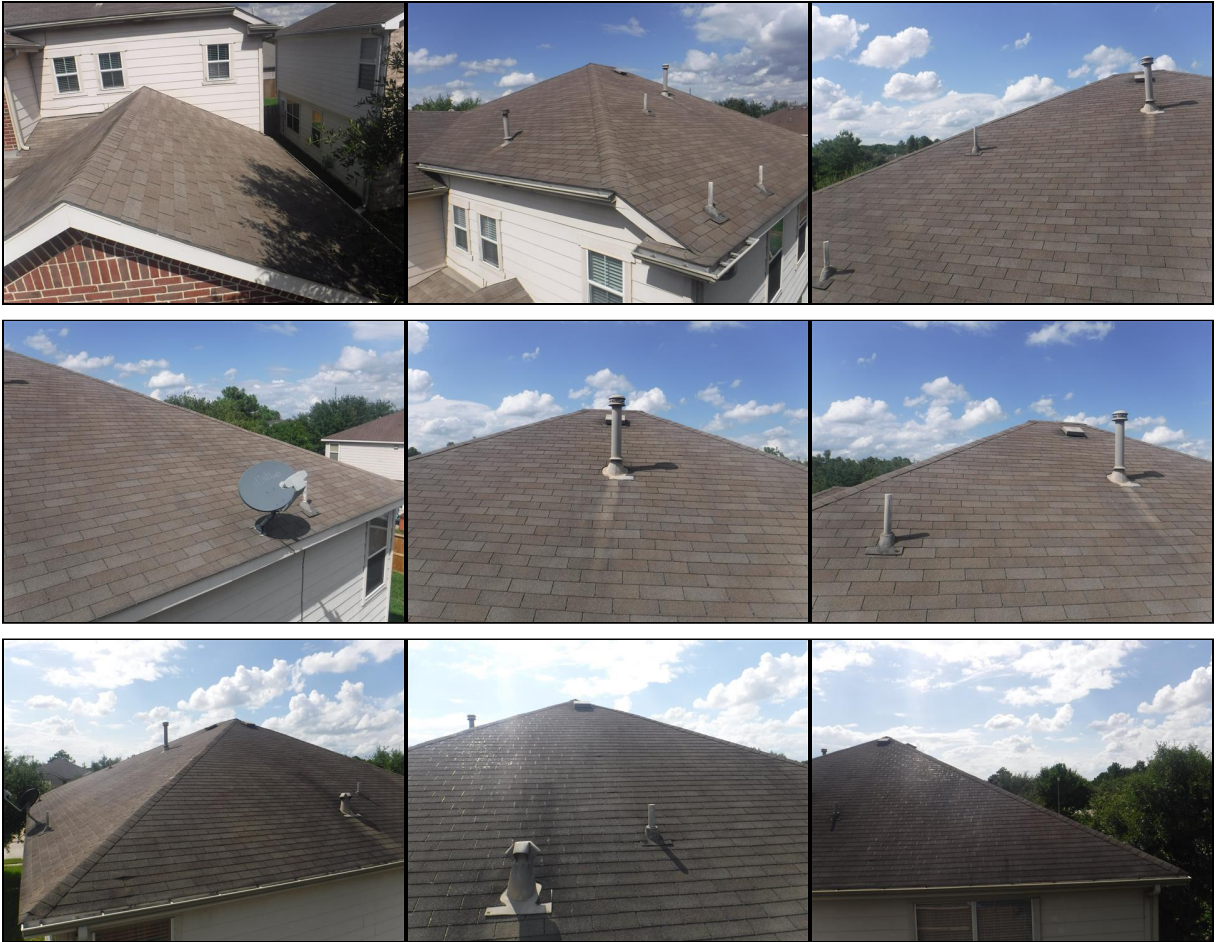
☒ There are damage shingles at the front of the home that may allow water penetration. I recommend having a licensed roofer repair as needed.

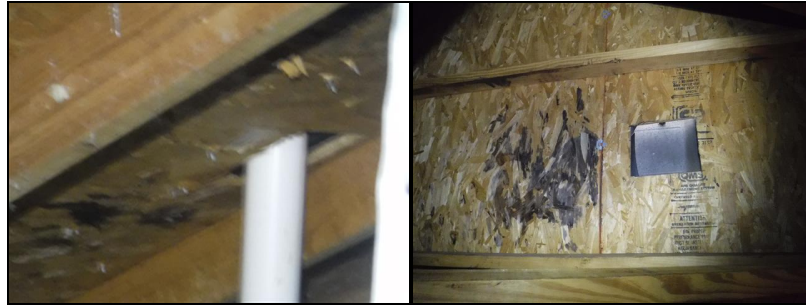
Moisture was found on the air handle from a possible roof leak. I recommend having a licensed contractor evaluate for repair.

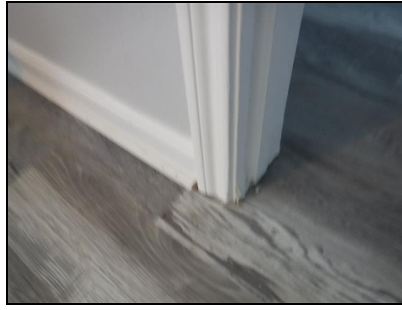
Doors and frames should be sealed, made weather tight with proper seal contact between the frame structure and door. The seals at the entry and rear door are deficient and should be improved or replaced.

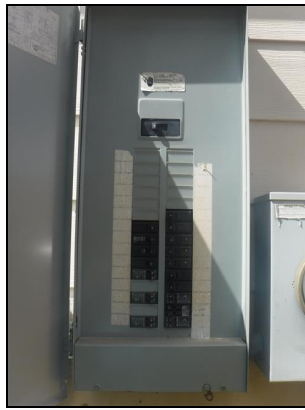
Main breaker panel

☒ Recommend sealant between panels/meters and wall to prevent moisture entry into wall.

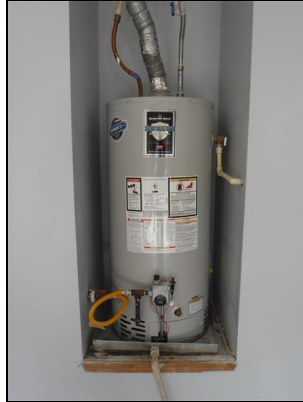
Water heater

**☒** Flue vents not properly secured at elbows with sheet metal screws. Tape is currently being used, which can become a source of combustion. Remove tape and properly secure vents with sheet metal screws.

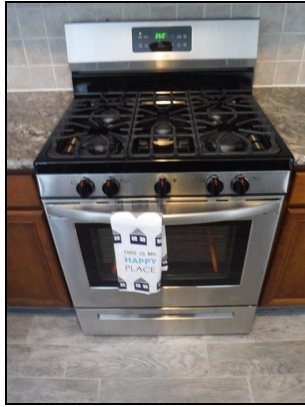
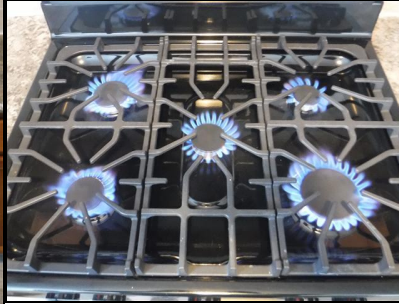
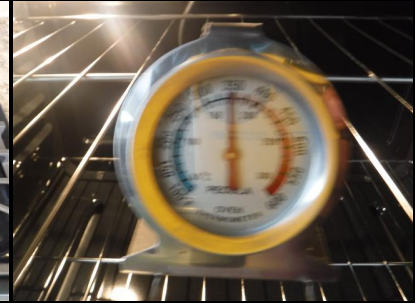
☒ There is no child protection anti-tip device installed. Anti-tip brackets prevent the stove from accidentally tipping over if weight is placed on the oven door
