Lone Star Stucco, LLC

Moisture Assessment Report

1607 W 24th Street, Unit B

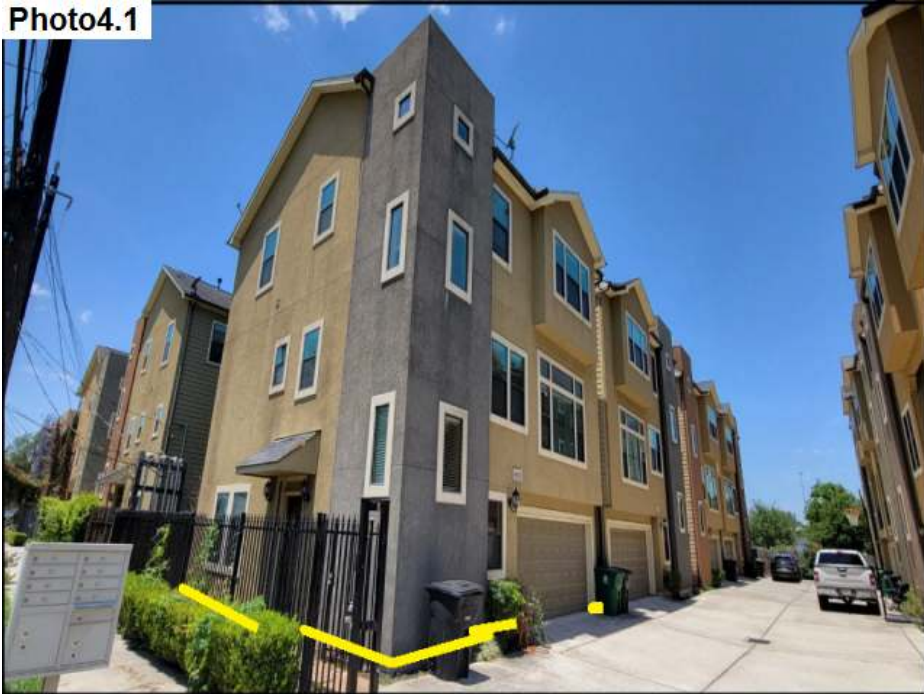
Photo4.1

- Stucco appears to be typically detailed at grade for the time of this construction. The inspector suggests that this is a positive detail and recommends no modification at this time but to always keep soil away from the structure. Please refer to photos #4.2, #4.3, #4.4, #4.5 and #4.6 for more detail.

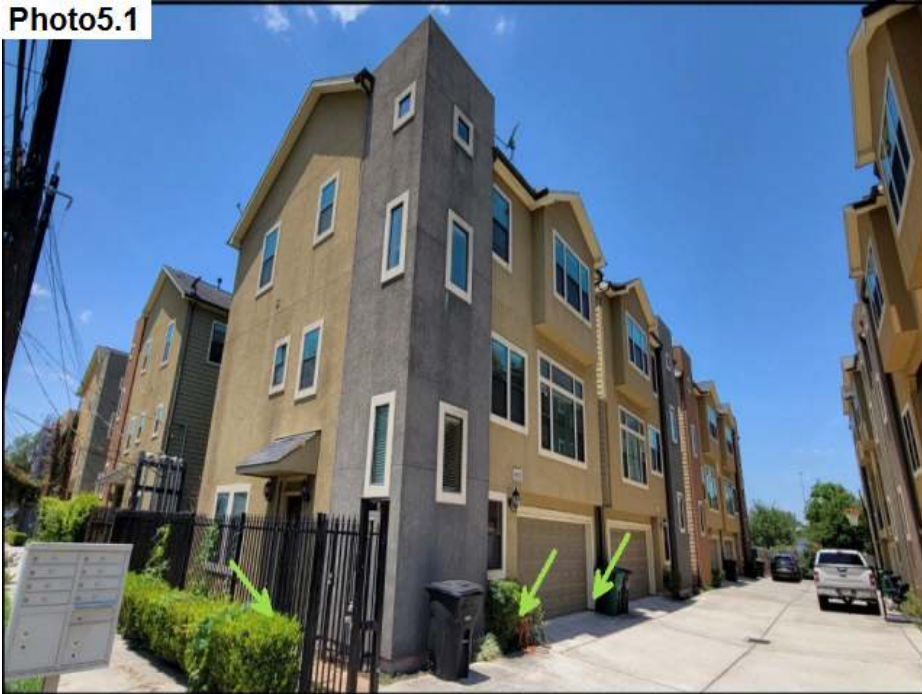
Photo5.1

- The door trim and miter sealants are aged, separated or missing at this location. The inspector suggests to have a qualified waterproofing contractor seal this area with a low modulus sealant in an effort to prevent moisture intrusion. These types of sealants are of high quality and compatible with stucco and other termination points. Please refer to photos #5.2, #5.3, #5.4, #5.5 and #5.6 for more detail.

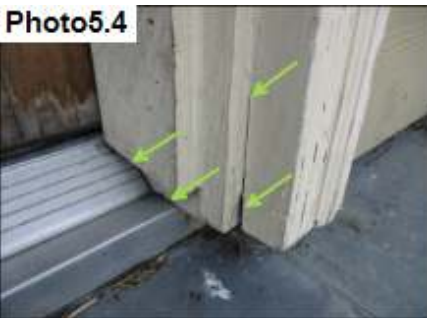
Photo5.5

Door Sealants / Seal

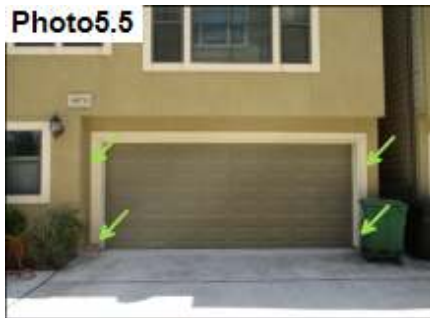
Photo5.6

Door Sealants / Seal

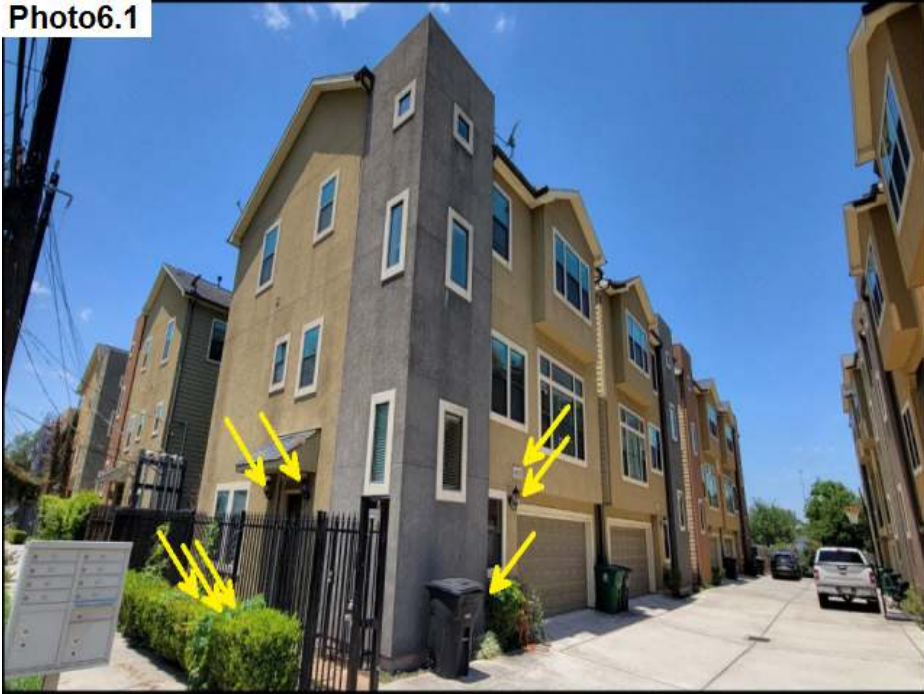
Photo6.1

- The penetration sealants are aged, separated or missing in these locations. The inspector suggests to have a qualified waterproofing contractor seal these areas with a low modulus sealant in an effort to prevent moisture intrusion. These types of sealants are of high quality and compatible with stucco and other termination points. Please refer to photos #6.2, #6.3, #6.4, #6.5 and #6.6 for more detail.

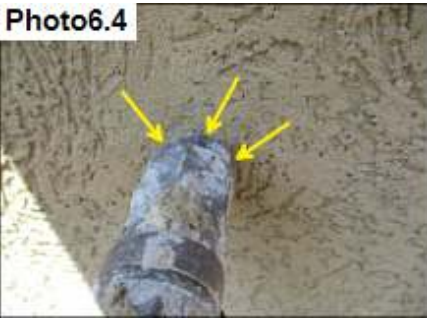
Photo6.5

Penetration Sealants / Seal

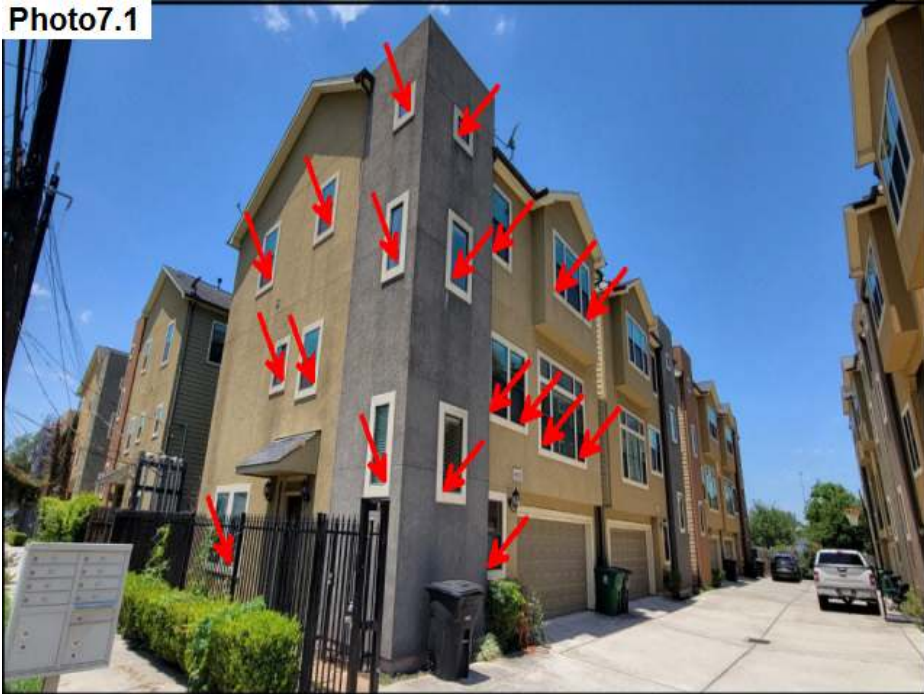
Photo7.1

- The window sealants are aged or separated. The inspector suggests to have a qualified waterproofing contractor further assess and seal this area with a low modulus sealant in an effort to prevent moisture intrusion. These types of sealants are of high quality and compatible with stucco and other termination points. Please refer to photos #7.2, #7.3, #7.4, #7.5, #7.6, #8.1, #8.2, #8.3 and #8.4 for more detail.

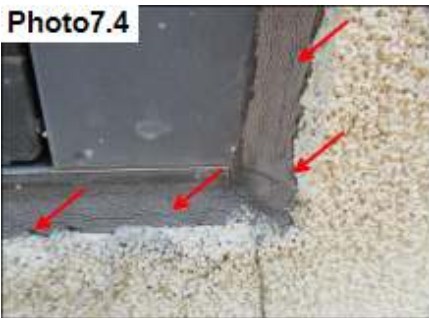
Photo7.5

Window Sealants / Seal

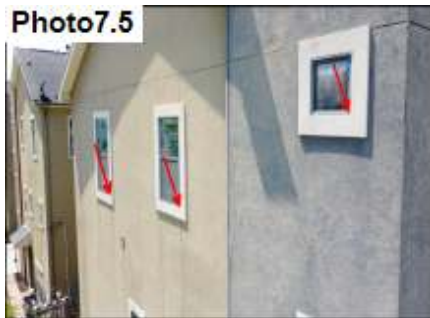
Photo7.6

Window Sealants / Seal

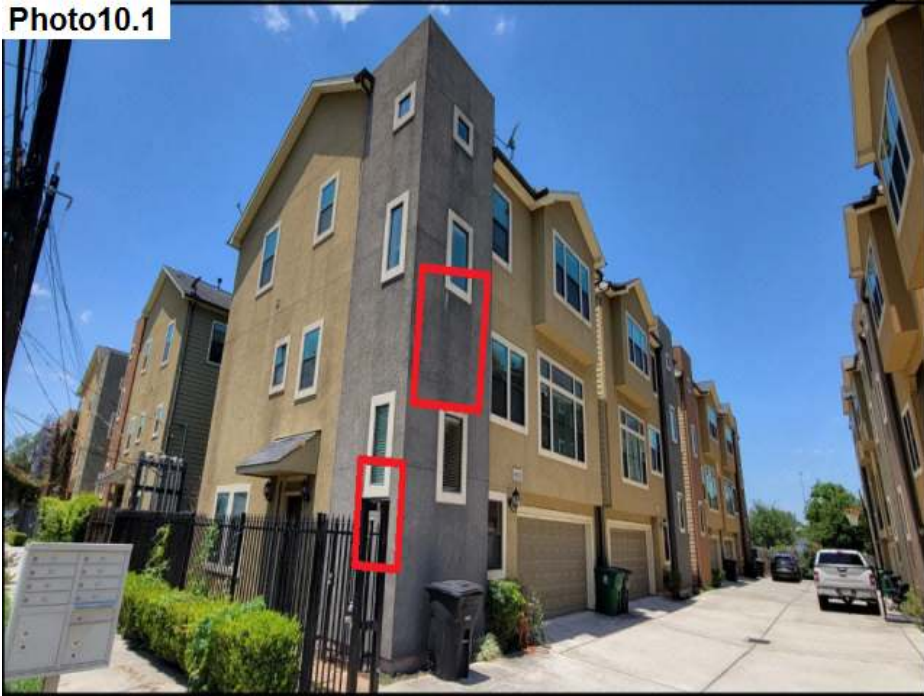
Photo10.1

- Confirmed substrate and potential frame damage is noted at these locations. The inspector suggests to have a qualified waterproofing contractor further assess the extent of damage and repair as needed in an effort to prevent moisture intrusion. Please refer to photos #10.2, #10.3, #10.4, #10.5 and #10.6 for more detail.

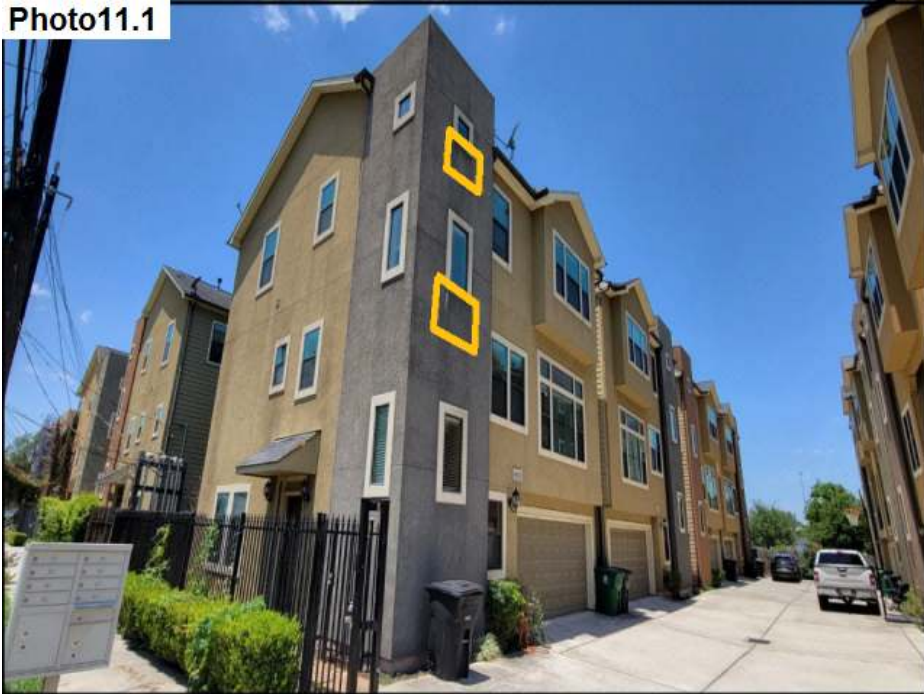
Photo11.1

- Efflorescence has been noted in these areas of the home. This is when a naturally occurring salt migrates to the surface of the system causing a coating. The inspector suggests to consult with a qualified stucco contractor to treat these areas with commercial cleaners or contact the system manufacturer for the best explanation of removal. Please refer to photos #11.2, #11.3, #11.4, #11.5 and #11.6 for more detail.

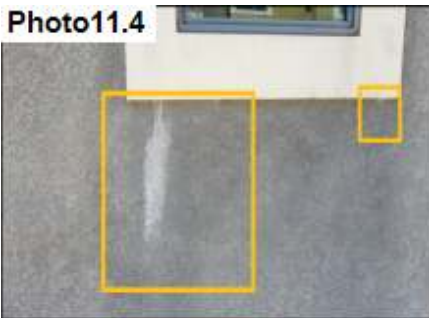
Photo11.5

Efflorescence / Clean as Needed

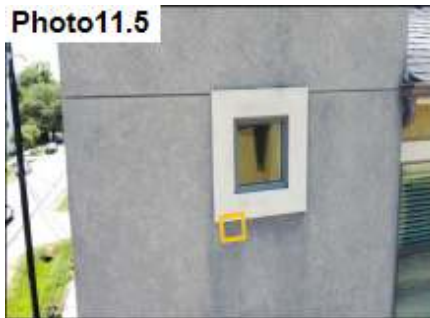
Photo11.6

Efflorescence / Clean as Needed

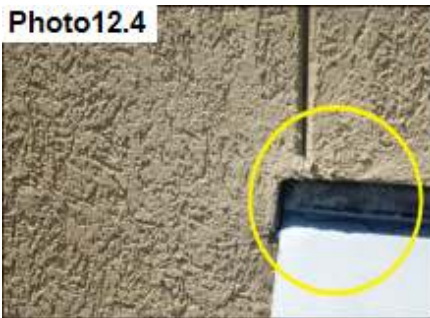
- The roof flashing sealants are aged at this location. The inspector suggests to have a qualified waterproofing contractor further assess and seal this area with a low modulus sealant in an effort to prevent moisture intrusion. These types of sealants are of high quality and compatible with stucco and other termination points. Please refer to photos #12.2, #12.3, #12.4, #12.5 and #12.6 for more detail.

Roof Flashing / Seal

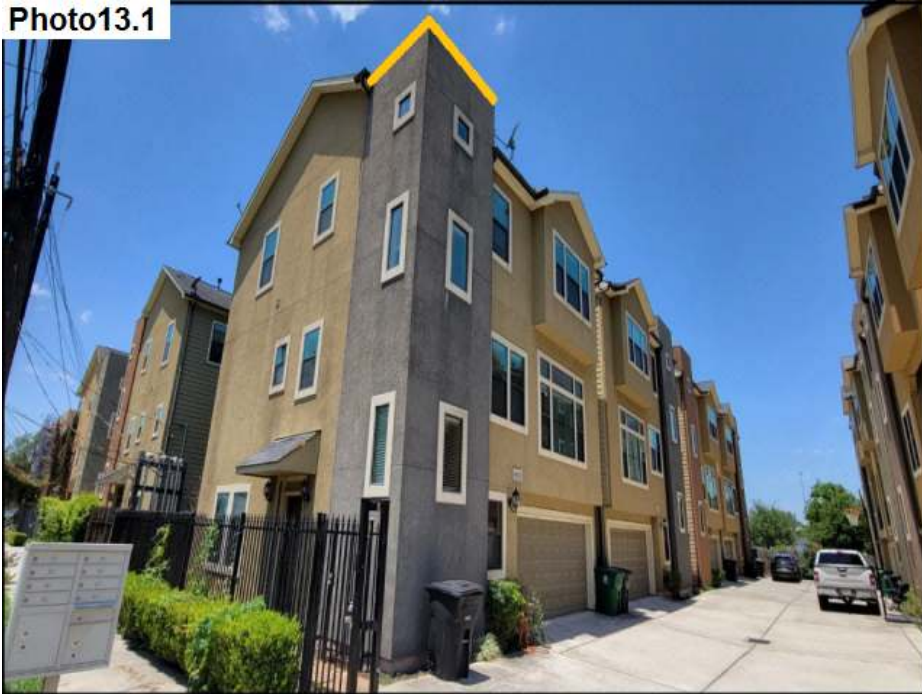
Photo13.1

- A metal cap is missing at the parapet wall allowing moisture to penetrate the system at this location. The inspector suggests having a qualified waterproofing contractor further assess and install proper a metal cap with a minimum of a 3" overlap of the stucco, then seal in an effort to prevent moisture intrusion. Please refer to photos #13.2, #13.3, #13.4, #13.5 and #13.6 for more detail.

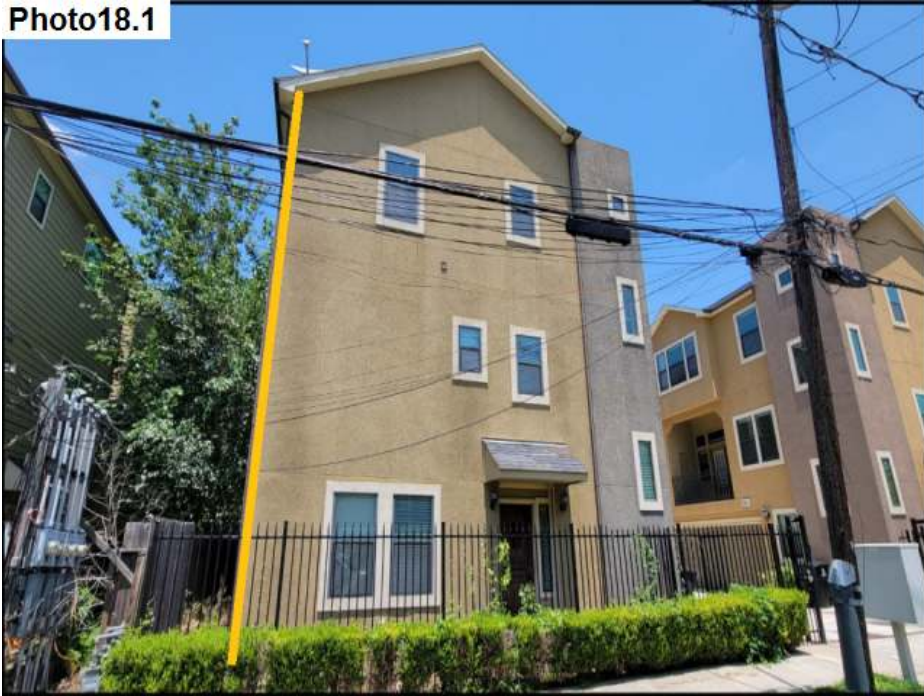
Photo18.1

- The trim/stucco termination sealants are missing at this location. The inspector suggests to have a qualified waterproofing contractor further assess and seal this area with a low modulus sealant in an effort to prevent moisture intrusion. These types of sealants are of high quality and compatible with stucco and other termination points. Please refer to photos #18.2, #18.3, #18.4, #18.5 and #18.6 for more detail.

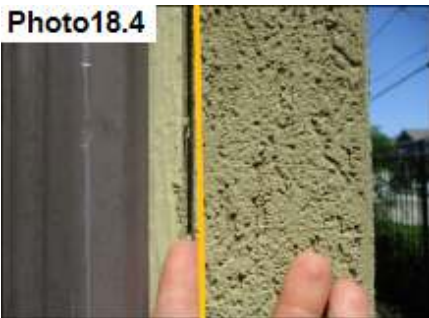
Photo18.5

Trim & Stucco Termination / Seal

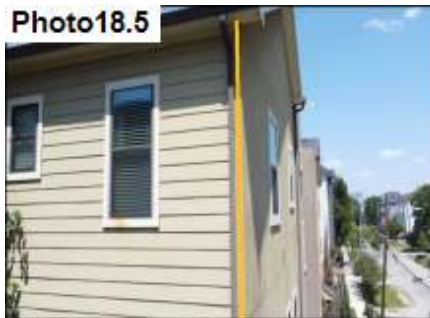
Photo18.6

Trim & Stucco Termination / Seal
