March 27, 2019

PROPERTY INSPECTION REPORT

Concerning: 30415 Avera Creek Dr, Spring, TX 77386
(Address or Other Identification of Inspected Property)

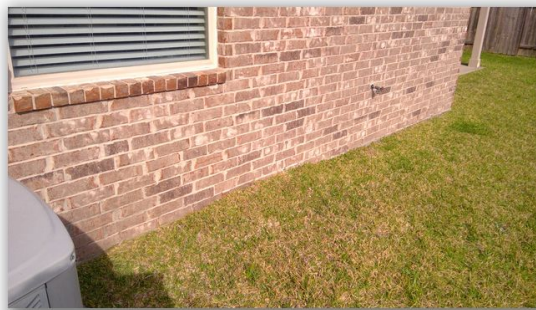
- 1. The soil line is too high on the back side of the structure. Under current building standards there should be at least 4-inches of foundation visible below masonry veneer and 6-inches of foundation visible below wood type veneer.

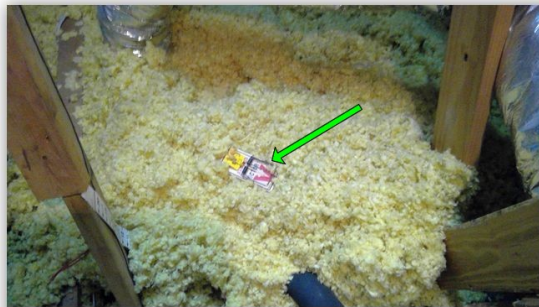
- **Note:** Visible evidence of rodent activity was observed in the attic area. It is recommended to have a Certified Pest Control Operator further evaluate this condition and make corrections as necessary.

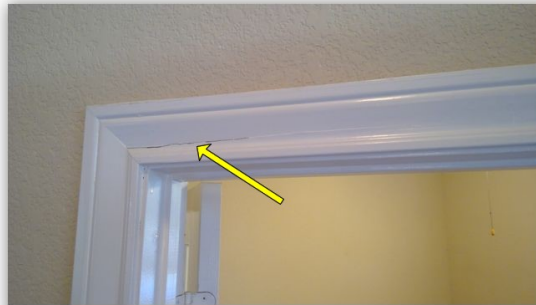
- Observed cracked door trim at various areas of the interior
- Observed area around hall closet door trim in need of caulk improvements

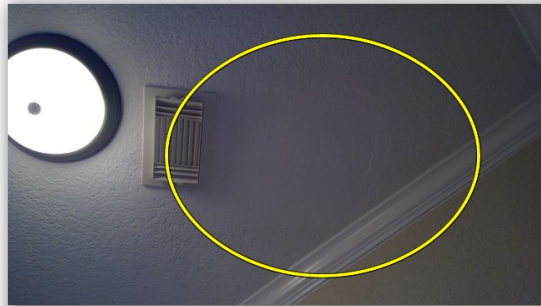
- 5. Water stains were observed on the ceiling finish in the front entry hallway. The cause and remedy should be further evaluated and corrected as necessary.
-

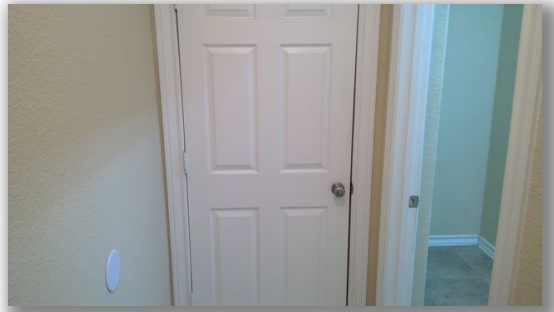
- 7. The garage entry door is not equipped with a self-closing device.

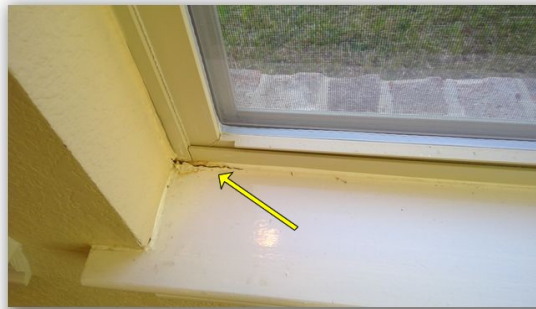
- 8. The window sill(s) have some deteriorated and/or damaged to various locations.

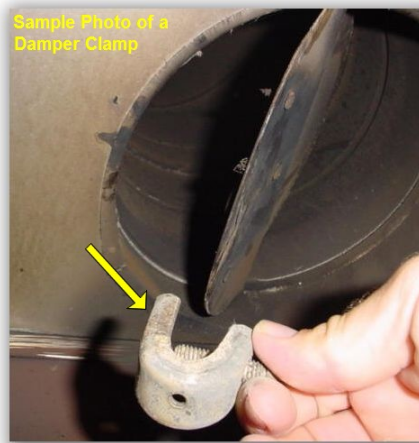
- When artificial gas logs are installed in a firebox with a damper; the damper should be permanently blocked open with a damper clamp to prevent accidental spillage of carbon monoxide into the living space.

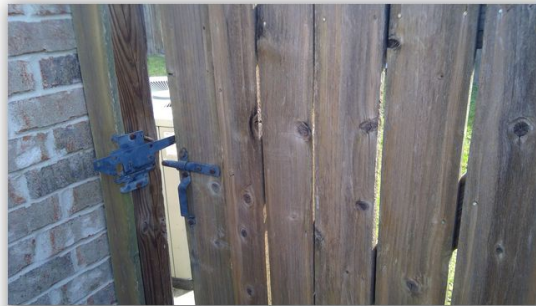
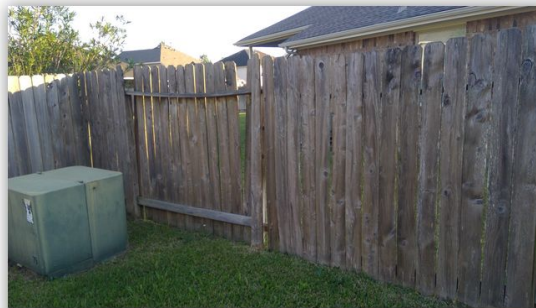
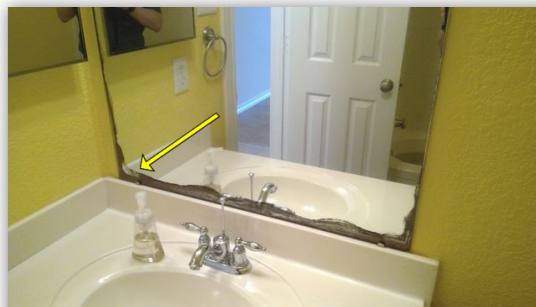
- Observed several fence pickets and gate to be in poor condition
- Observed deteriorated bathroom mirrors

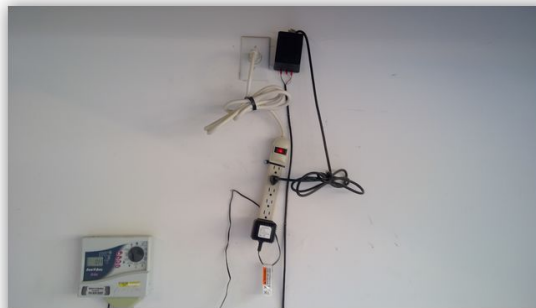
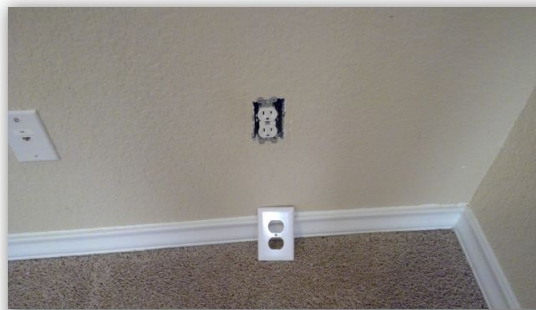
- Not all of the garage receptacles appear to be connected to a ground fault circuit interrupter (GFCI) device. Under current electrical standards, all of the garage receptacles should have GFCI protection. There New National Electrical (NEC) Code no longer has an exception for “non-appliance dedicated”. *****Sprinkler system dedicated outlet*****
- 11. One or more of the receptacles were observed to be damaged in the kitchen, rear corner bedroom.

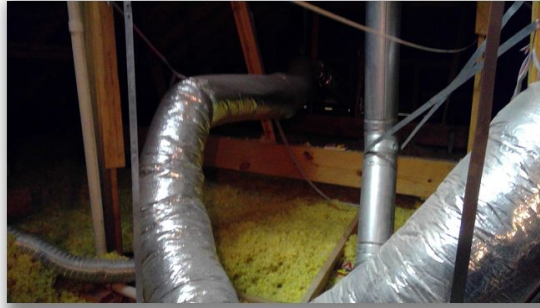
- 15. The duct work in the attic area appears to have excessive sags between the supports. This condition can cause pressure loss and affect the airflow through the duct system. *****Broken strap*****

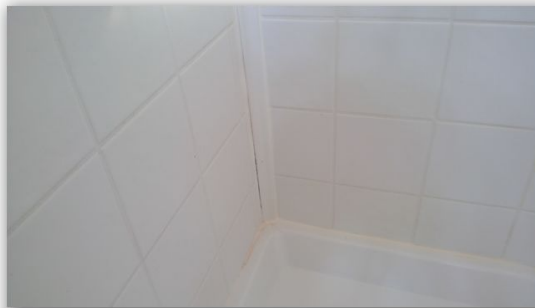
22. *Shower*

- Shower weepholes were observed to be caulked over. Weepholes are recommended to be open to allow condensation an escape path

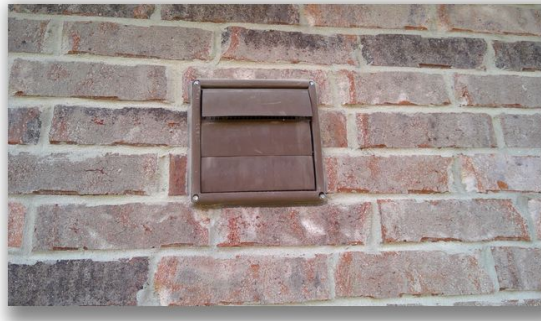
- **Note:** Louvered vent does not close completely

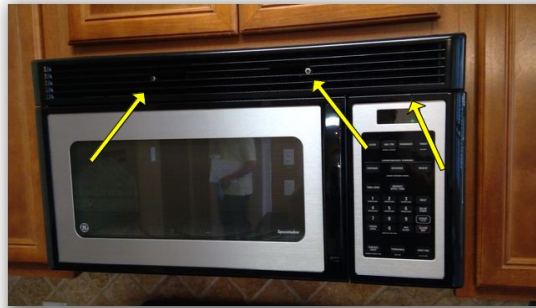
- Observed damage to exterior of microwave
