# HOUSTON INSPECTIONS

# PROPERTY INSPECTION REPORT FORM

09/09/2022

306 Fargo Street, Houston, TX 77006

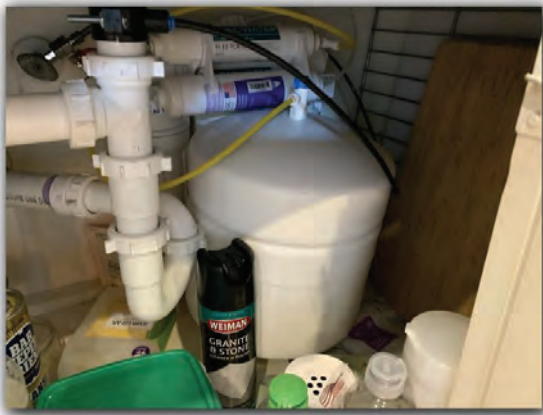
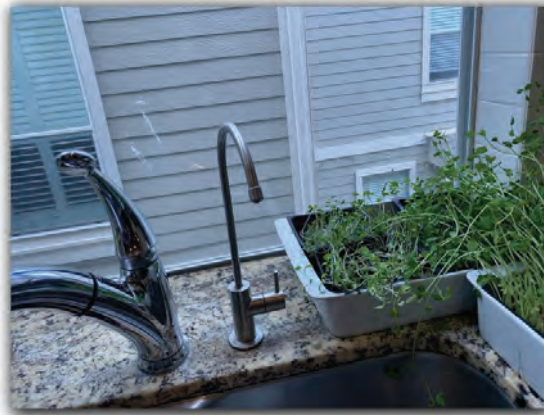
1. Kitchen sink water filtration system

These systems are beyond the scope of this inspection and were not inspected. The client is urged to have the system(s) along with associated components evaluated prior to closing to insure proper installation and performance.

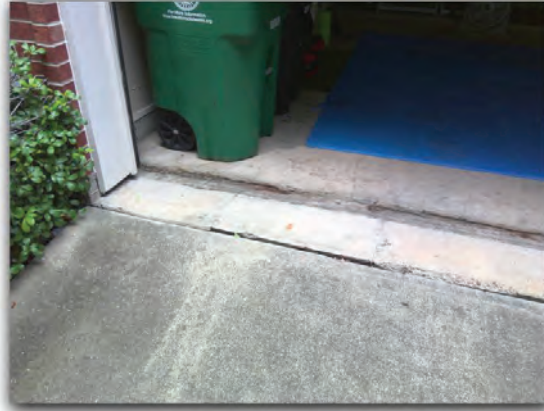
Signs of previous foundation repairs were noted around the perimeter of the foundation at the concrete flatwork as evident by pier caps. The seller / current owner should be consulted to determine the extent of repairs and any transferable warranties that apply to the foundation repairs.

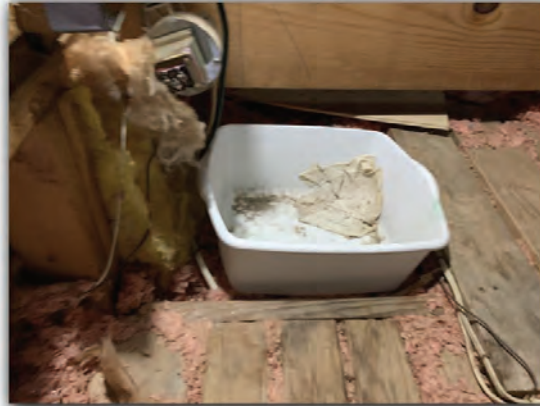
Plastic bins/tubs were found in multiple areas of the attic as indication of potential roof leaks. Patched/repaired shingles were found at portions of the roof covering, potentially to correct the leaks above these areas. Due to these conditions, the wear noted at the roof covering, and the limitations of this inspection, further evaluation and repair by a qualified contractor is recommended.

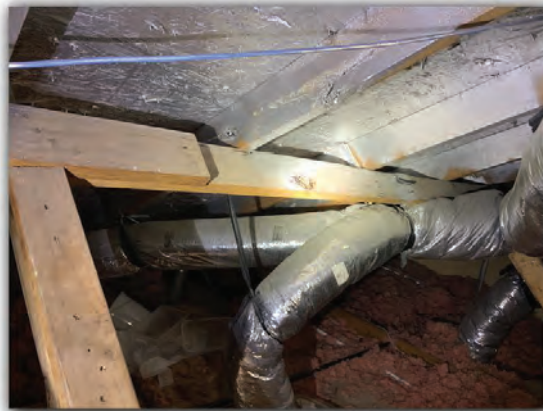
Purlin braces are spaced improperly according to current codes (maximum of 4' apart).

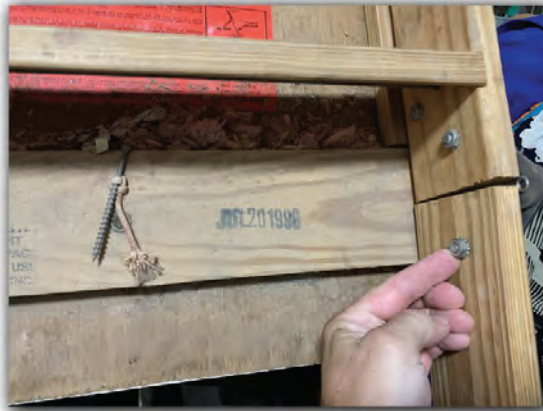
Loose and missing hardware was found at the attic door. This is a safety hazard that should be corrected.

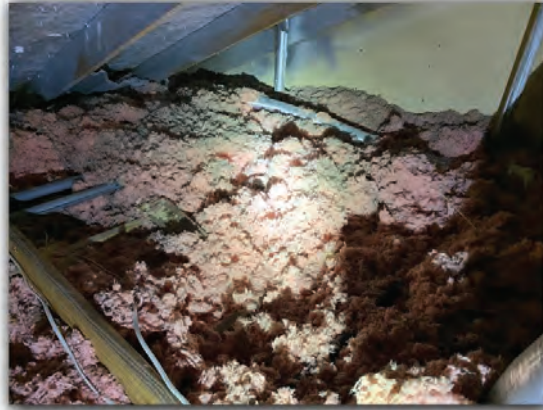
The level / depth of insulation in the attic is considered less than normal in some areas of the attic. The installation of additional insulation or the rearranging of the insulation is recommended to improve the energy efficiency of the building.

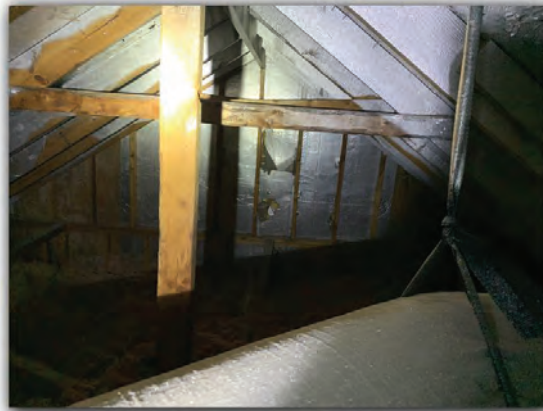
The front gable is obstructed in the attic. Improvement is recommended to ensure proper ventilation.

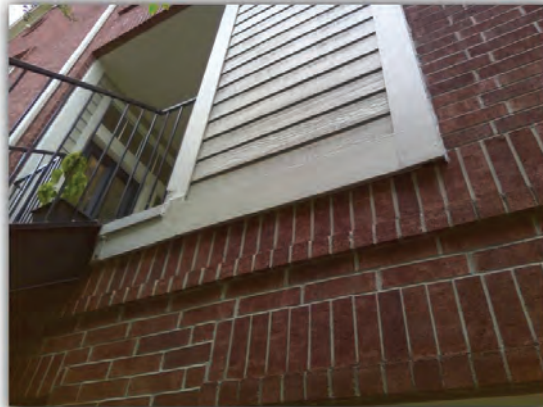
Siding appears to be improperly installed at corners / trim boards. Typically manufacturers recommend to not install trim over siding. Confirm with manufacturer.

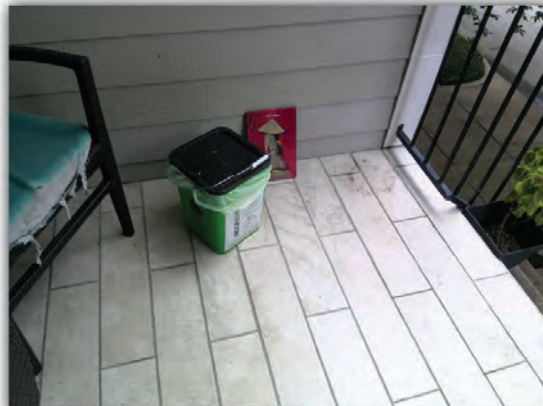
Improper clearance of the exterior veneers from flatwork (2").

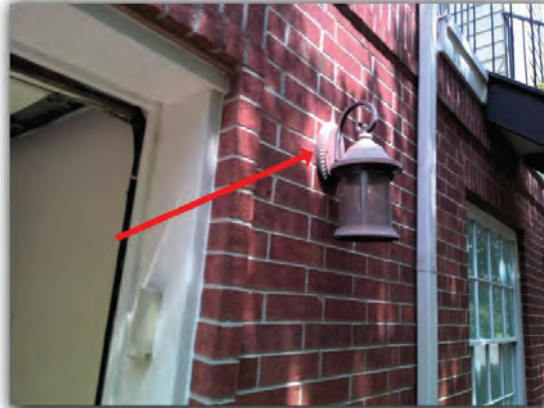
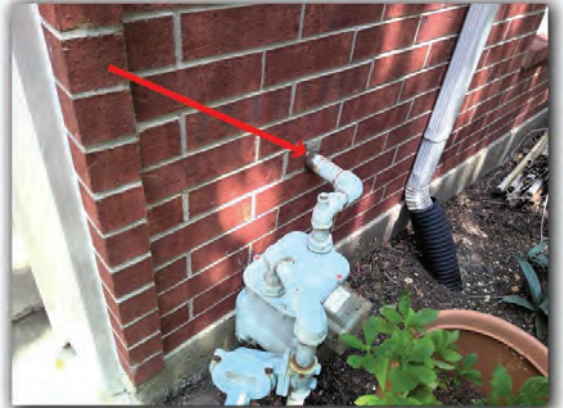
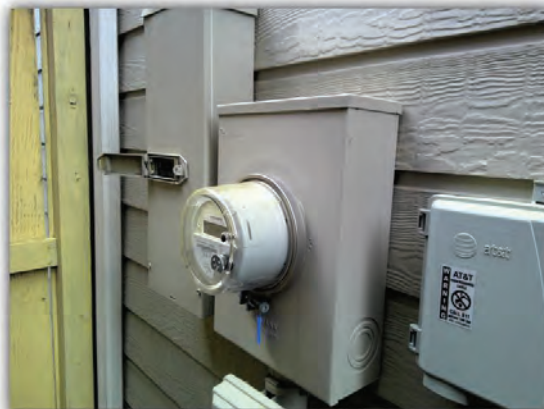
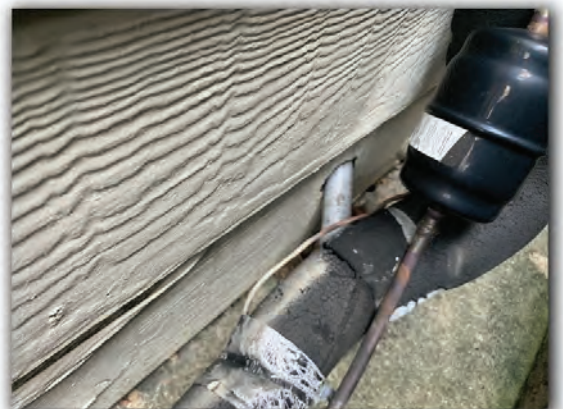
All exterior wall penetrations (electrical panels, electrical disconnects, light fixtures, etc. ) and openings (expansion joints, windows, door thresholds, etc. ) should be sealed with an approved material to prevent water penetrations into the wall cavities. Properly sealed exterior veneers help provide a barrier against the weather, insects, and enable environmental control of the interior spaces.

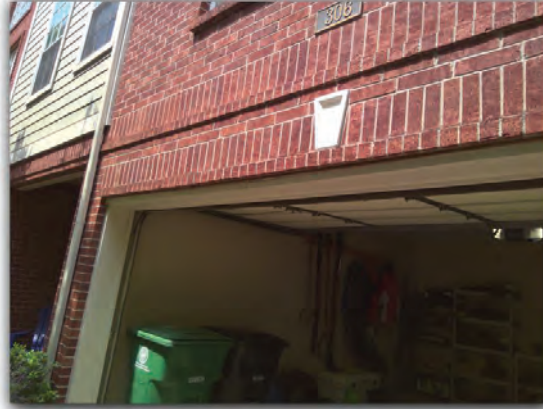
The metal lintels on the exterior of the structure are rusted. Lintels are metal that is installed over openings in the brick veneers (doors, windows, etc). Recommend cleaning and re-painting.

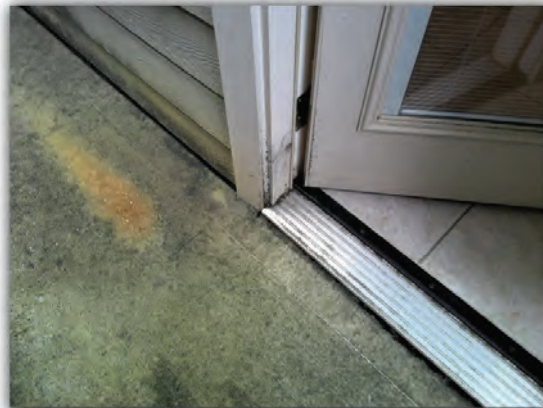
Damaged and / or missing items were found on the exterior of the property. The damage was found at the following locations:

1. Rear exterior door jamb/trim
2. Rear siding
3. Rear window trim

Recommend repairs / replacement of the affected areas. In addition, areas where decay is present should be removed, exposing underlying materials for inspection prior to repair by a qualified tradesman.

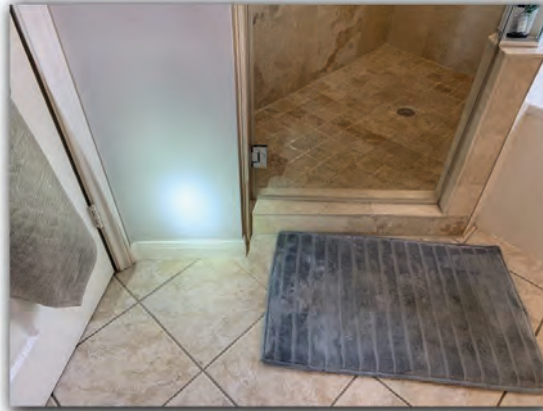
1. Primary bathroom wall near the shower

The problems have been possibly caused by one or more of the following: water penetrations, insects, impact, foundation / structural movement, etc. Repairs should include replacement of damaged underlying materials where needed.

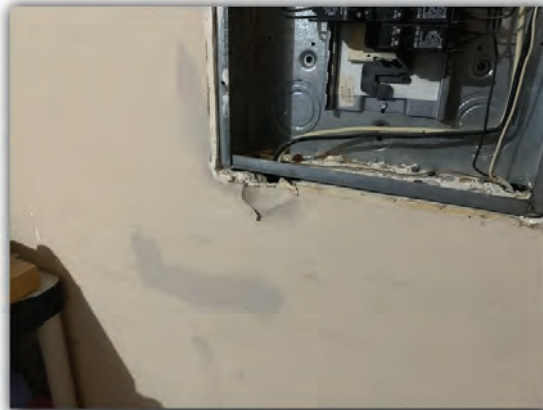
Damaged drywall should be repaired at the garage electrical panel.

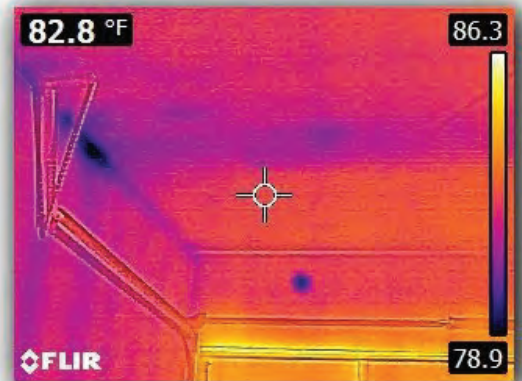
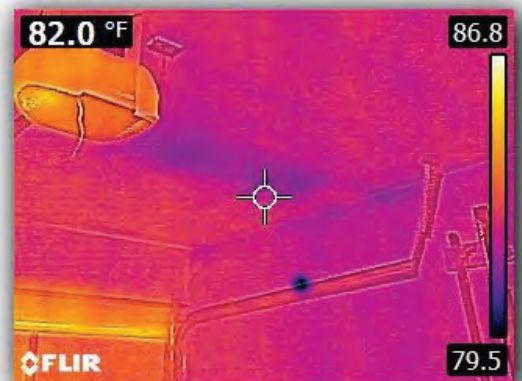
A thermal abnormality was noted in the garage ceiling spanning from one side of the garage ceiling to the other, approximately 8 feet from the front of the house. Elevated moisture content of 19-20% was measured at the left and right portions of this abnormality (As pictured). Drywall cracking/discolorations were found extending from the front to the back of the garage ceiling. Further evaluation of the ceiling and underlying space with repair of the moisture source as well as any underlying damage is recommended.

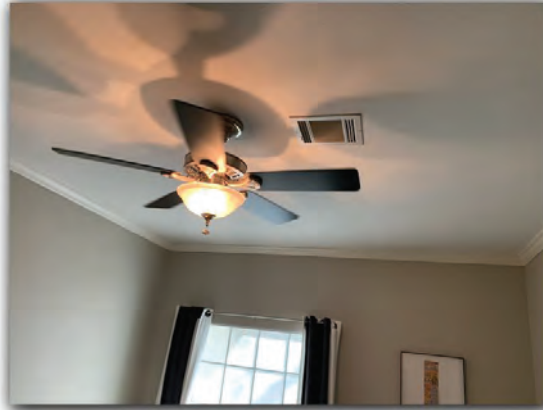
Evidence of patching was found at the first floor guest bedroom ceiling beneath the second floor porch/balcony.

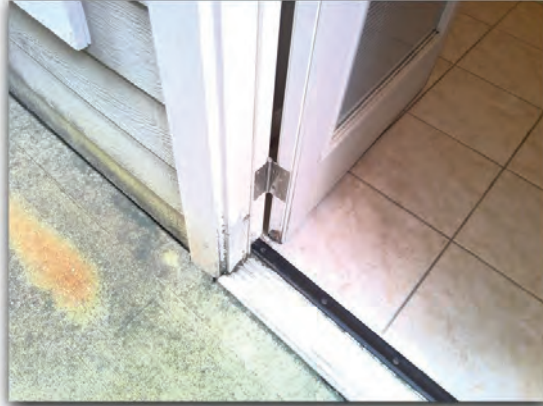
Damage was found at the rear exterior door core. This is typically caused by water splashing off of the concrete flatwork from the roof or due to wind-driven rain. In addition to the repairs, steps should be taken to correct the water exposure problem if possible. Replacement of the damaged items is recommended.

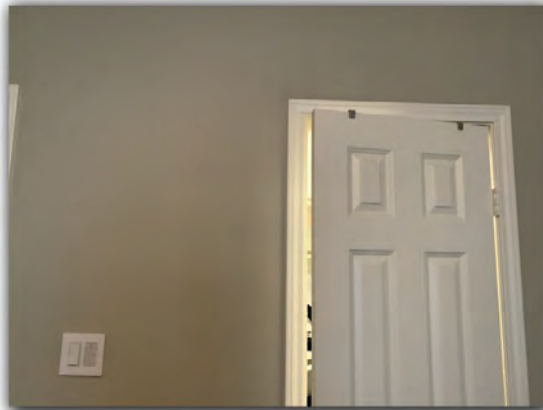
1. First floor guest bedroom entry door

Door(s) were found in the following locations that are in need of adjustments (do not latch, stick when closed, etc):

All doors at the property should be adjusted to operate properly.

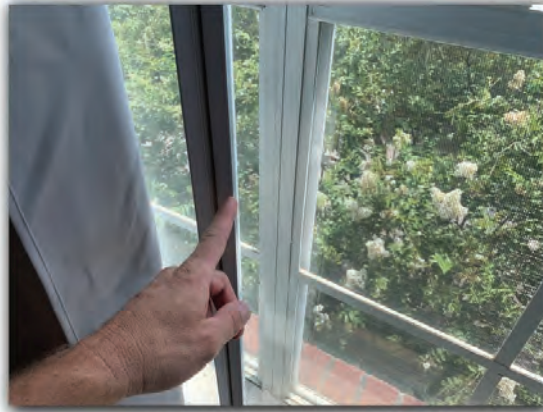
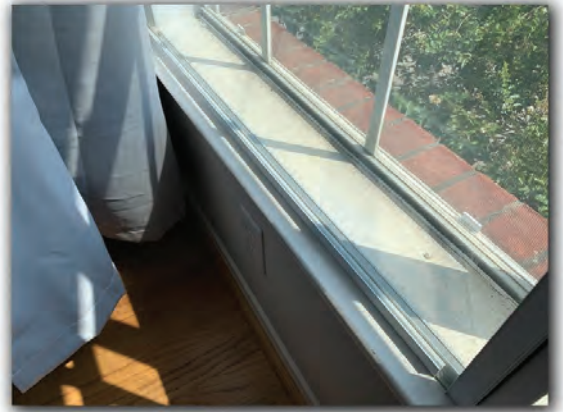
Windows are secured closed by screws/fasteners and were not tested in the first floor bedroom, dining room, primary bedroom. Additional window panels were installed and were not removed for testing in the first floor guest bedroom, primary bedroom.

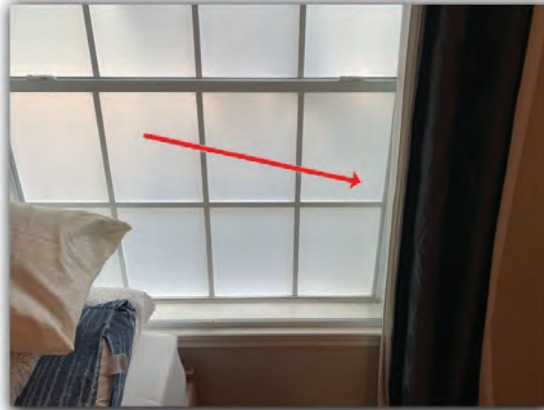
Chipped glass was found in the first floor guest bedroom.

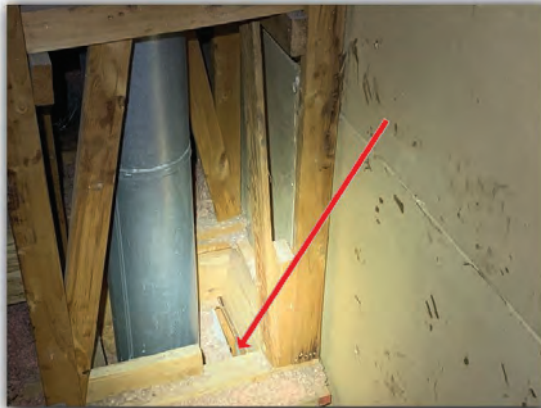
Fire stopping is not present or improperly installed at the chimney chase in the attic

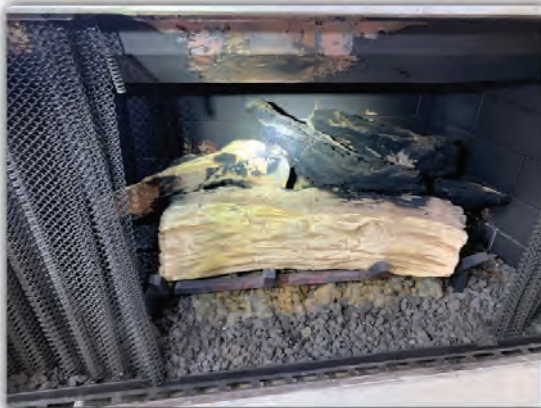
Discolorations and surface damage were found at the firebox/faux logs as indication of improper combustion. Repair/improvement by a qualified contractor is recommended.

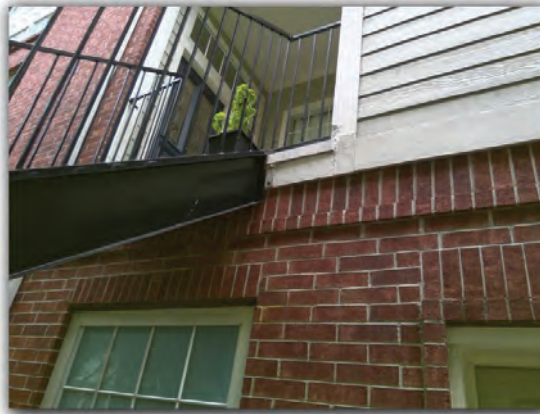
Diverter Flashing Not Visible / Improperly Installed - Further Investigation is Recommended

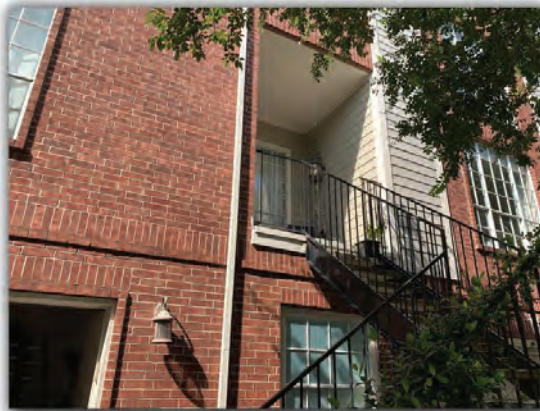
The front balcony flashing and pan are not visible. Previous repair as evidence of previous leaks were noted at the bedroom ceiling beneath this area. Further evaluation for repair/improvement by a qualified contractor is recommended.

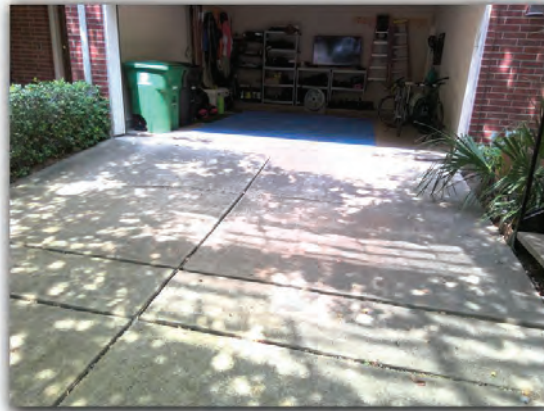
Significant cracks and breaks were found at the driveway.

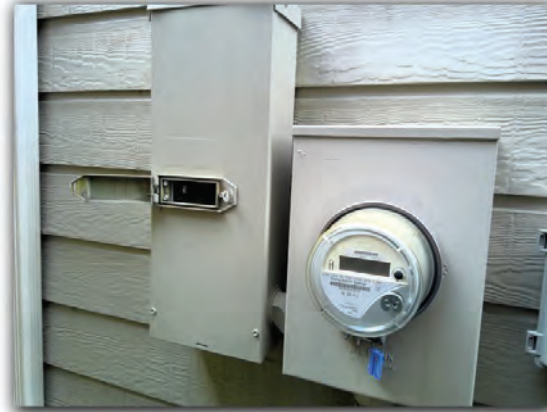
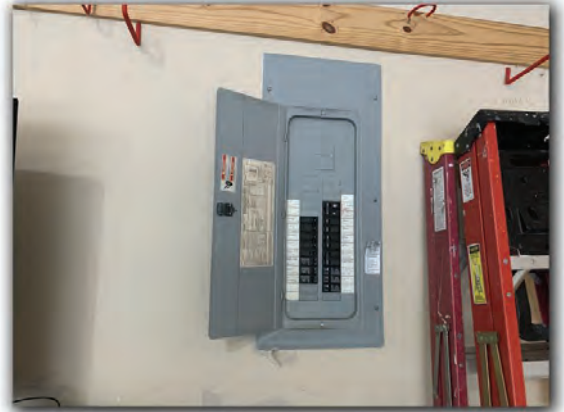
**Location of Main Electrical Panel:Exterior, Garage**

- Grounding clamp improper style for rod Installations
- Arc fault protection not installed at all required locations. Current codes require AFCI protection to be installed in kitchens, family rooms, dining rooms, parlors, libraries, dens, bedrooms, sunroom's, rec rooms, closets, hallways, and laundry rooms.
- Surge Protection not Installed Main Panel - Currently Required by Code

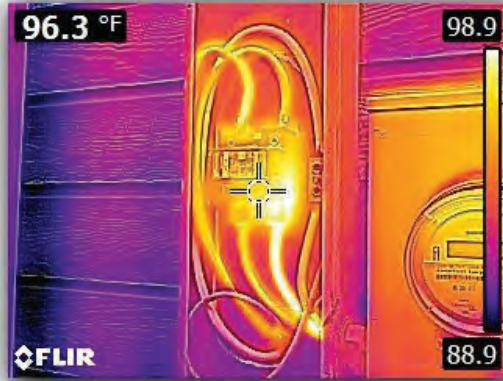
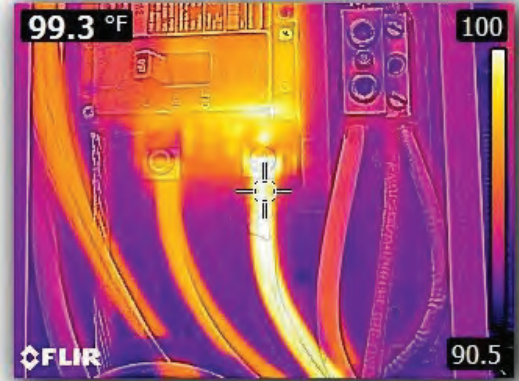
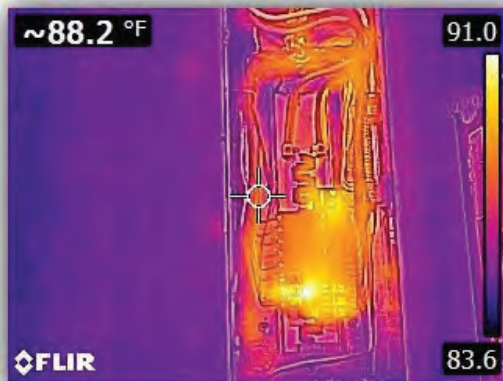
During the inspection of the electrical panel with an infrared camera significant abnormalities were not noted. The picture(s) below are a sampling of some image(s) taken during the inspection.

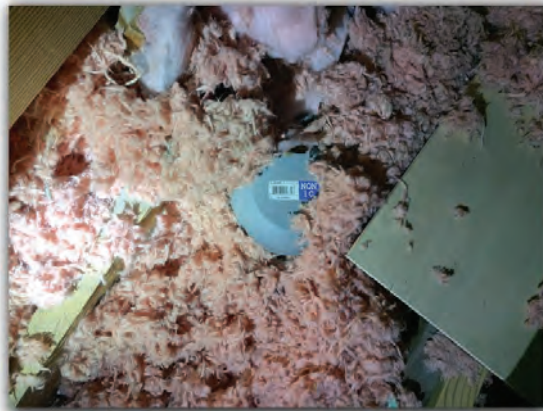
Recessed lighting is in contact with the insulation / combustible materials in the attic. A label could not be located on the cans that indicate they are rated for this type of installation. This is a fire hazard and should be corrected if fixtures are not approved for contact.

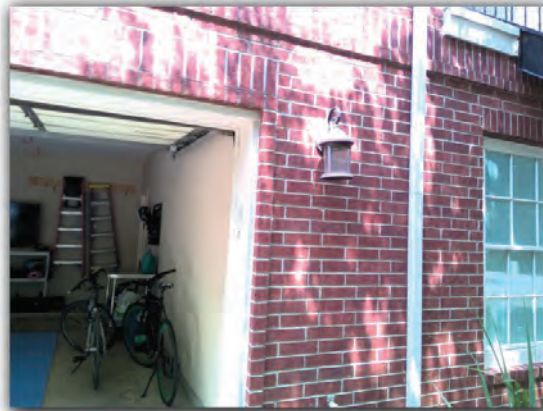
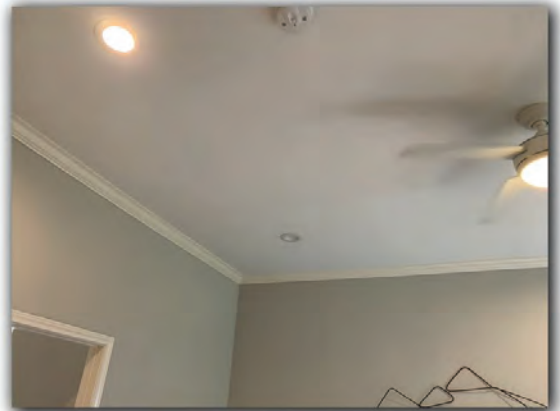
1. Front exterior (Missing bulb)
2. Primary bedroom ceiling

If the bulbs are not blown, the circuit should be investigated.

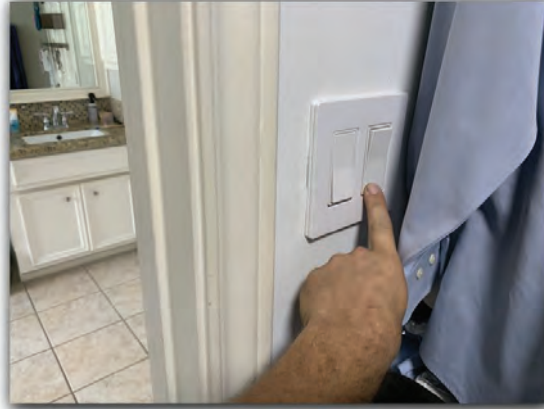
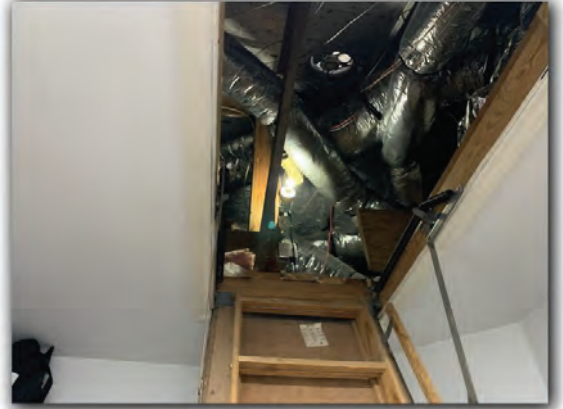
It is recommended that the attic light switch in the primary bathroom closet is labeled to help prevent the light being left on when the attic is not being accessed.

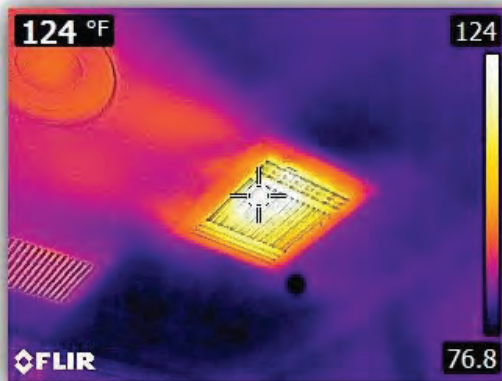
At the time of the visual inspection, the furnace was performing its intended function. However, the heat exchanger within the furnace is not visible & was not inspected. Yearly inspections of the heat exchanger and servicing of the furnace should be performed by a licensed HVAC technician to keep the system in good working order.

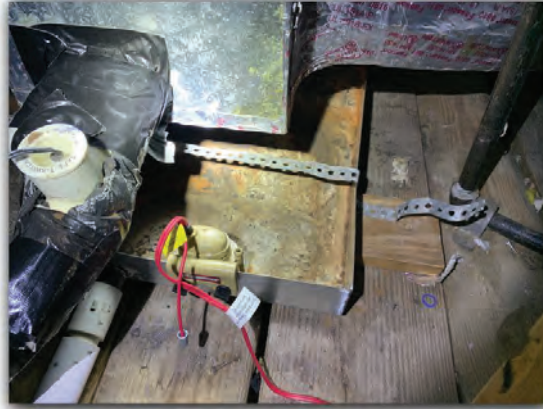
The overflow pan is rusted under the evaporator coil of unit(s) # 1, apparently from water overflowing from the condenser drain line in the past.

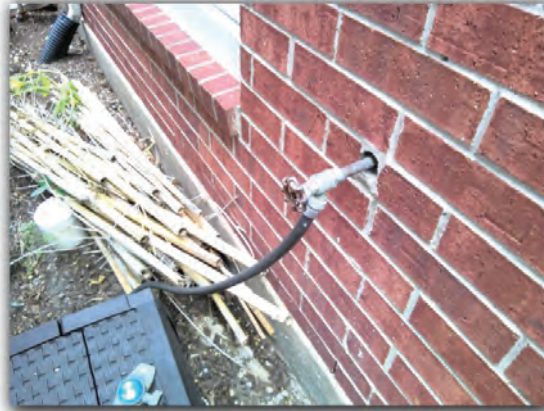
The supply piping on the exterior of the building / structure should be insulated to protect from freezing.

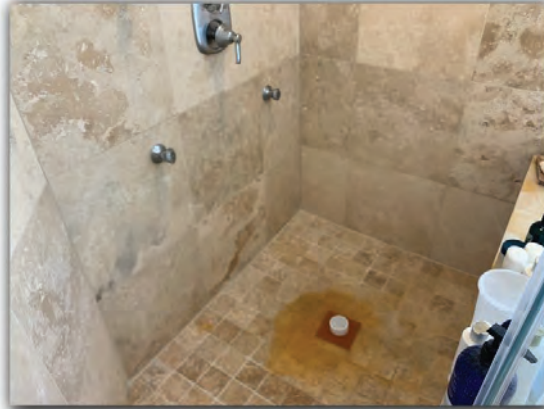
**Primary Bathroom**

Discolored water was noted while operating the shower supply plumbing. The source of the this discoloration could not be determined. A licensed plumber should determine the source and make the needed repairs.

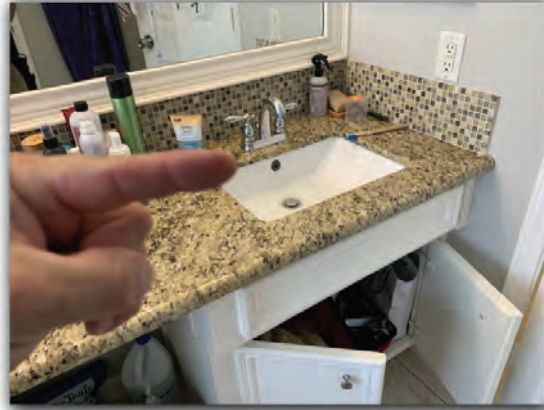
The right sink is draining slowly. It is suspected that the waste piping is obstructed. Further investigation is needed.

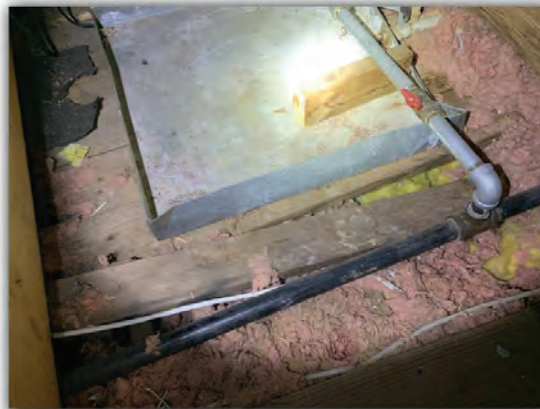
Debris and damage were found at the emergency drain pan. Repair /improvement is recommended.
