SELLER'S DISCLOSURE NOTICE

CONCERNING THE PROPERTY AT 909 Riverside Ct, Friendswood, TX 77546
(Street Address and City)

Style of Home: Single Family, One Story	Age Of Home: 1965	Home Faces: South, SW
Vacant or Occupied: Vacant	Utilities Active: No gas service to water heater, No electrical service to oven/range	Attendees/Personnel Present: Buyer
Weather: Partly Cloudy	Temperature: Over 80	Rain in last 3 days: No
Ground/Soil Condition: Dry, Standing water	Ancillary Services: Wood destroying insect, Pool	Recommended Professionals: Foundation, Structural Engineer, Roofer, Licensed Electrician, Licensed HVAC, Licensed Plumber, Appliance Contractor, Licensed Pest Control, Handyman, Carpenter, Pool, General Contractor, Leak/Water Remediation Contractor

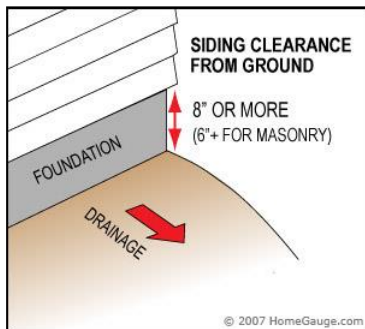
☒ Gutters are recommended where not installed. Water cascading off the roof where gutters are not installed could result in excessive erosion and possibly undermine the foundation.

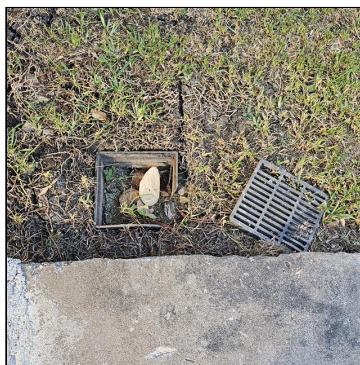
☒ Maintenance Recommendation: Noted home is equipped with below grade drainage system. Recommend as regular maintenance that drain covers are clear of debris, rocks, overgrown grass to ensure covers are not obstructed from proper drainage. Current condition reveals drains are clogged with debris; clear for proper drainage.

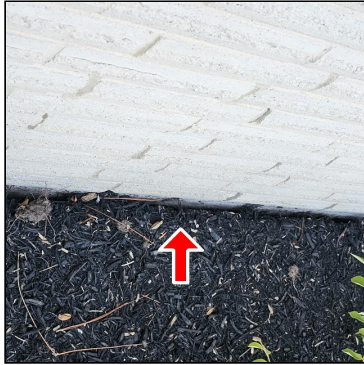
Noted there are areas at parameter of home where grading is pulling away from foundation. This is a sign of area potentially experiencing drought conditions. When soil pulls away exposing a cap the home has a chance of more than normal movement. Recommend having areas affected filled and packed as needed. During drought periods it is recommend foundation areas are properly watered to reduce soil pull-away conditions.

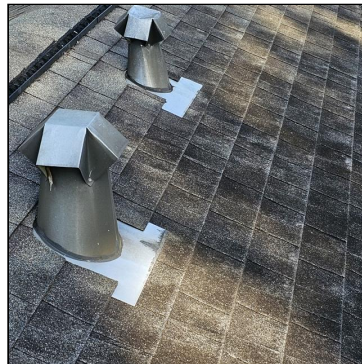
The original gas flue vents for the hot water heater and heating system are "dated". (Insufficient height, not screened, inappropriate cap, etc.). Current standards require flue "B" vents to extend minimum 36 inches above roof.

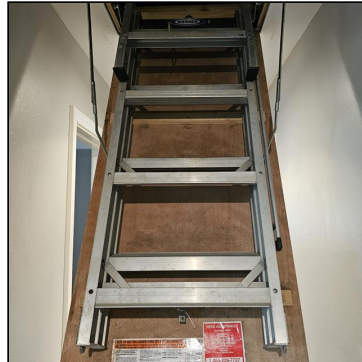
The attic pull down ladder is not insulated completely, nor does it have weather stripping installed at edge of door that meets ceiling framing. Recommend fully insulating the attic stairway to keep the house more energy efficient. On average the insulation R-value for the entire attic area will drop approx. 27% when the attic stairs/hatch is not fully and properly insulated. The reason for this is that, although the attic stairs/hatch account for only 1% of the total attic area, the rate that heat flows through them by conduction (per square foot) is 38 times higher than in the insulated part of the attic.

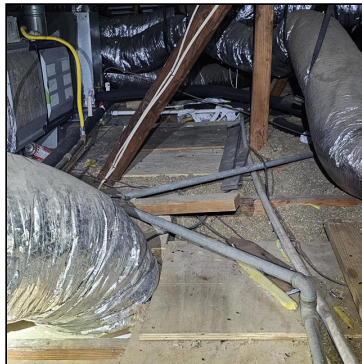
There is no walkway access to the appliances installed in the attic. The passageway should have continuous, solid flooring not less than 24 inches wide. There should be a work space that is level and at least 30 inches deep and 30 inches wide in front of the water heater.

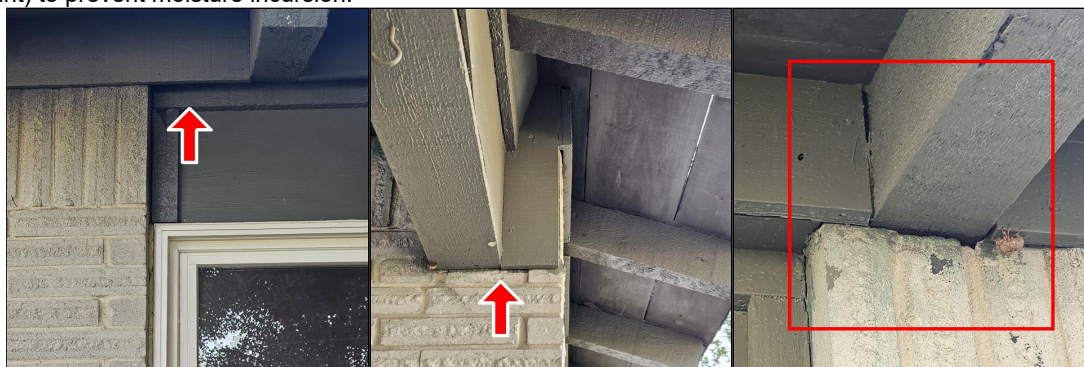
Noted areas of siding trim and edges that have missing or deteriorated caulking. These areas can be a point of water infiltration if not addressed. Noted no evidence at interior sides of home areas with previous water infiltration at time of inspection. Recommend fully and properly sealing all areas affected.

All exterior siding butt & transitional joints that are separated more than 1/8" should be re-sealed (caulk and paint) to prevent moisture incursion.

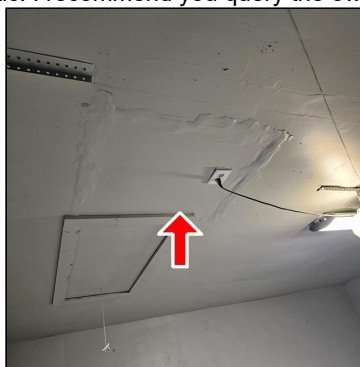
There is evidence of previous repairs on the ceiling in the garage. There was no prior disclosure of this repair, and no evidence of damage in the attic. I recommend you query the owner for the history on this area.

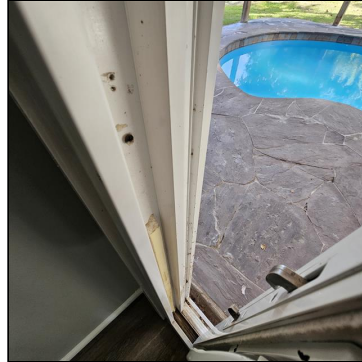
The door(s) and frame are damaged from water intrusion at the rear door. Repair is recommended by a qualified contractor. An entry cover or storm door may be recommended to reduce incidence of water intrusion.

The rear sliding glass door does not operate properly, indicating the hardware requires replacing.

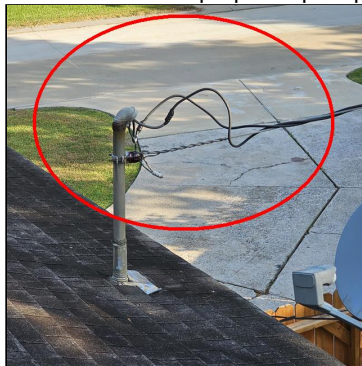
Main service wires at the weather head do not have proper drip loop.

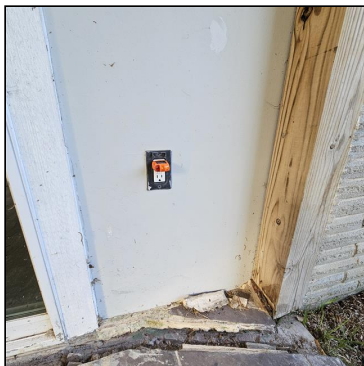
An exterior outlet(s) with a missing cover was observed. Missing or damaged covers on exterior outlets/ switches render them no longer wet location rated. Repair or replace receptacle cover to maintain wet location rating required by current standards.

Exterior light switches were not wet location/exterior rated as required. Have an electrician replace these with properly rated devices.

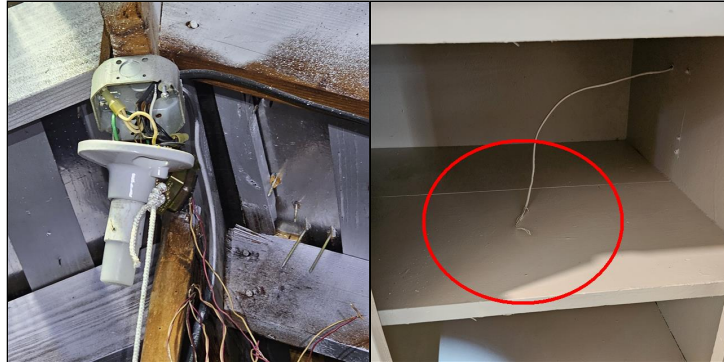
There were exposed connections, open boxes observed in the attic and in the kitchen closet. Secure, enclose in rated enclosures to prevent hazards.

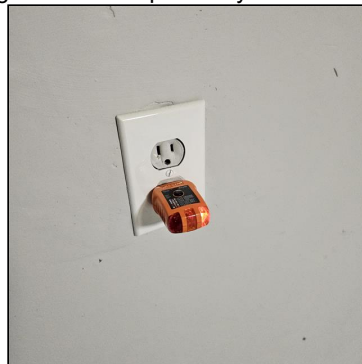
There was a circuit with an open neutral observed in the kitchen (above dishwasher) and in the garage to left of door. The cause should be diagnosed and repaired by a licensed electrician.

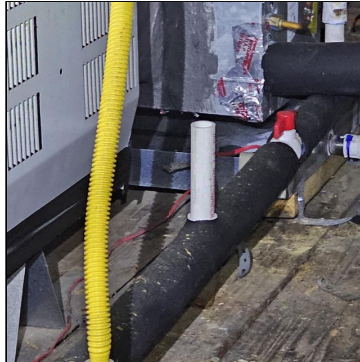
The secondary condensate drain lines are producing water, indicating the primary drains are obstructed. A licensed HVAC technician should clean and repair the lines as needed.

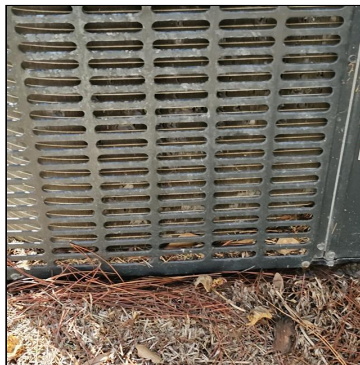
The A/C condenser(s) should be elevated 4" above grade to avoid lower cabinet (rust) damage.

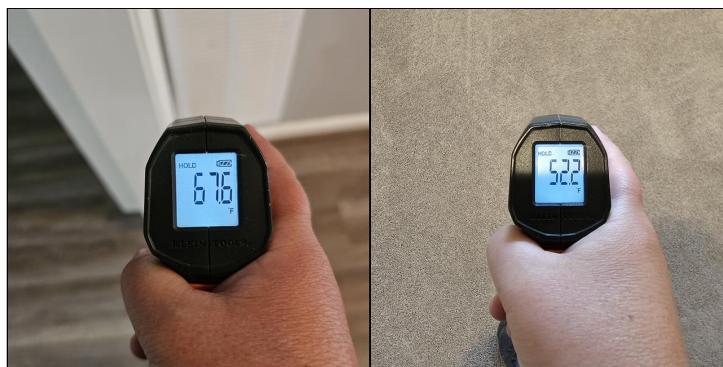
The main unit(s) functioned at the time of inspection. Target temperature drops between 15-22 degrees were obtained. Thermal imaging of the condenser coil did show possible evidence of constricted coolant lines at time of inspection.

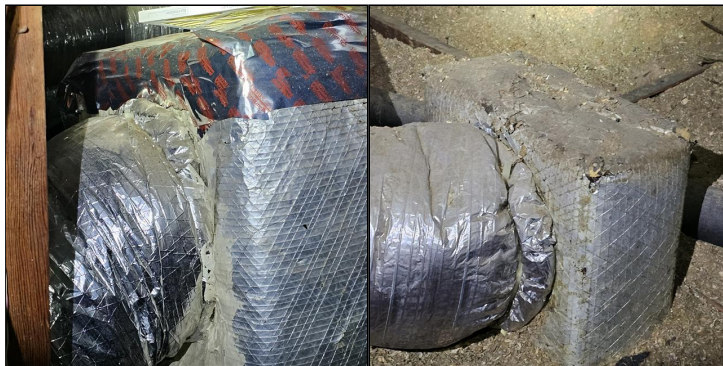
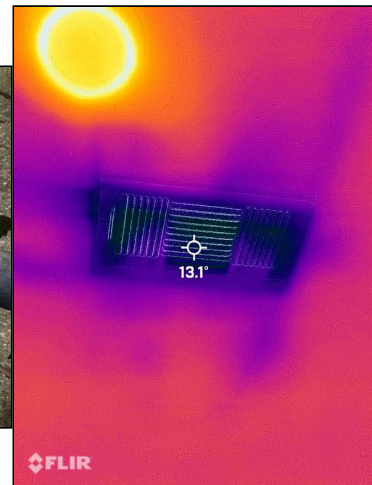
The temperature differentials were off by 5 or more degrees when measured at random vents. This may be corrected by balancing ducts and will provide a more even temperature distribution throughout the house.

Duct seals are deficient or not present in various areas. Recommend repair by HVAC technician as needed.

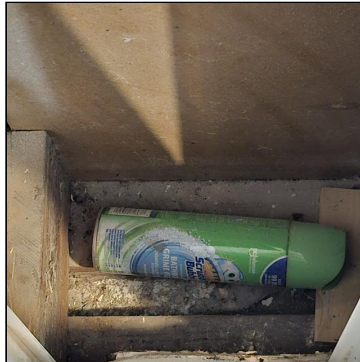
Recommend cleaning return air chase of debris.

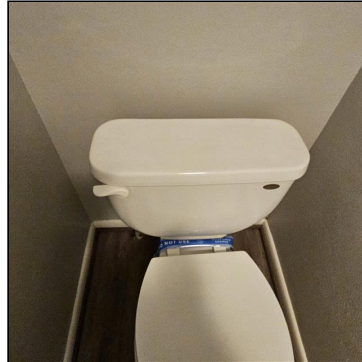
Toilet tank was loose on bowl in the master bath. Tanks should be secured, and not have movement on bowl assembly to prevent damage to seals and/or leaks.

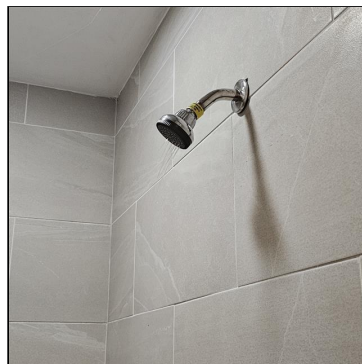
Home has original galvanized supply lines. Lines of this age are known to develop leaks and clogs overtime. Supply problems may not be detectable until they actually fail. Consider updating these supply lines. Consult with licensed plumber for options and pricing.

Noted low pressure/flow at guest bathroom shower. May be due to lack of hot water service at time of inspection. Monitor and repair as needed.

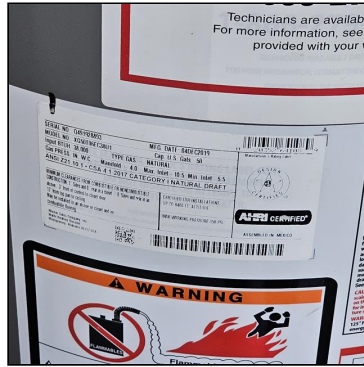
No gas service to unit at time of inspection. Unit could not be operated for inspection. Return inspection recommended after service has resumed.

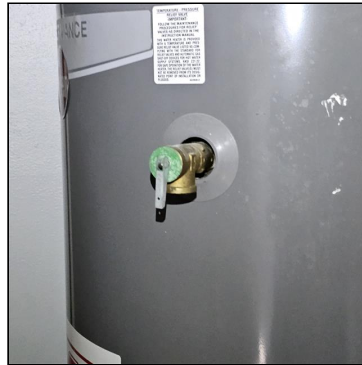
The water heater abuts to an interior wall and there is no emergency leak catch pan installed. Today's standards now require a catch pan that is plumbed to the exterior in locations where tank leaks could cause interior water penetration. For interior installations there are retrofits available, with water leak detectors that shut of the water supply. Consult with a licensed plumber for viable solutions.

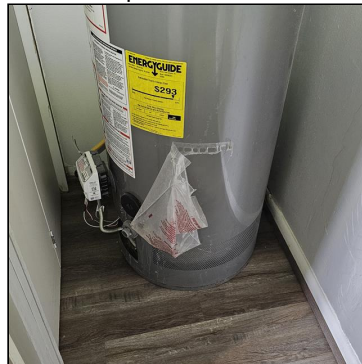
The combustion air supply is deficient. For interior installation of furnace type appliances, adequate combustion air should be supplied from exterior or attic spaces. Recommend retrofit with solid core appliance door and installing combustion air supply vents to exterior or attic space. Air vents from attic (2) should extend 12" from ceiling and 12" above base of closet floor for proper air circulation and supply.

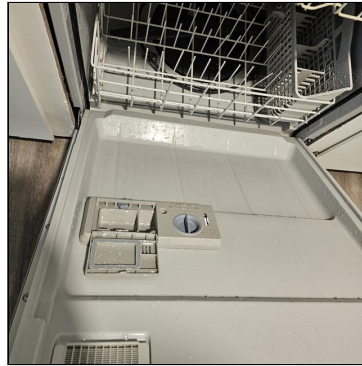
Dishwasher drain line does not have a sanitary anti-siphon line loop installed properly as called for by today's standards. An anti-siphon device prevents the wastewater from the dishwasher from being siphoned back into the dishwasher and contaminating its contents. A drain loop should be attached to highest possible point in the cabinet, or above the sink water line to prevent drain back from the sink and disposal.

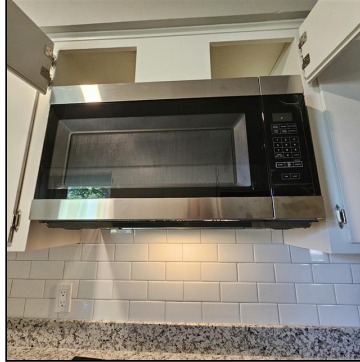
Breaker was off to the unit at time of inspection. Inspectors do not reset breakers. Unable to test unit for functionality.

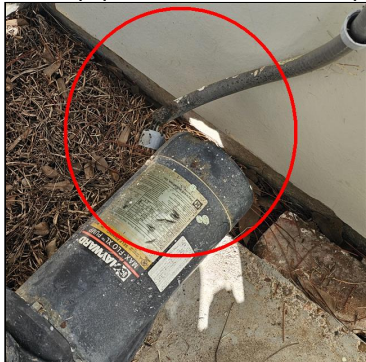
The pump motor and/or furnace does not have a visible bond/ground wire present as called for by today's standards. All pool electrical equipment should be grounded, bonded to pool structure.

Conduit is loose at motors or electrical equipment. Make secure to prevent damage to conductors.

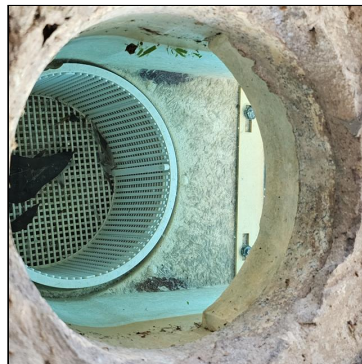
There was no weir door present at the skimmer entry. These devices prevent debris from floating out of the skimmers and back into the pool.

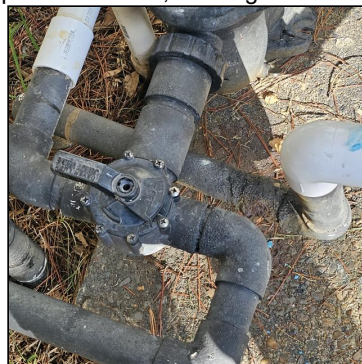
The pool equipment is not secured to the cement slab as recommended by manufacturers. Movement of equipment could cause damage to pipe connections, causing leaks.

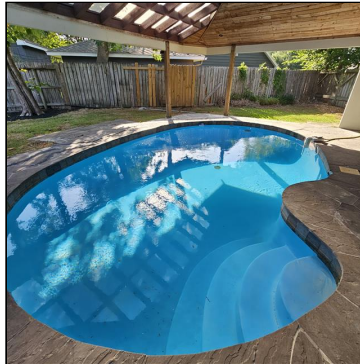
There are no depth markers present.

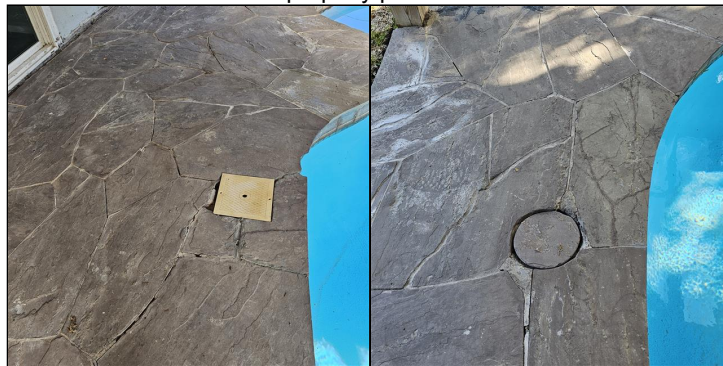
Noted some cracking, movement or missing or aged sealant around areas of walking deck. Recommend having area repaired and sealed as needed to properly protect.
