RedFish Inspections

Property Inspection Report

16118 Arborlea Dr, Friendswood, TX 77546
Inspection prepared for: Del Whittington
Real Estate Agent: Cindy Kipling - Realty Associates

Date of Inspection: 5/4/2022 Time: 2:30 PM - 6:00 PM
Age of Home: 30 years old Size: 2228 sqft
Weather: Mostly Cloudy

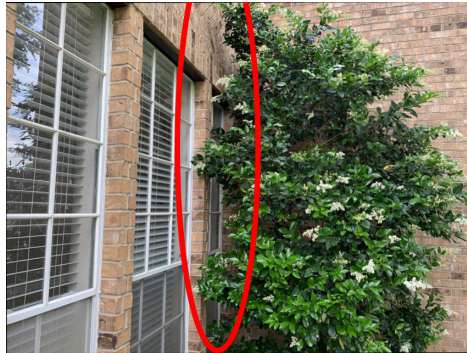
Front: Foliage close to structure

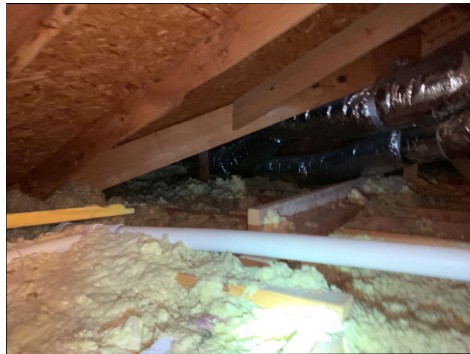
Insulation improvement needed

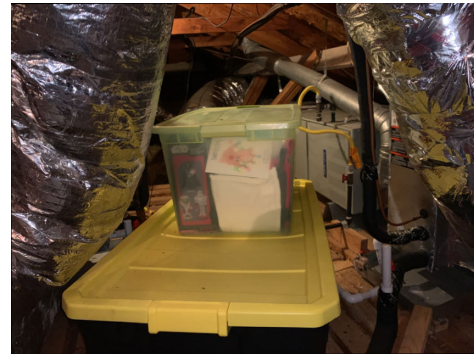
FYI: Owner's belongings obstructing path to HVAC equipment

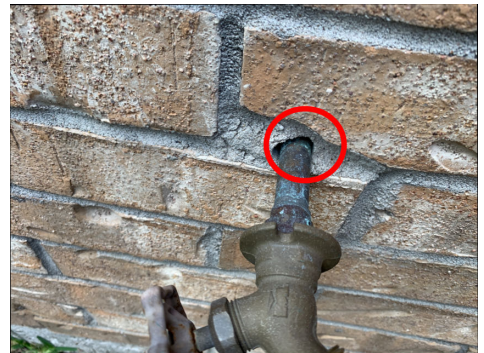
Left: Hole at plumbing pipe

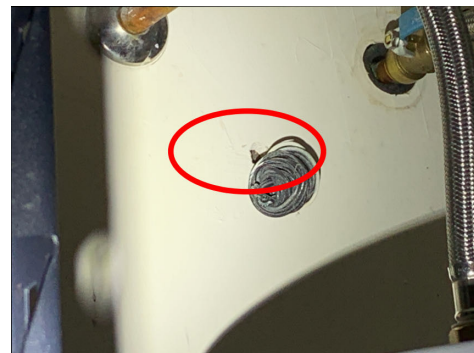
Garage: Hole in firewall separation

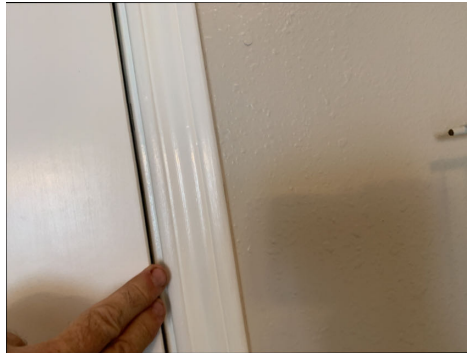
Garage man door: Rubbed on frame

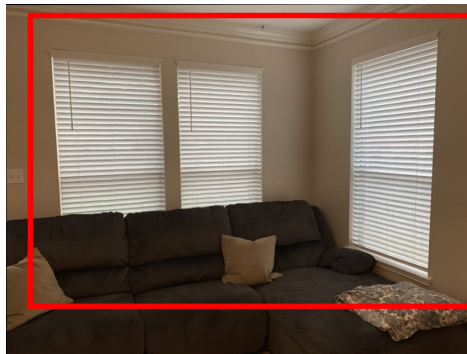
Living Room: Windows blocked

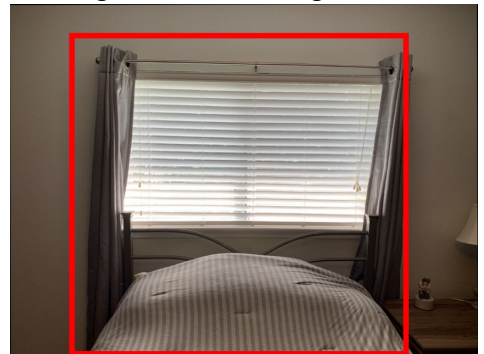
Bedroom 2: Window blocked

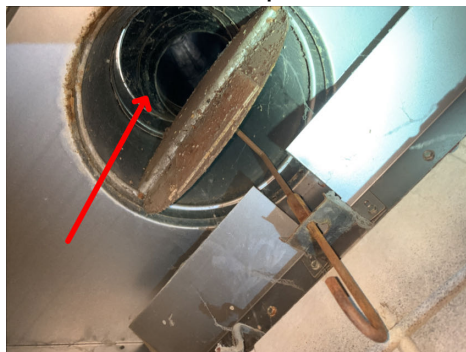
Damper locked open

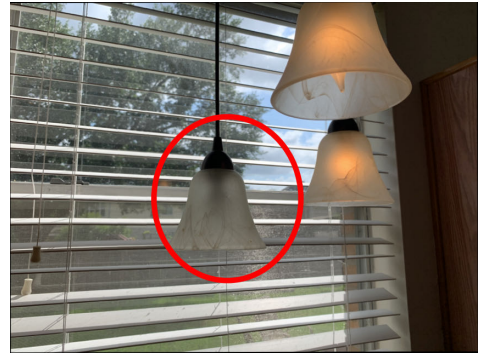
Kitchen: inoperative light fixture

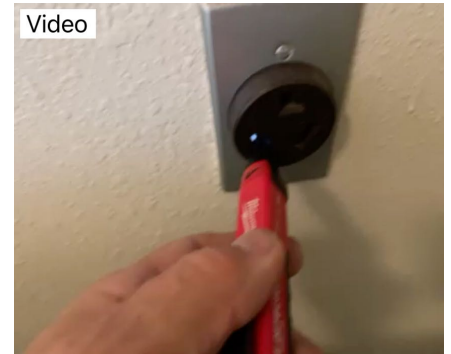
One or more outlets in the home were improperly secured and moved when plugs were inserted. Outlets should be securely installed to prevent fire, shock and/or electrocution hazard. We recommend having these improved. This was observed in the front room, breakfast nook 2nd floor hallway.

Breakfast Nook: Loose outlet

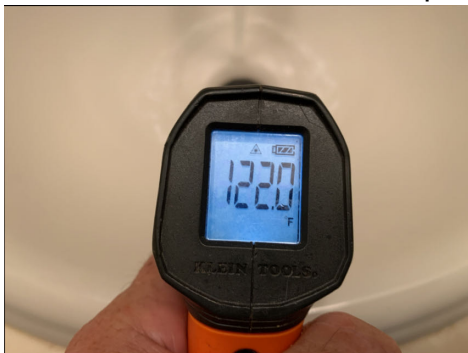
The water temperature was measured at 122 degrees. This is scalding. We recommend reducing the temperature at the water heater to maximum 120 degrees.

Hot water temperature: Scalding

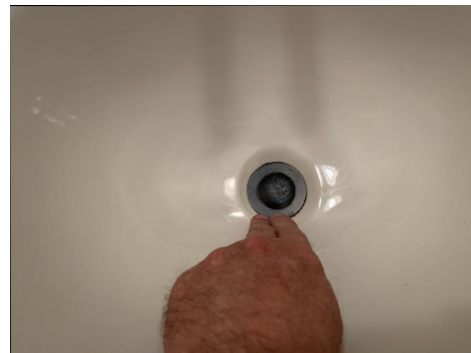
MAINTENANCE: A stopper was not functional at a bathroom lavatory/tub. We recommend having stoppers adjusted or repaired to retain water as designed. This was noted in the half bathroom, bathroom 1 tub and bathroom 2 (both lavatories).

Half Bathroom: Inoperable stopper

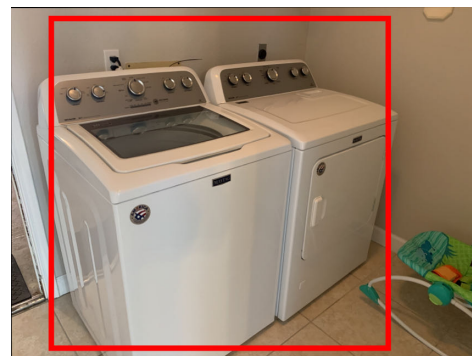
Note: Inspection of the clothes washer and dryer is beyond the scope and qualification of our standards of practice. These appliances were not operated. If this is a concern, we recommend further evaluation and repair as needed by a qualified technician.

Washer and dryer not inspected
