# Your Inspection Report

12128 Ostermeyer Road  
Galveston, TX 77554

**INSPECTION DATE:**  
Tuesday, November 15, 2022

**PREPARED BY:**  
Charles Lehnhoff, 23070

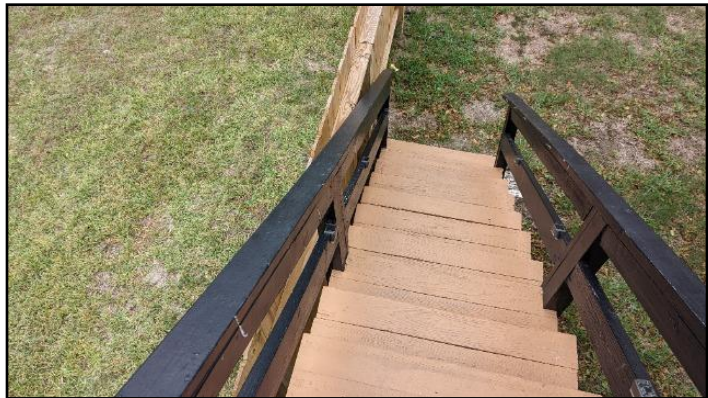
Location: Throughout Rear Exterior Staircase

22. Openings between spindles (balusters) too...

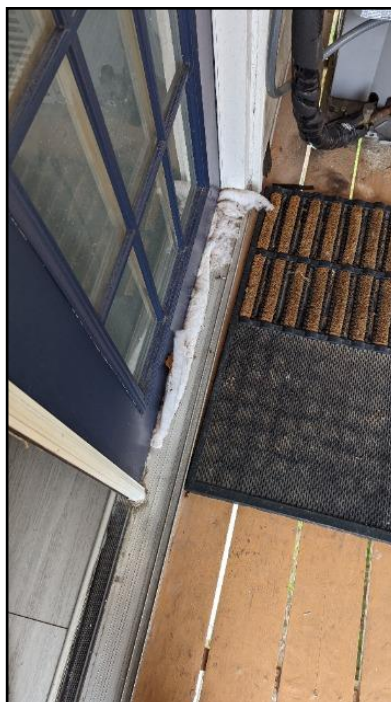
Implication(s): Hazardous combustion products entering home | Increased fire hazard

Location: Left Side Exterior Wall

24. Door not tight-fitting and weatherstripped

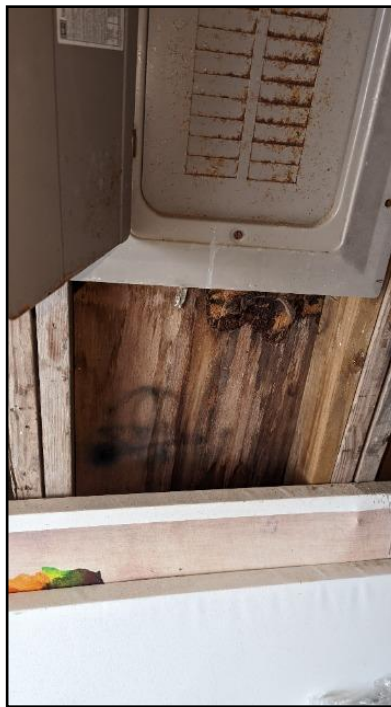
in many jurisdictions, the panel support (or back-up) must be a non-combustible material such as drywall

plywood or wood planking were commonly used for panel support in older installations

34. Inappropriate mounting surface

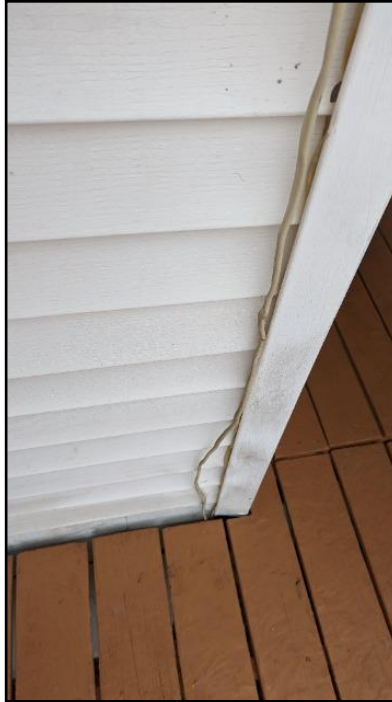
**Implication(s):** Shortened life expectancy of material | Electric shock

**Location:** Various Throughout

**38.** *Indoor wire used outdoors*

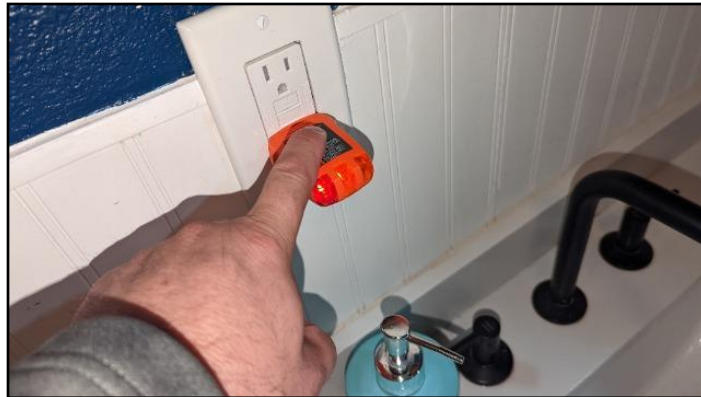
**Location:** Various Throughout

46. Test faulty on GFCI/GFI (Ground Fault...

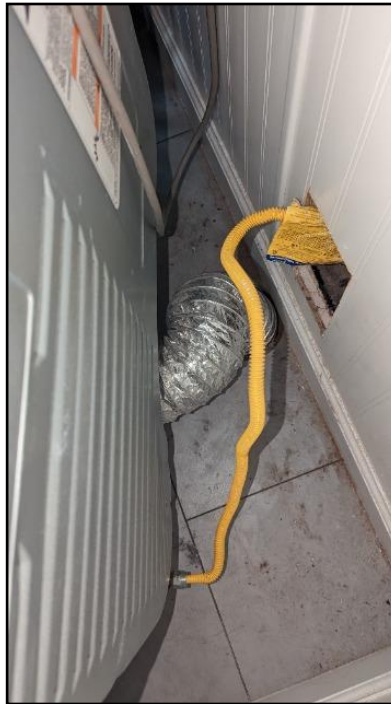
73. No drip leg (sediment trap, dirt pocket)

**60. Condition:** • [No drip leg \(sediment trap, dirt pocket\)](#)

**Implication(s):** Equipment not operating properly

**Location:** Laundry Area

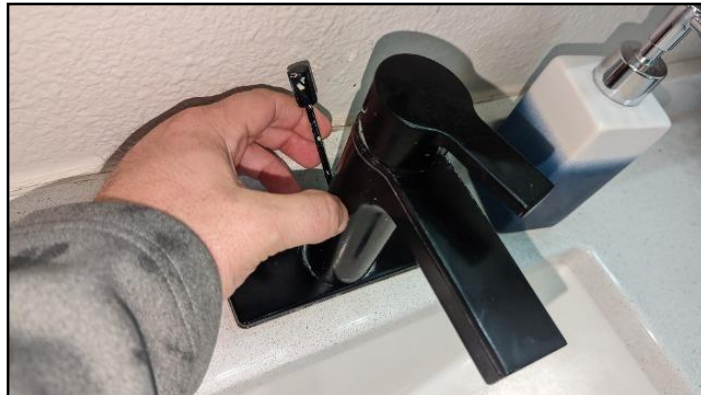
80. Drain stop ineffective

68. Condition: • Drain stop ineffective

Location: Second Floor Master Bathroom

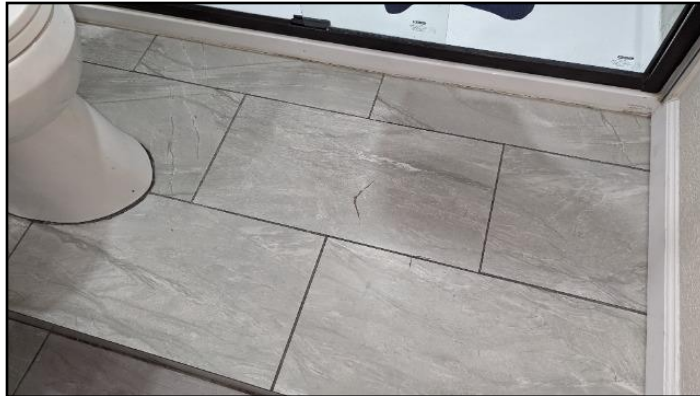
82. Odor around toilet

70. Condition: • [Odor around toilet](#)

Implication(s): Sewer gases entering the building | Sewage entering the building

Location: First Floor Hallway Bathroom

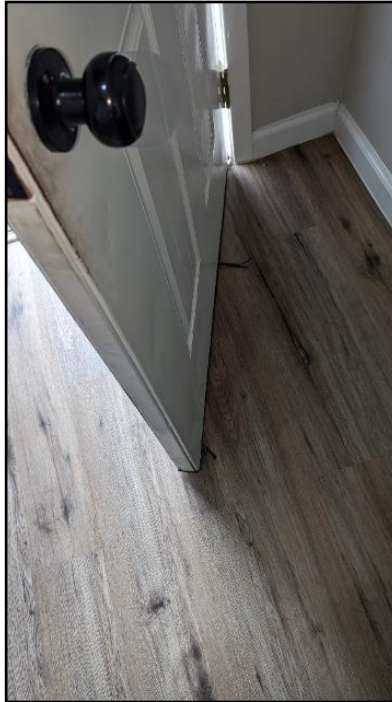
99. Weatherstripping missing or ineffective

81. Condition: • [Weatherstripping missing or ineffective](#)

Location: Front Second Floor Door
