Property Inspection Report

**Shane and Ashley Morris
1805 Autumn Pond Circle
Alvin, TX 77511
Midtown Park
Key Map 695M**

Monday, August 31, 2020

PROPERTY INSPECTION REPORT

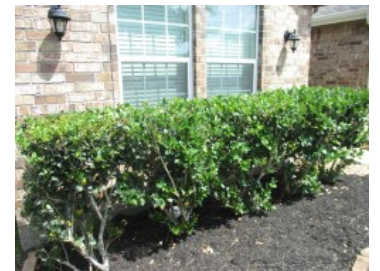
Representative

Maintenance: Shrubs planted too close to the foundation will hide the slab from view as they mature, creating conditions conducive to infestation by Wood Destroying Insects (WDI). Shrubs should not be planted closer to the slab than half of the mature width of the shrub.

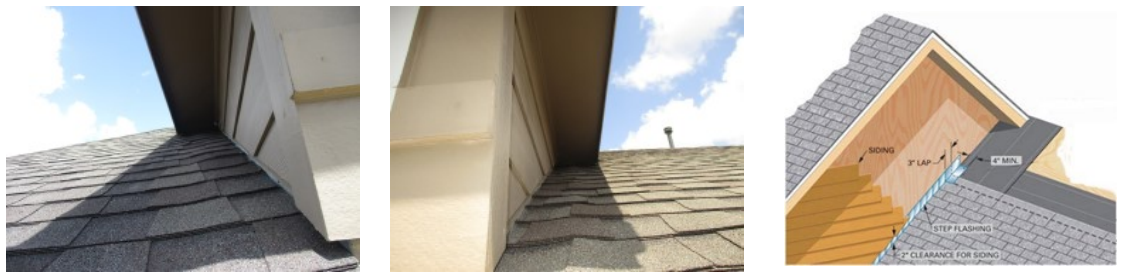
Information: The flashing noted between the side walls and roof was hemmed (also known as “J” or “L” flashing). This type of installation prevented some shingles from lying flat. While this method of installation is now acceptable by Code, it does not generally follow the manufacturer’s installation recommendation. *National Roofing Contractors Association (NRCA)* recommends using a 7- by 8-inch (180- by 200-mm) step flashing for a standard asphalt shingle. These dimensions ensure a 2-inch (50-mm) minimum step flashing head lap, 4-inch (100-mm) extension onto each underlying shingle and 4-inch (100-mm) leg up the vertical surface to prevent leaks. The figure shows proper step flashing and diverter installation. No recommendation other than monitoring the roof cover.

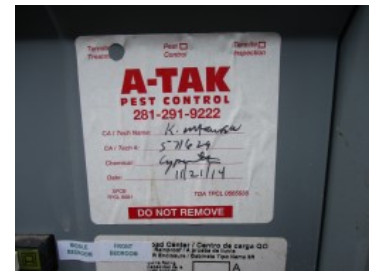
Notice: *There was evidence of previous treatment for Wood Destroying Insects (WDI) which may include subterranean termites.*

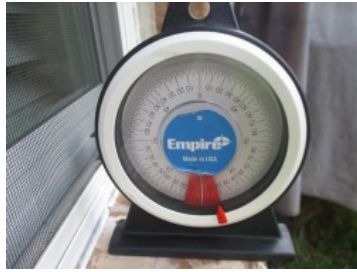
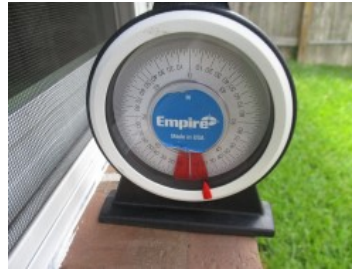
Figure 7
Window Jamb and Sill

Information: The masonry rowlock-type sills had a shallow overhang. Brick Industry Association (BIA) recommends that the masonry overhand by a minimum of 1 1/2 inches. (Technical Note 36, "Brick Masonry Details: Sills and Soffits"). There was no visible evidence of water penetration at the time of this inspection. We make no recommendation for repair. No recommendation.

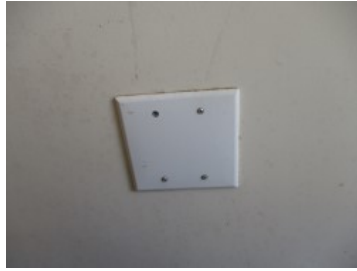
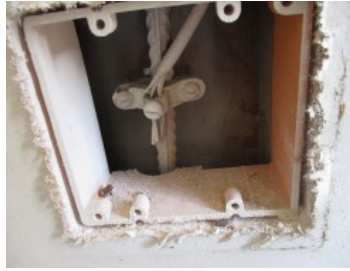
The raceway was not bonded to the electrical grounding system. Short Sections of Raceway. Isolated sections of metal raceway or cable armor, where required to be grounded, shall be connected to an equipment grounding conductor.

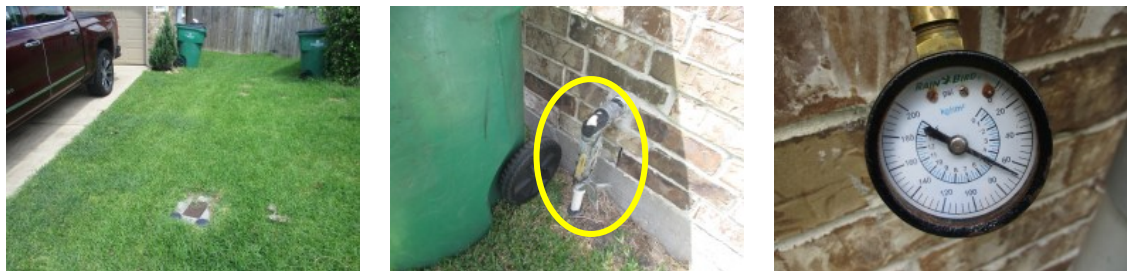
Vacuum breakers were missing from one or more hose bibs. Sill cocks, hose bibs, wall hydrants and other openings with a hose connection shall be protected by an atmospheric-type or pressure-type vacuum breaker or a permanently attached hose connection vacuum breaker for protection of the potable water supply.

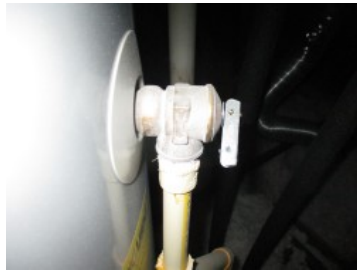
Normal position

The temperature and pressure relief valve was not functional; I could not open the valve without the use of force. Recommend that the valve be replaced for safety.

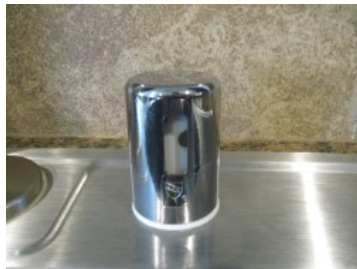
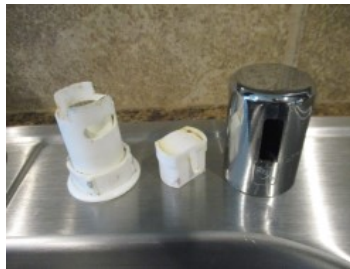
Maintenance: This appliance incorporated an airgap mounted on top of the counter to prevent water from the sink returning to the dishwasher. Should water discharge from the device, the line between the airgap and the drain's tail piece should be cleaned and cleared.
