PROPERTY INSPECTION REPORT

Date of Inspection: 9/26/2022

Joseph Killion <i>Name of Client</i>	9/26/2022 <i>Date of Inspection</i>
3349 Jan Ct Katy, TX 77493 <i>Address of Inspected Property</i>	
Syed Waqif (Aj) <i>Name of Inspector</i>	TREC # 22011 <i>TREC License #</i>
<i>Name of Sponsor (if applicable)</i>	<i>TREC License #</i>

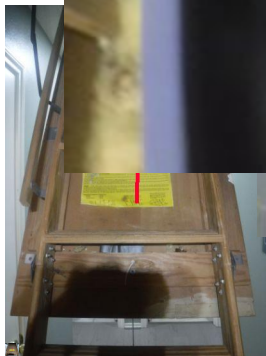
Attic access hatch needs insulation
