Inspection Report

Property Address:
8643 Vista Hills Dr
Richmond TX 77407

PROPERTY INSPECTION REPORT

Xuan Tien Le - TREC License # 23885 9/21/2022

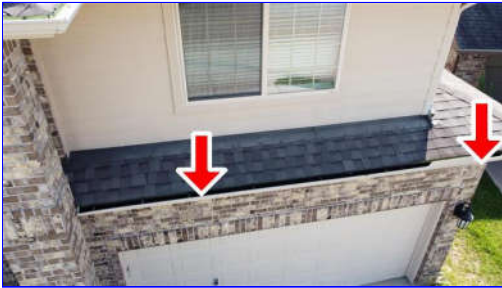
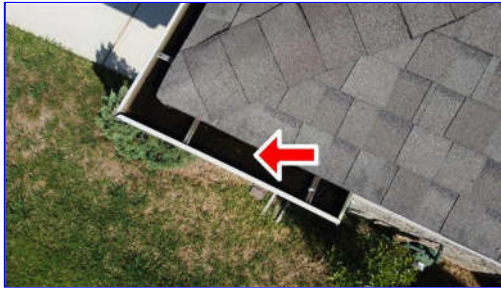
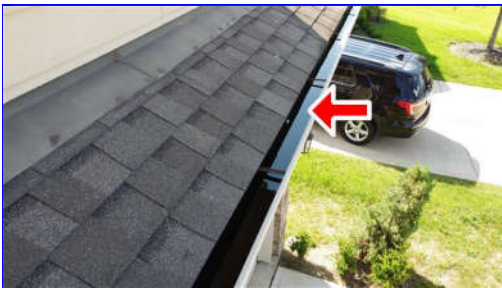
(2) Gutters in front of house are holding water. Repairs should be made for proper drainage.

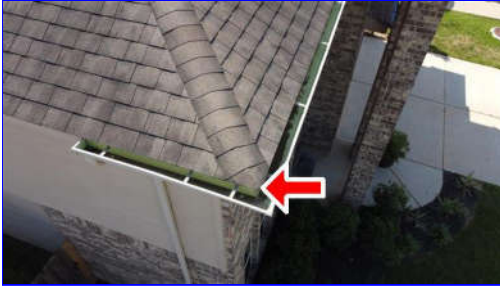
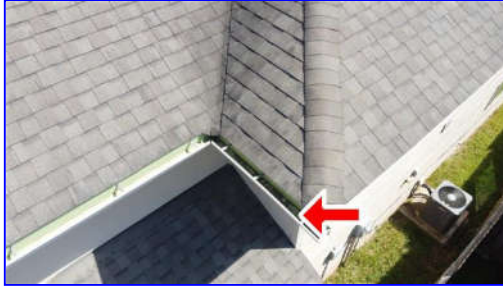
(3) The gutters and down spouts was observed to be in need of cleaning. Gutters and downspouts should be further examined for possible defects after cleaning for proper drainage.

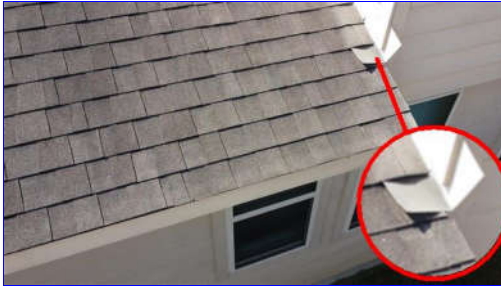
C. Item 27(Picture)

(4) The flashing(s) on Left Side was/were observed have the following defect(s): raised. Defective flashing should be repaired to prevent water intrusion.

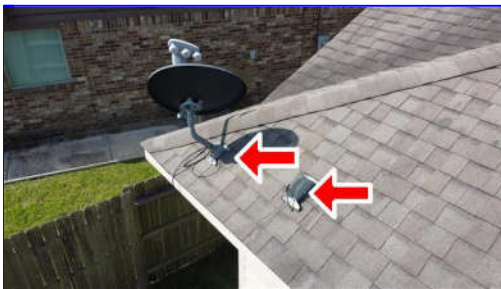
C. Item 28(Picture) Rear

(5) **Buyers Advisory Notice:** This home was observed to have a roof mounted satellite dish and/or unused brackets from removed satellite dishes. The type mounting bracket observed has been known to create roof leaks. Installation of a mounting bracket that will not damage shingles may be advisable. In addition, when removing the brackets, the roof covering beneath the bracket should be replaced to avoid water intrusion.

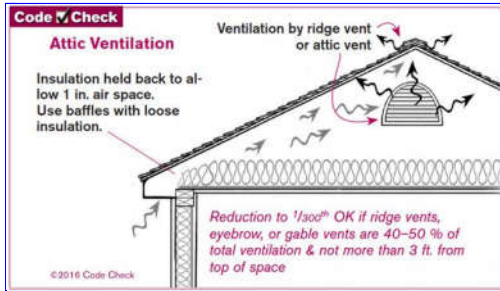
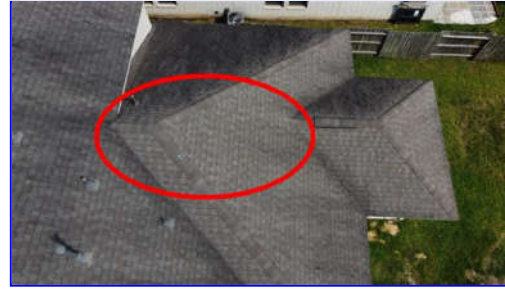
low clearance, plumbing lines or A/C-Heating ductwork. No solid surface walkway has been installed, and it also has a low ceiling. This inhibits the inspector's ability to fully inspect different components of the attic. (3) Ridge vent or passive vent was not observed at a part of roof. The level of ventilation should be improved. It is generally recommended that one (1) square foot of free vent area be provided for every on hundred and fifty (150) square feet of ceiling area. Proper ventilation will help to keep the house cooler during warm weather and extend the life of roofing materials. In colder climates it will help reduce the potential for ice dams on the roof and condensation within the attic.

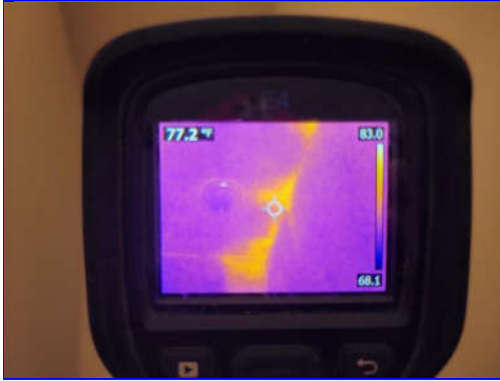
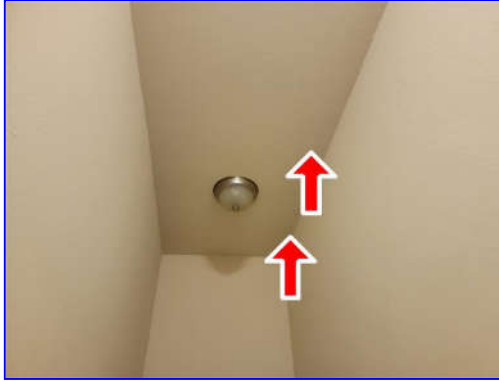
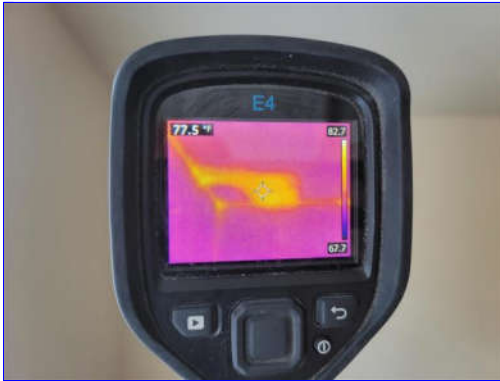
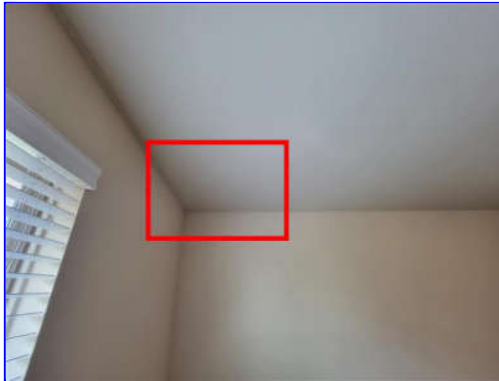
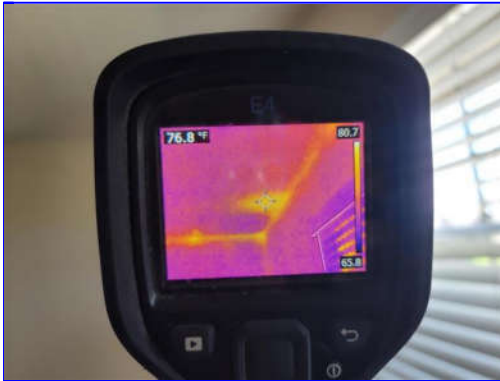
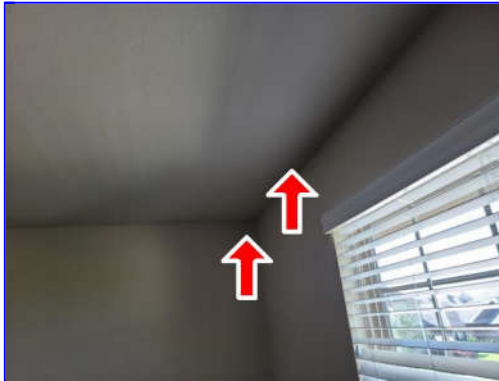
(4) Areas of the attic space were observed to be missing insulation. Missing insulation should be replaced. Missing insulation can cause energy loss and higher electric/gas bills. Insulation no less than R30 should be used. Insulation should cover the ceiling joists to prevent potential thermal bridging. Thermal bridging is the movement of heat across the framing that is more conductive than the materials around it. The framing material creates a path of least resistance for heat. Thermal bridging can be a source of energy loss in homes. This can lead to increased energy bills.

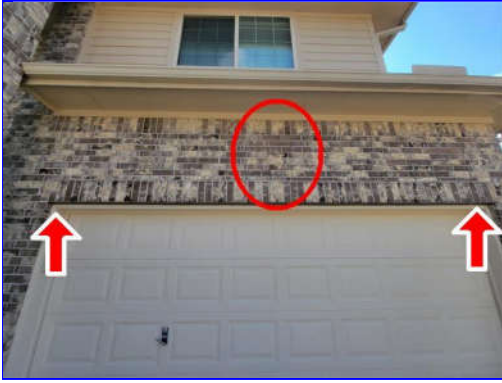
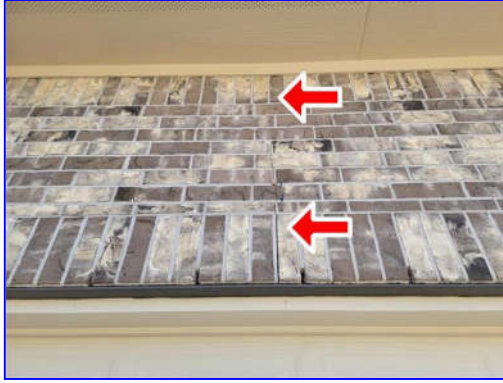
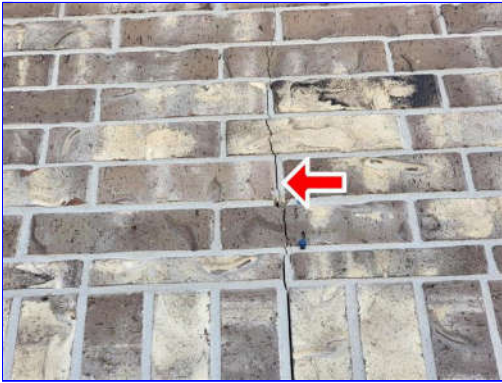
- (1) **Buyers Advisory Notice:** Freshly painted or repaired interior/exterior wall coverings may conceal defects that would otherwise be observed. The inspector recommends that the interior/exterior walls be monitored over time for defects concealed at the time of the inspection.
- (2) Masonry (brick / stone) cracks were observed above garage door. The lintel is minor sagging and not fully support the brick wall above. Recommend to repair.

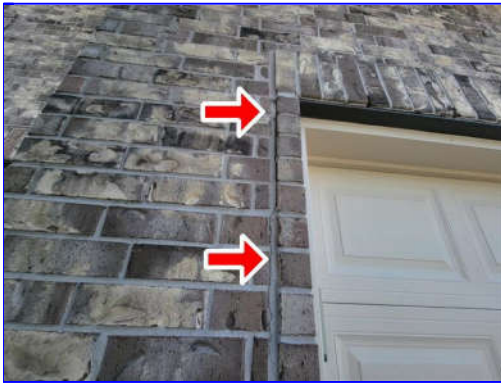
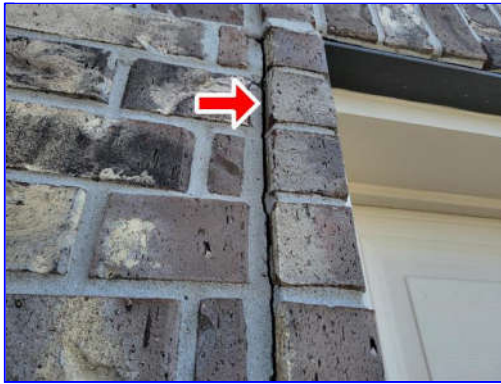
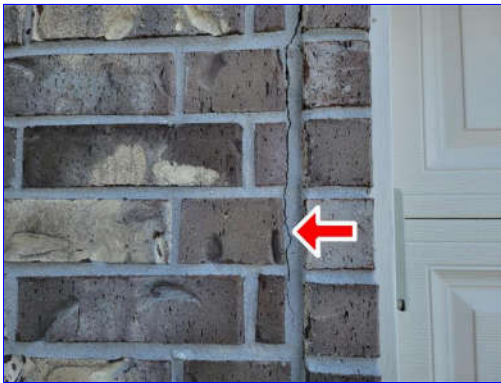
(3) Mortar separation was observed in Front of the house. Depending on the degree of deterioration, repairs may be needed. In the event repairs are needed, a qualified, verified mason should be consulted regarding proper repairs.

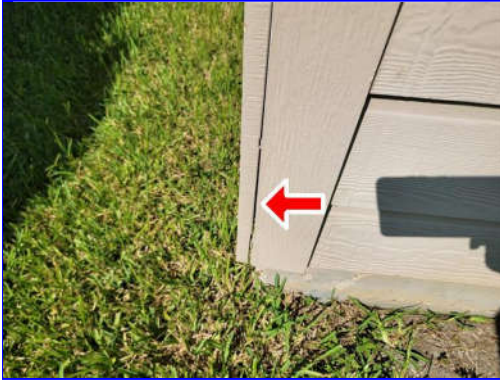
E. Item 9(Picture) Rear

(4) Caulking trim and windows in some locations, was observed to need improvement. Make improvements as needed.

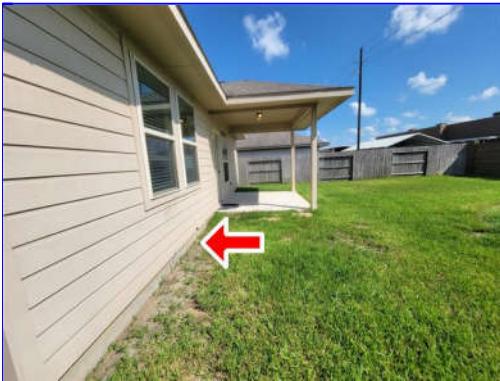
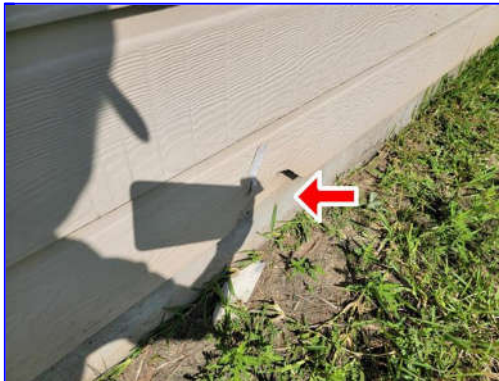
(5) The siding in Rear of house was/were observed to have the following defect(s): broken. This condition could lead to moisture intrusion into the home.

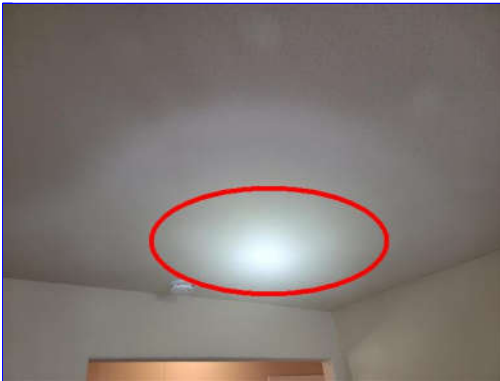
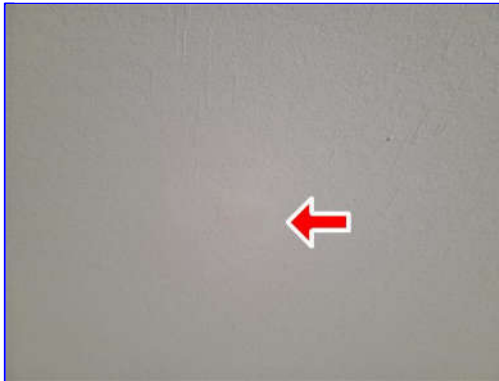
- (1) **Buyers Advisory Notice:** Freshly painted or repaired ceilings may conceal defects that would otherwise be observed. Ceilings should be monitored over time for defects that may be concealed at the time of the inspection.
- (2) Evidence of repairs/previous damage were observed in Family Room. Not high moisture level was observed at time of inspection. The cause of this condition was not determined. If sheetrock and insulation were affected by moisture, it should be removed, replaced and preventive measures for microbial hazards should be undertaken by a qualified, verified, licensed professional. The structural components related to

this condition are not accessible to inspect for quality of installation, or possible component failure. This leave some degree of uncertainty regarding the condition. The buyer should obtain any and all information available regarding this condition prior to closing.

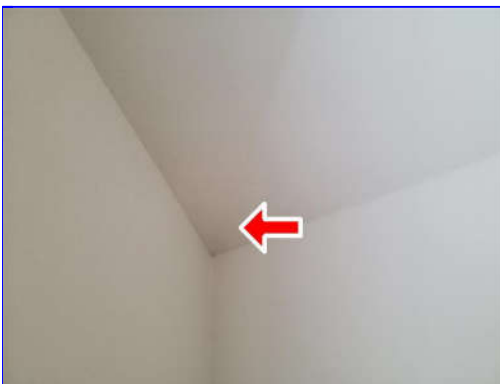
F. Item 3(Picture) Master

(3) Minor ceiling cracks were observed at some corners of the house. I recommend monitor and repair if needed.

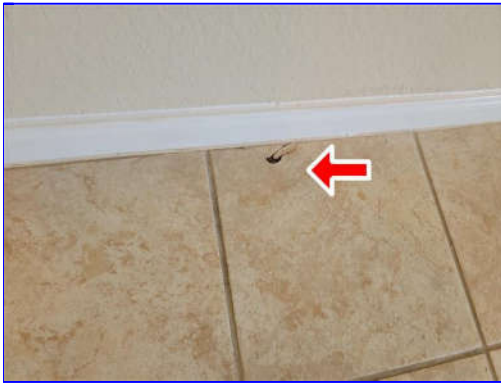
F. Item 7(Picture)

(4) The floor tile(s) in Living Room was/were observed to have the following defect(s): chipped.

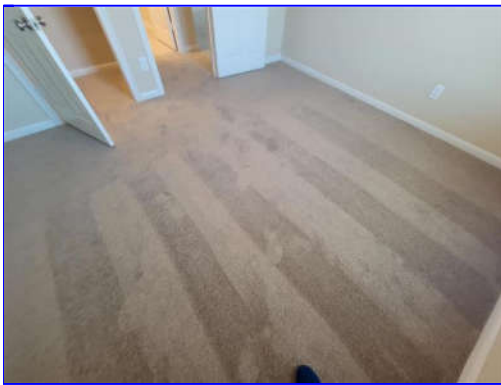
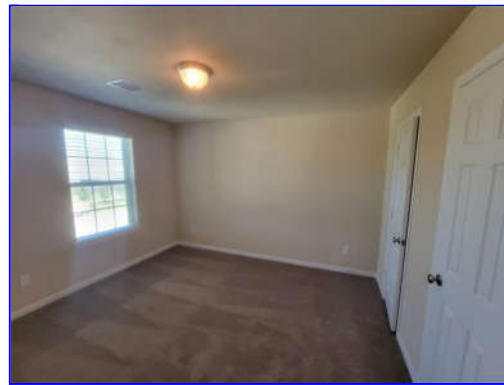
(5) Carpeting should be deep cleaned before move-in.

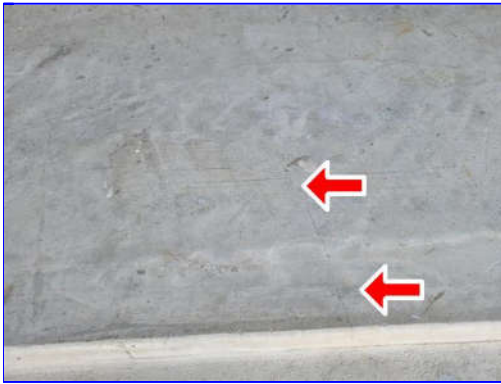
F. Item 11(Picture)

(6) There were cracks in the garage floor. This is typical of concrete and is not considered significant. It should be monitored for large separations or differential movement.

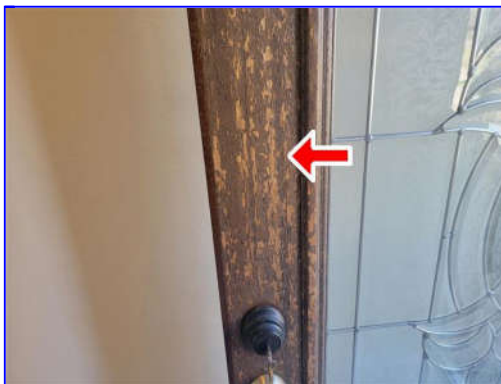
G. Item 2(Picture)

The exterior door(s) at the front of home was/were observed to have the following defect(s): finish is damaged. Repair or replacement is needed.

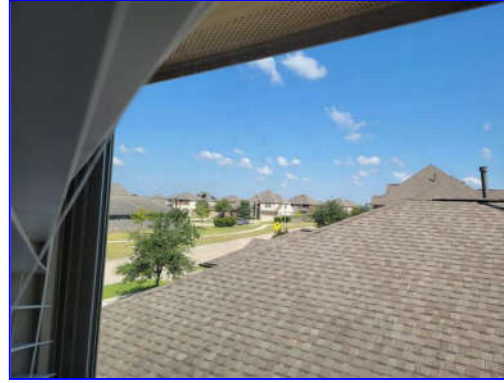
H. Item 2(Picture)

One window at Rear Left bedroom is/are fogged suggesting the seals have failed. A qualified, verified window specialist should be consulted regarding this condition.

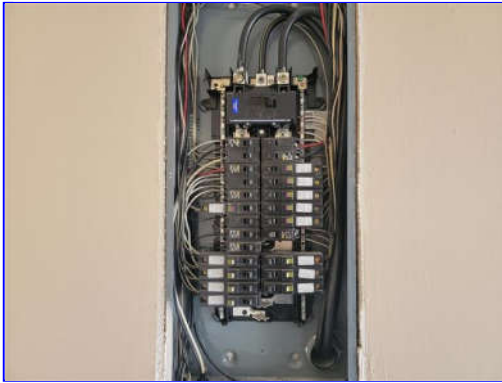
A. Item 2(Picture)

(3) The aluminum feeder wires are not coated with anti-oxidant paste to prevent corrosion.

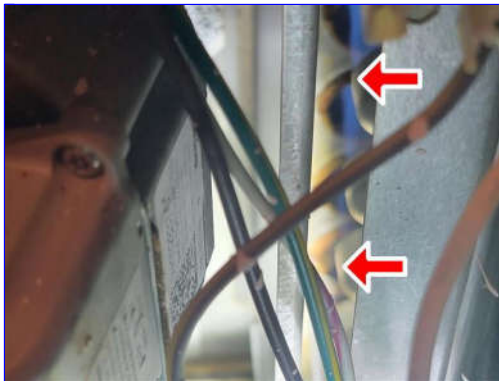
A. Item 4(Picture)

(3) There were areas of rust present at the heater cabinet. Recommend further investigation.

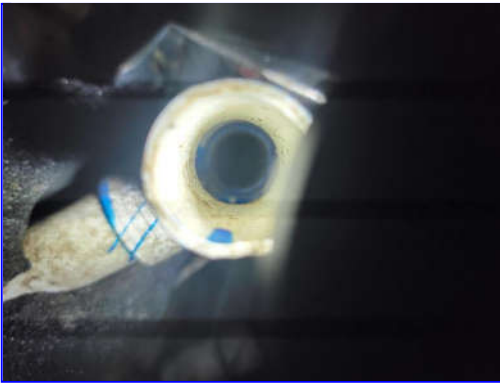
B. Item 9(Picture)

(6) There is evidence of past blockage of the cooling system primary condensation drain line.

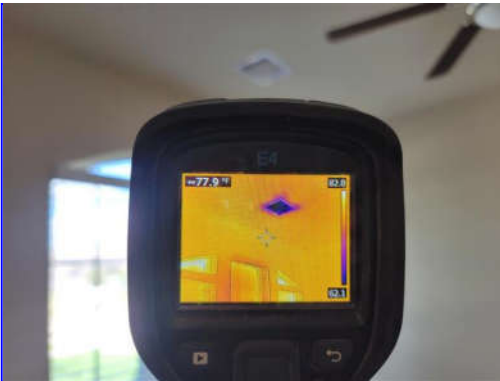
B. Item 11(Picture)

(7) The cooling system does not appear to have been serviced recently. It is the inspectors recommendation to request receipts from the current home owner documenting any service that may have been performed. If the system has not been serviced within the last year, it is the inspectors recommendation to have the heating / cooling equipment serviced by a licensed HVAC technician.

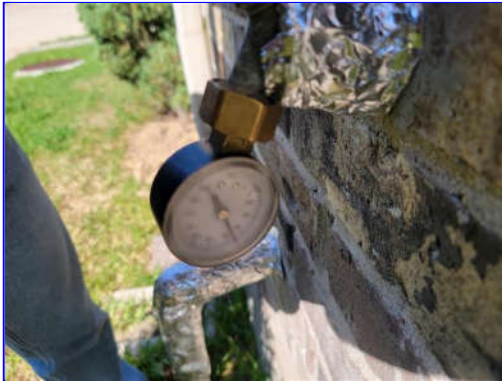
A. Item 1(Picture)

(1) Static pressure at the time of inspection. Normal pressure should be between 40-80 psi (pounds per square inch)

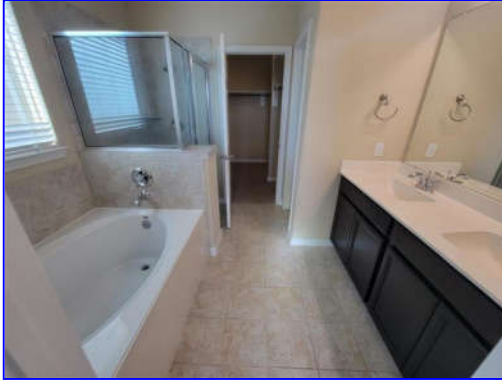
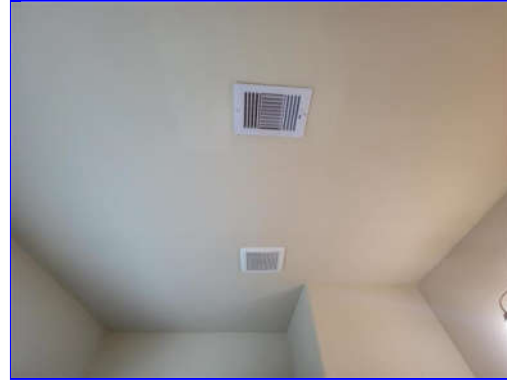
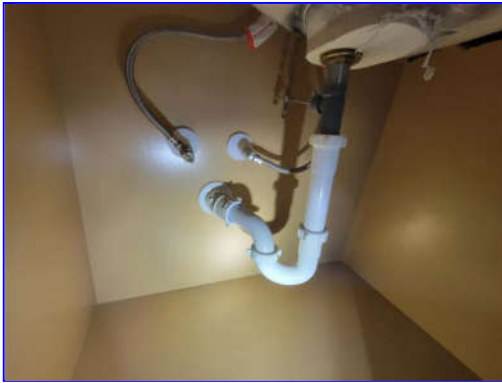
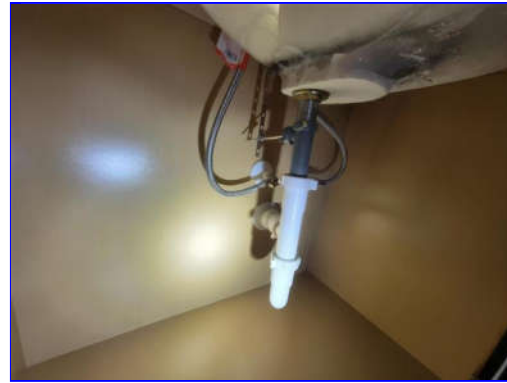
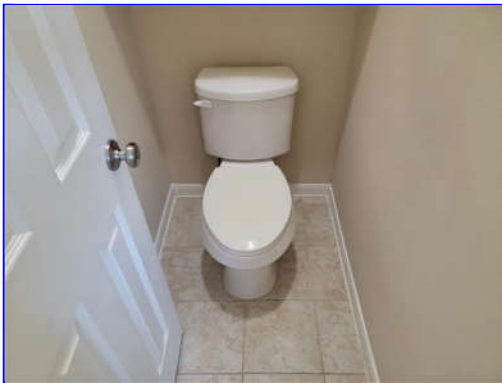
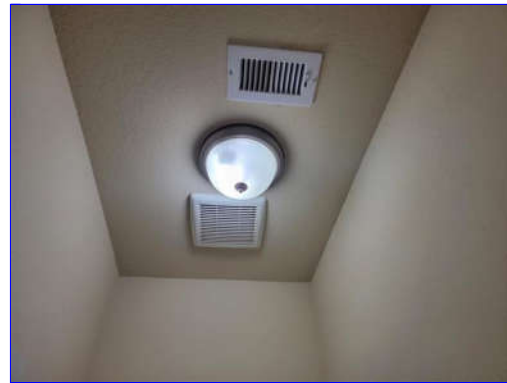
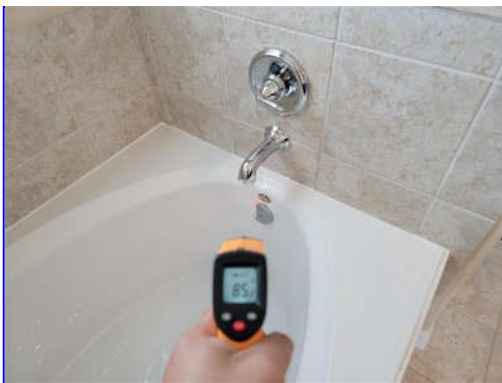
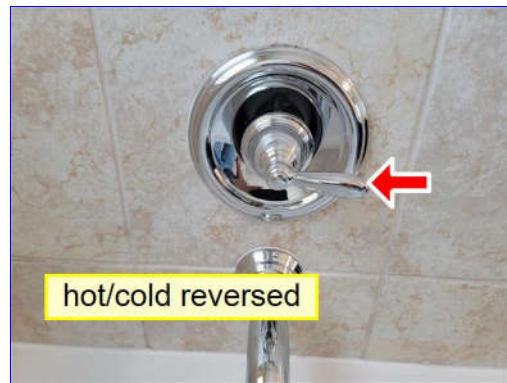
- Faucet(s) was/were observed to have the following defect(s): hot cold orientations reversed.

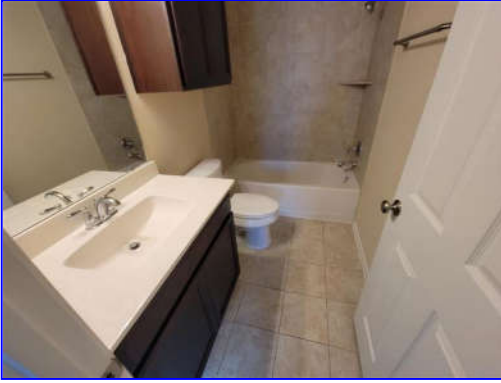
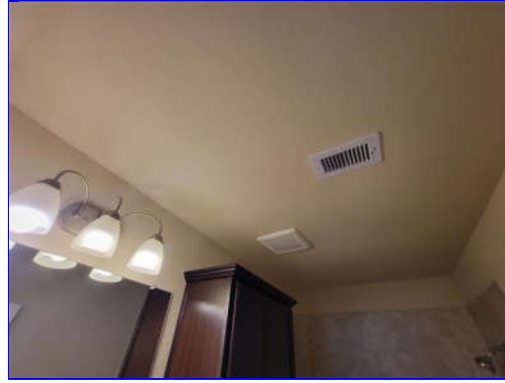
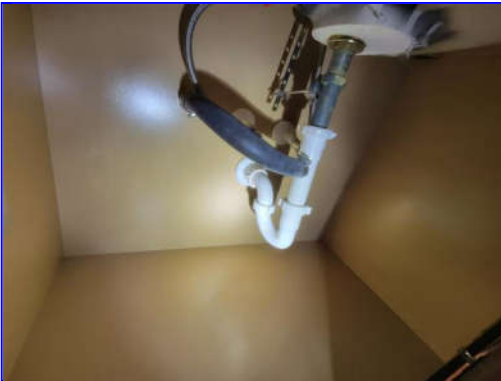
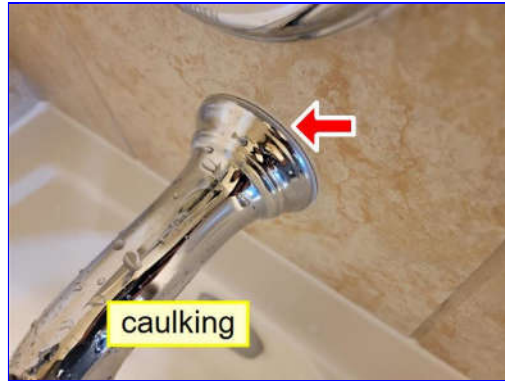
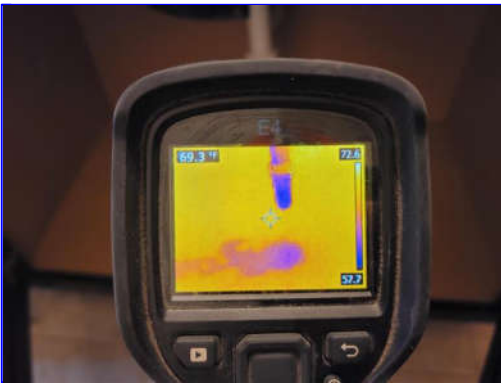
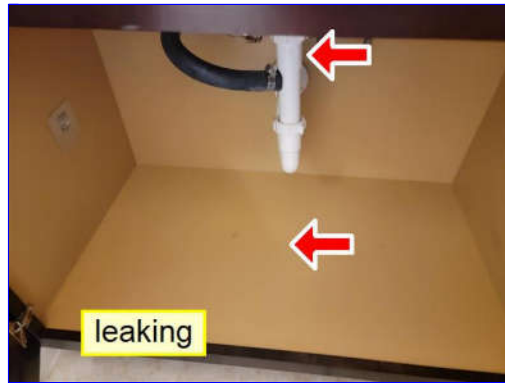
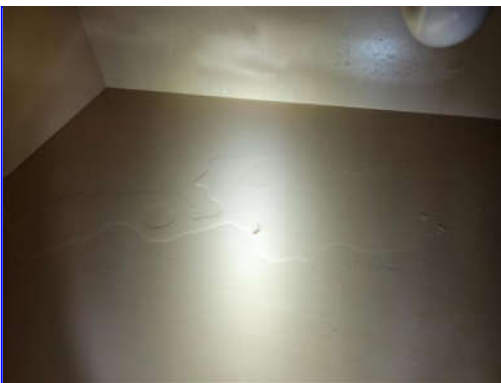
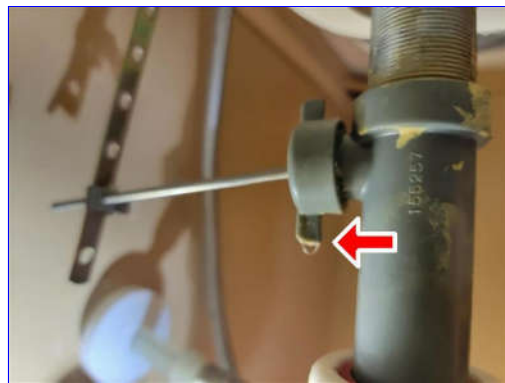
Visible leaks were observed under sink.

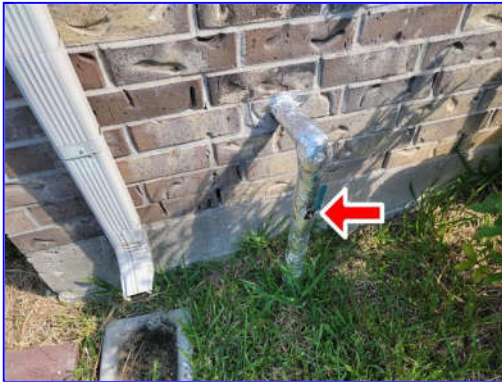
A. Item 27(Picture)

(10) The supply valve to the home is located exterior right of home. This is the main shut off to the home. In the event of a plumbing emergency this is where you will shut off the supply of water to the home.

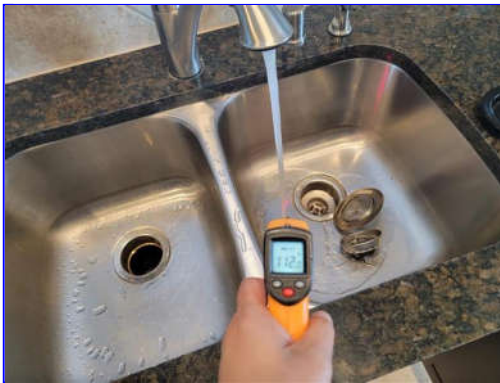
C. Item 5(Picture)

(2) The water heater(s) was/were observed to be functioning as intended.

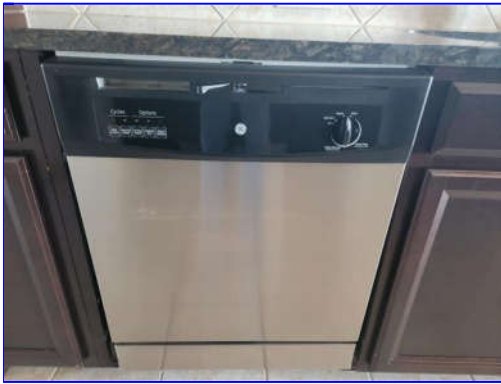
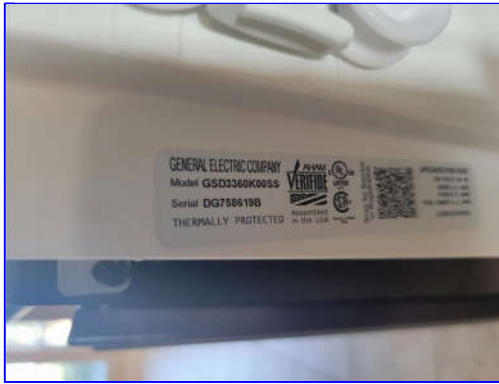
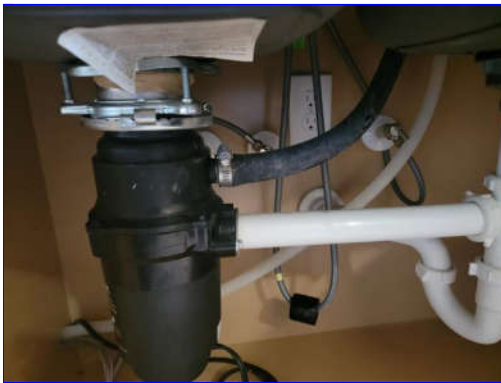
(2) The dishwasher was found to be inoperable using the normal controls at the time of inspection. This condition should be further investigated by a qualified appliance professional.

(3) The dishwasher was observed to be improperly installed in the cabinet opening. The unit was observed to be loose in the opening and should be secured with proper length screws to the underside of the cabinet.

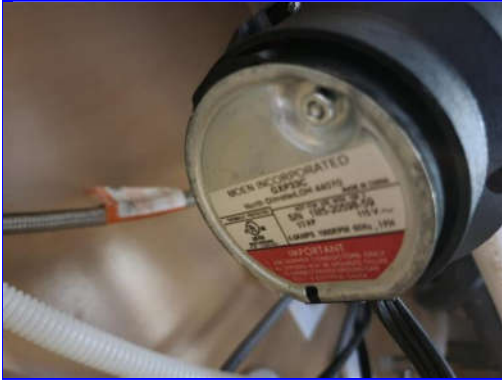
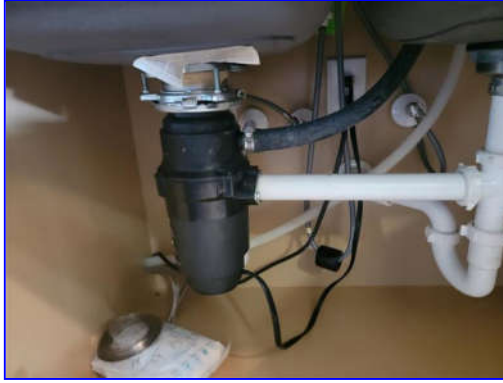
(2) The food waste disposer was inoperative at the time of the inspection. Furthermore, food disposal was observed to have the following defect(s): rusted inside at the blades. An appliance specialist is recommended to evaluate and estimate repairs.

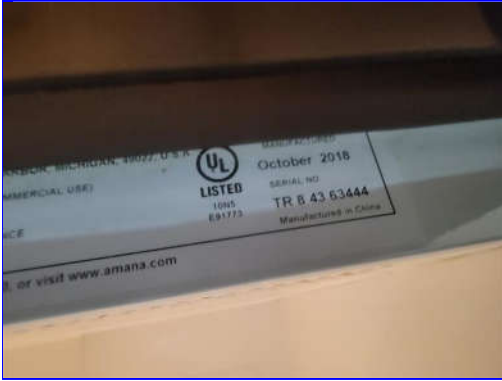
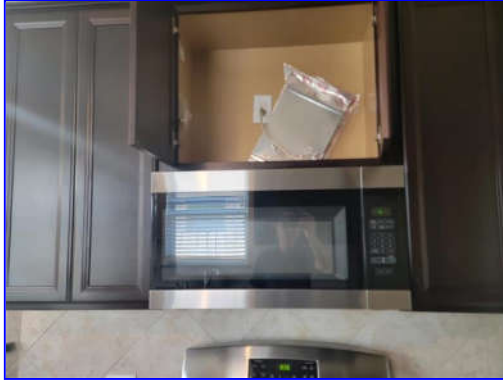
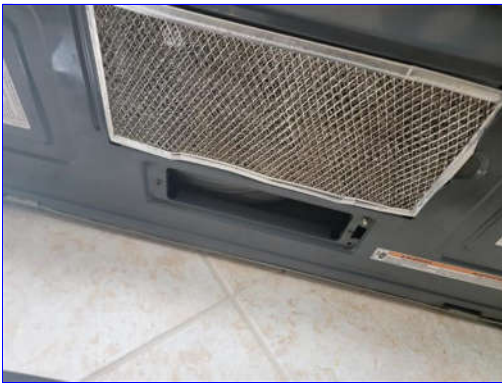
(2) The bulb for the range hood was observed to be inoperative. I recommend repair or replacement as needed.

(3) The range hood vent was observed to have the following defect(s): not properly installed and is venting into the interior of the home/cabinet space. The range hood vent should be sealed where needed.

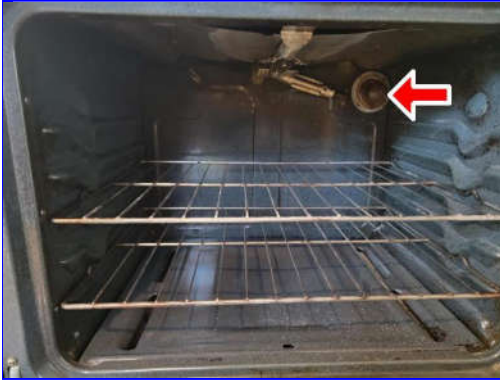
D. Item 5(Picture)

(4) The range was observed to be properly functioning as intended.

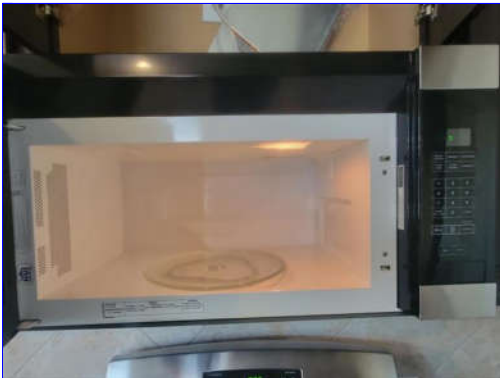
E. Item 1(Picture)

(1) View of Microwave and Data Plate (if available)

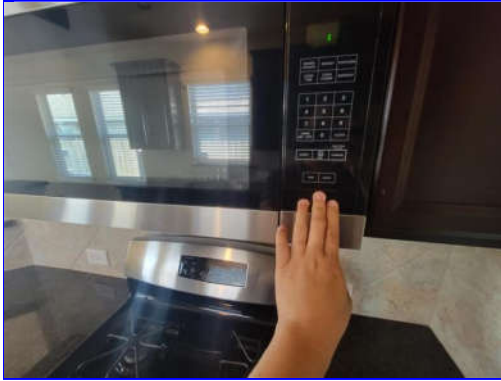
E. Item 2(Picture)

(3) The microwave was observed to have the following defect(s): door does not able to open properly. Repair is recommended.

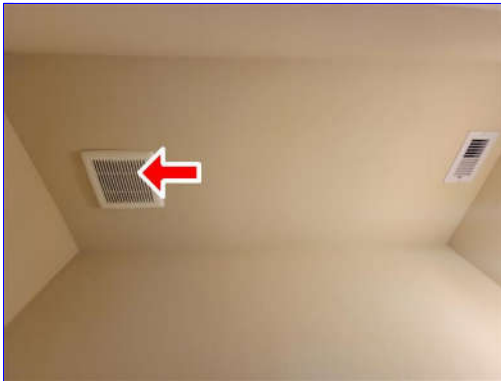
F. Item 1(Picture)

The exhaust fan(s) at the powder room was/were observed to have the following defect(s): unusually noisy and may need service

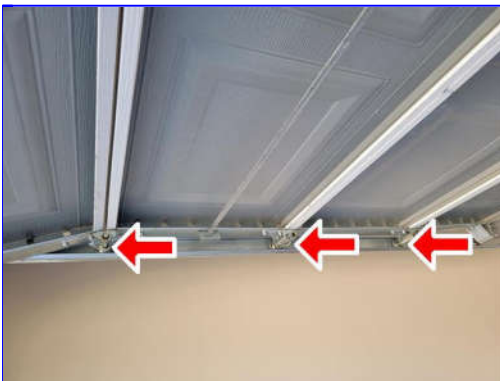
G. Item 4(Picture)

(2) Loud grinding or squealing observed when opening/closing garage door. This can be due to dirt or debris in the track or lack of lubrication. Recommend cleaning the track and lubricating.
