PROPERTY INSPECTION REPORT

22430 Smokey Hill Dr. , Katy, TX 77450
Inspection prepared for: Matt Messer
Real Estate Agent: Open House - Open House

Date of Inspection: 10/8/2022 Time: 8:30 AM
Age of Home: 1977 Size: 1,812
Weather: Clear 75 Degs F
Structure Type: Structure is a wood framed structure
on a concrete slab foundation.

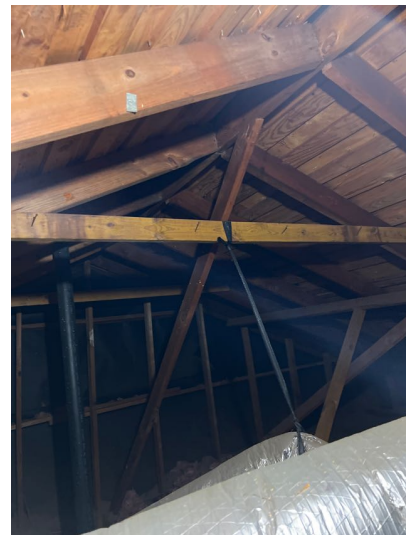
Attic access missing insulation.

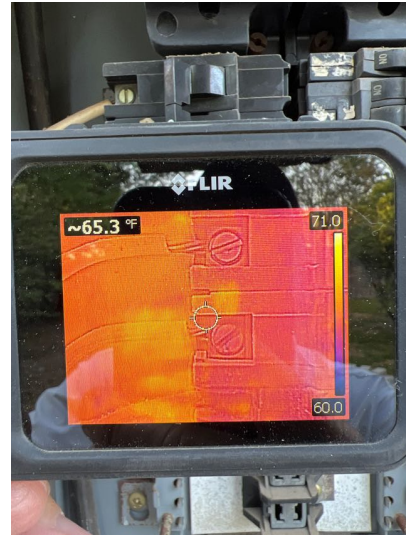
Thermal imaging camera used to detect over heating electrical components. No issues.

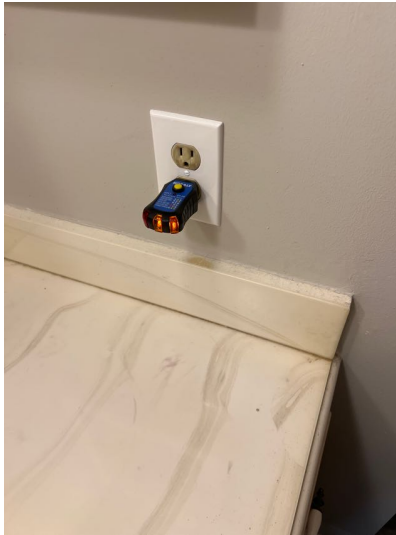
Bathroom electrical receptacle not GFCI protected.

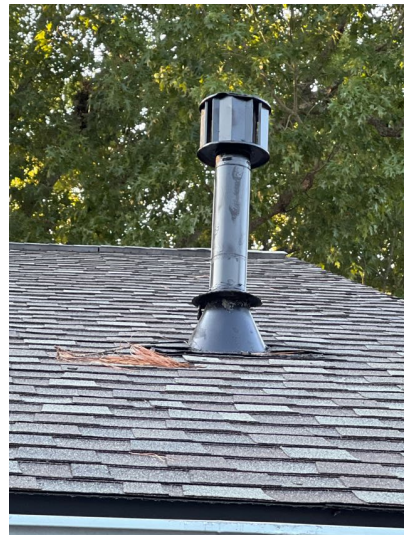
- The Temperature & Pressure Relief Valve appears to be defective.
- The water heater gas piping noted with missing sediment trap.
- Improper flue pipe venting was noted and further evaluation is recommended

Water heater exhaust pipe

Improper flue pipe venting was noted and further evaluation is recommended
