Property Inspection Report

5602 Bending Crest CT, Sugarland, TX 77479 Inspection prepared for: Kalpesh Mehta Real Estate Agent: -

Date of Inspection: 9/9/2019 Time: 10:00 AM Age of Home: 2019 Size: 3158 Weather: Clear 95° Order ID: 302.

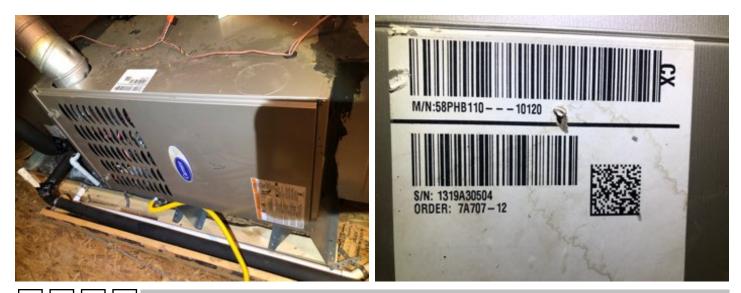
- 4 ton AC system (1st floor)
 2 ton AC system (2nd floor)
 The first and second floor AC system differential temperature readings are both 20°, and both appear to function as intended.
