**122 Vine Mint Drive
Montgomery TX 77316**

Client(s): Gryparis
Inspection Date: 2/23/2020
Inspector: Murray Campbell , TREC #22455

Concerning: 122 Vine Mint Drive, Montgomery, TX 77316

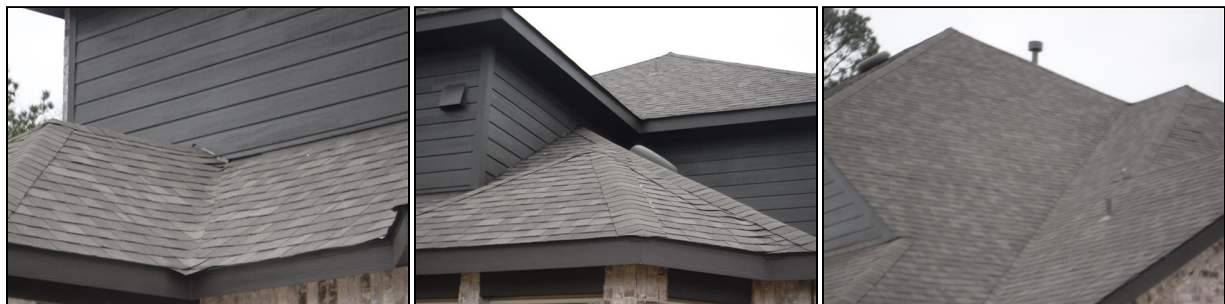
The roof covering appeared in good condition. No leaks were active at time of inspection. Shingles appeared to be properly fastened.

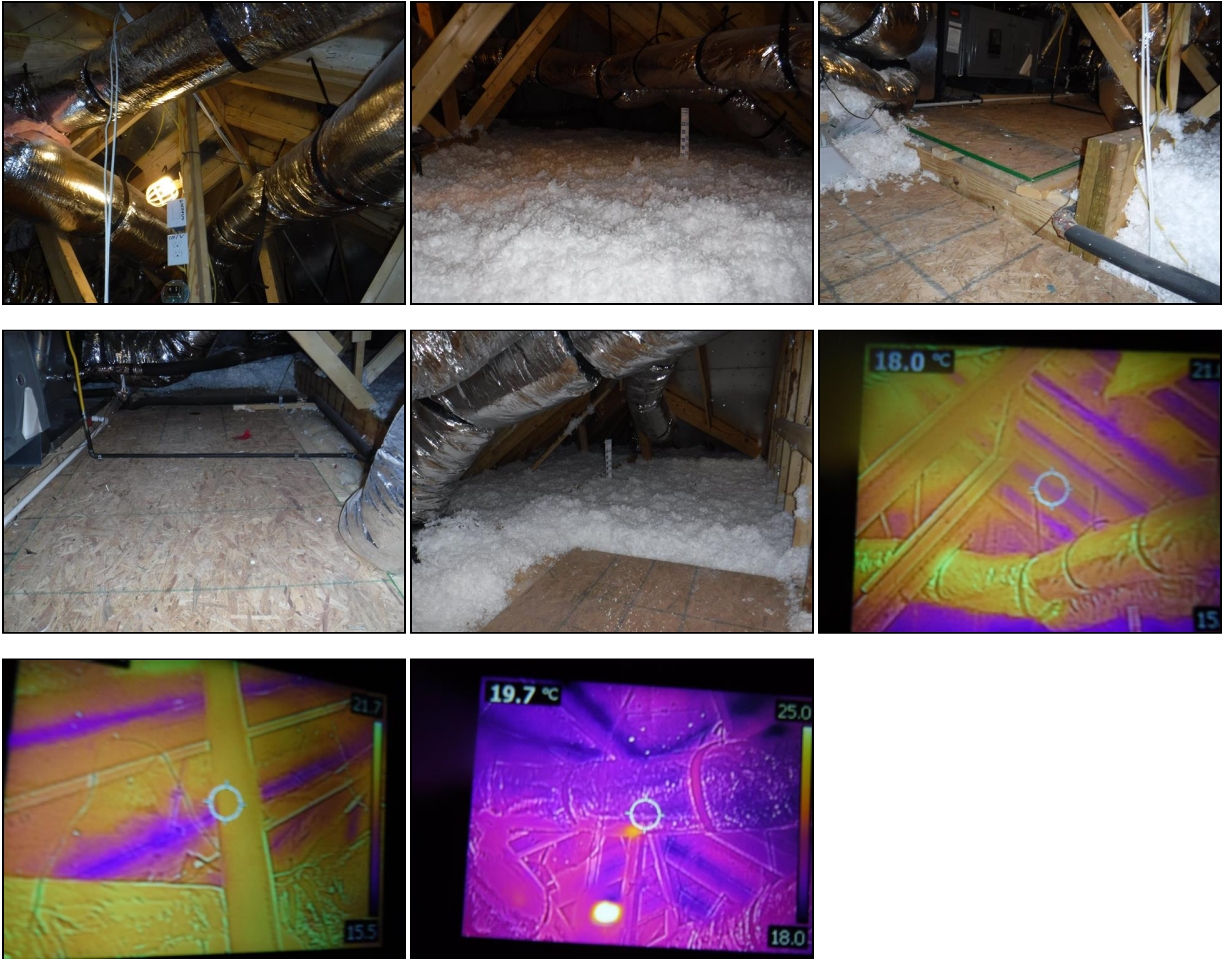
The structure was in good condition. No leaks were active or apparent at time of inspection. Insulation determined to be at acceptable levels/depths. At accessible areas inspected.

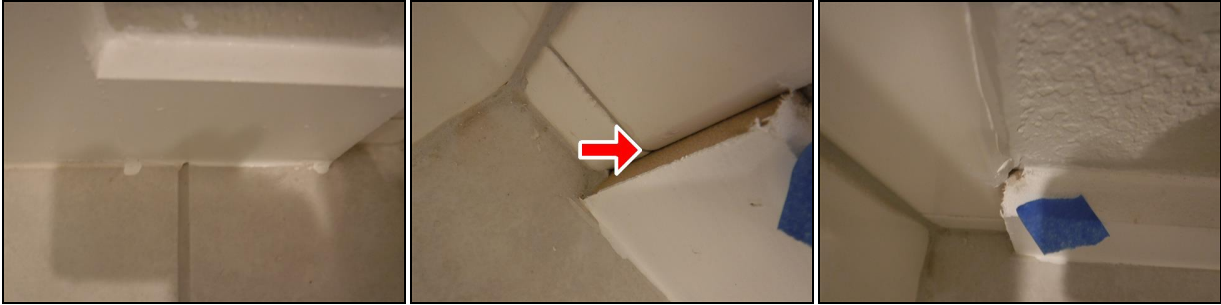
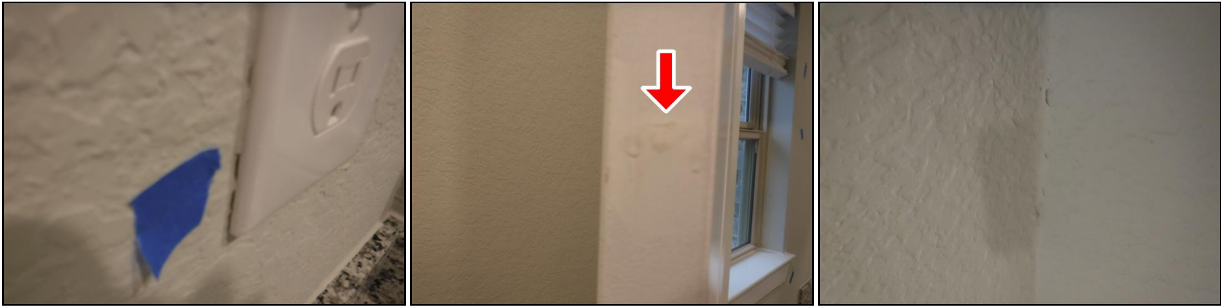
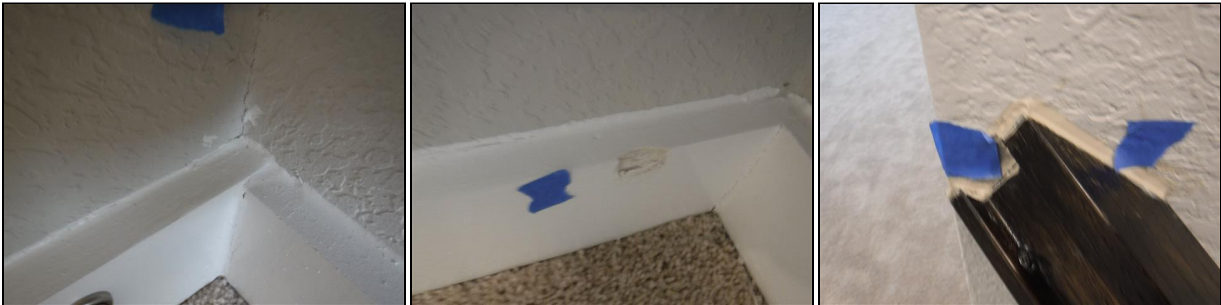
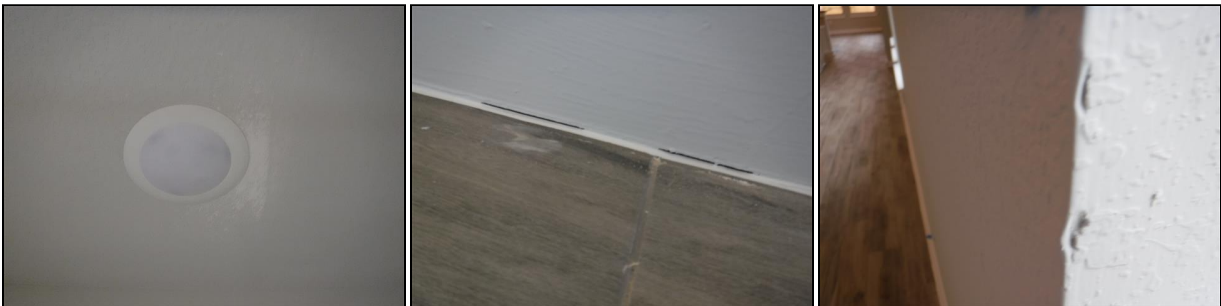
Scratch kitchen counter surface,

Seal (grout/caulk) around the tub and shower tile to wall abutment joints in the master bath guest bath.

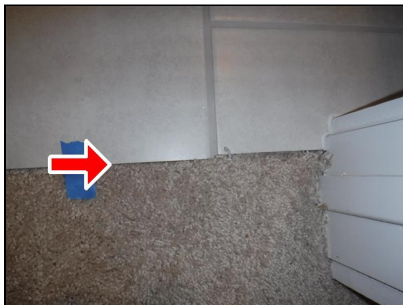
Transition missing upper guest bathroom.

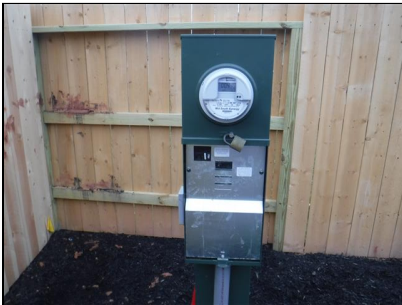
- 5. Missing dead front on main panel. Replace as needed.

Missing dead front on main panel. Replace as needed.

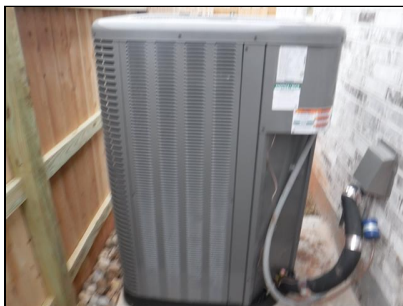
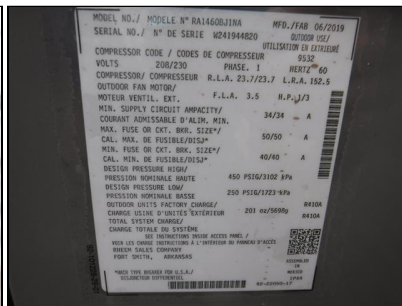
At time of inspection the ambient temperature was below 60 degrees. Safe and/or accurate air conditioning system testing is not possible when temperatures are below 60 degrees fahrenheit. Temperature must be above this threshold for minimum 24 hrs for safe operation. System did properly cycle on/off and appeared to produce sufficiently chilled air during limited test

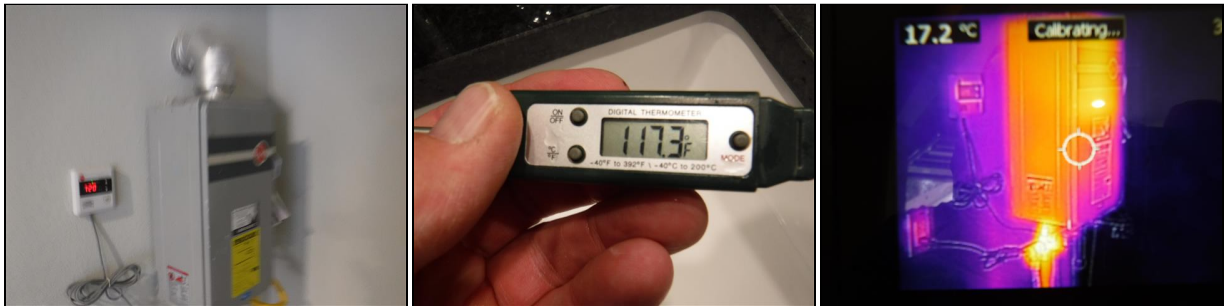
- 7. The water heater abuts to an interior wall and there is no emergency leak catch pan installed. Today's standards now require a catch pan that is plumbed to the exterior in locations where tank leaks could cause interior water penetration.

The water heater abuts to an interior wall and there is no emergency leak catch pan installed. Today's standards now require a catch pan that is plumbed to the exterior in locations where tank leaks could cause interior water penetration.

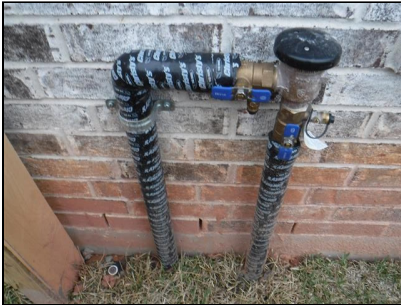
Irrigation back flow preventer located right side of residence.

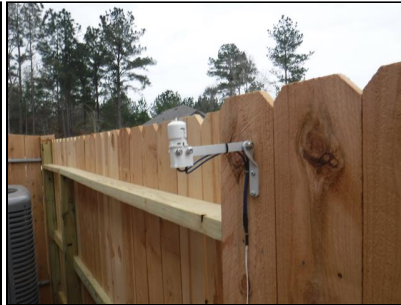
Irrigation rain gauge located left side of residence.

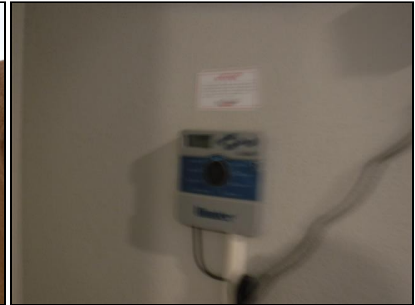
Irrigation control panel located within garage.

Tested and operated all seven zones of sprinkler system with concerns noted. System operated from controller in garage.

There is a damaged sprinkler head at front left side and stations #4 and #5 did not operate (facing front). The system is in need of further review and repair by a licensed irrigator.

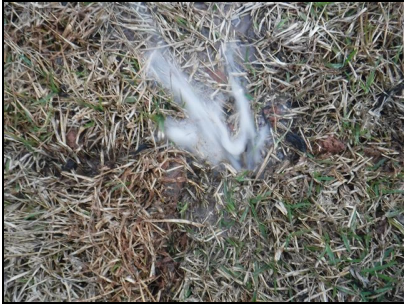
The sprinklers over sprayed into the street. This could result in a fine within certain municipalities. Adjustment or redirection is recommended.
