## PROPERTY INSPECTION REPORT

Report # 23003

Concerning: 2225 River Valley Dr Columbia Lakes, TX 77486  
(Address or Other Identification of Inspected Property)

By: Kenny Boulton January 9, 2023  
TREC Professional Inspector Lic.# 698 (Date)

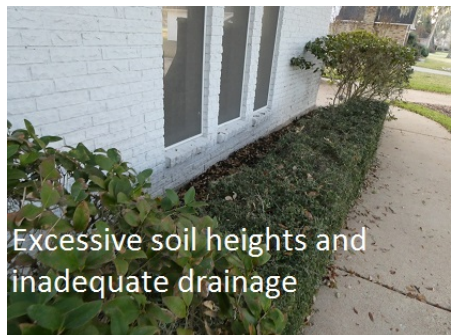
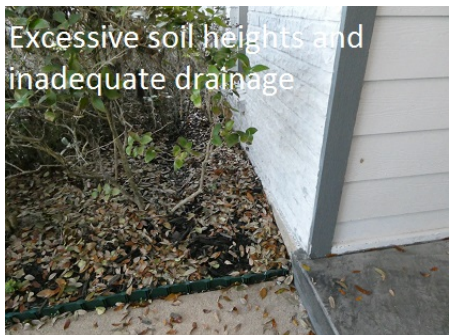
**GRADING AND DRAINAGE**

Ideally, a minimum of four (4) inches of clearance should be maintained between soil level and the bottom of the masonry and the finished grade should slope or fall away from the front of the house at a rate of one inch per foot for at least the first six (6) feet.

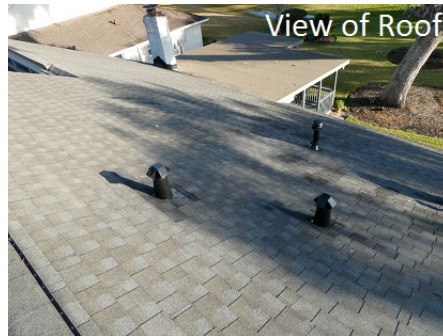
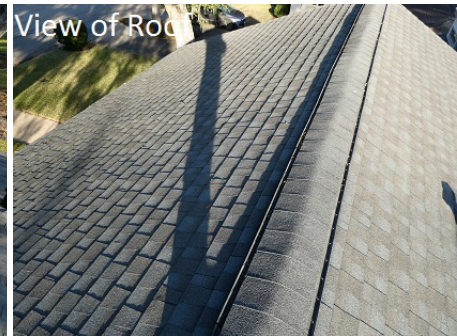
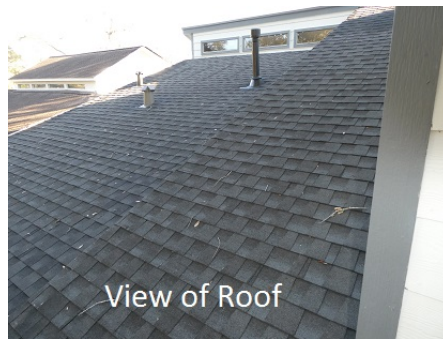
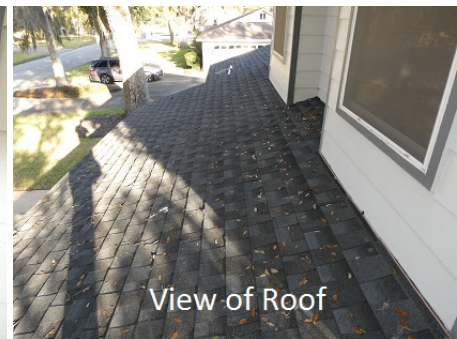
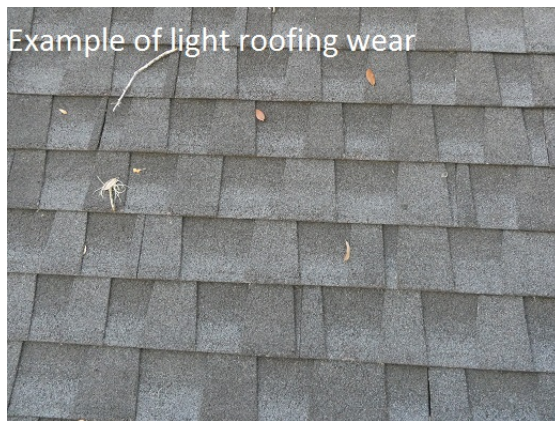
**SLOPED ROOFING**

The roofing is considered to be in relatively good overall condition, showing only minor signs of aging.

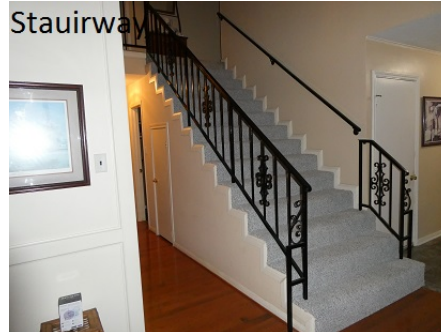
STAIRWAY

The 31 inch high stairway railings should be a minimum 34 inches high and maximum 36 inches high from the leading edge of the stairway steps.  
The opening in the stairway railings should be no greater than 4 inches.  
The stairway steps should be a maximum height of 7 3/4" with no more than 3/8" of variation between step heights.

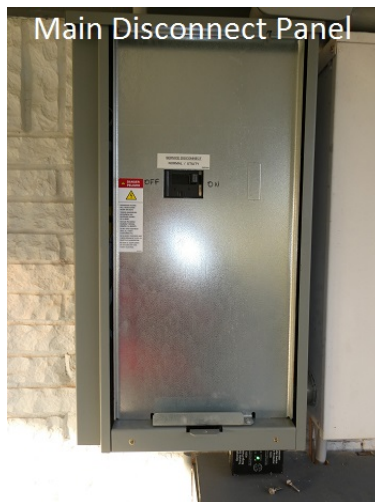
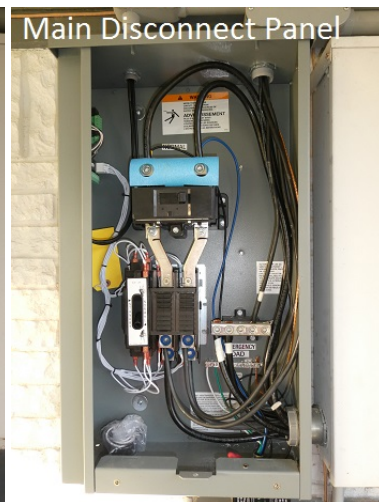
MAIN DISCONNECT PANEL

The ground wire to ground rod connection should be visible and accessible.

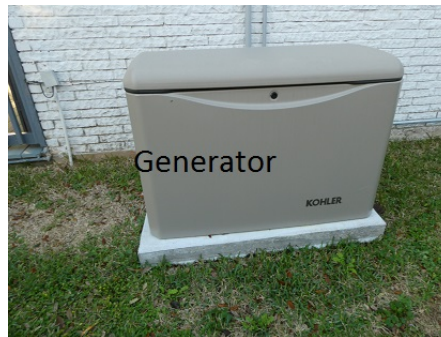
**GENERATOR**

The generator was not a part of the inspection.

The seller should provide all generator documentation along with the service contract and maintenance records.

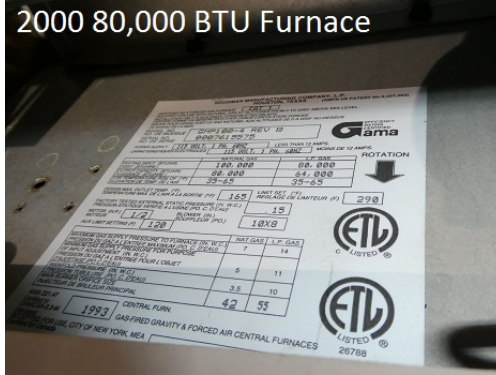
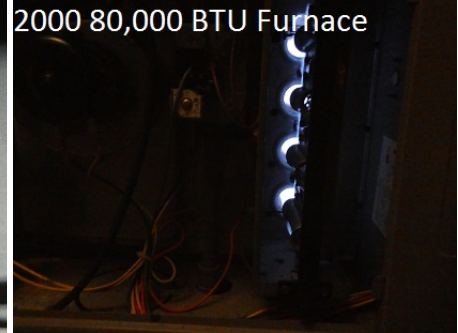
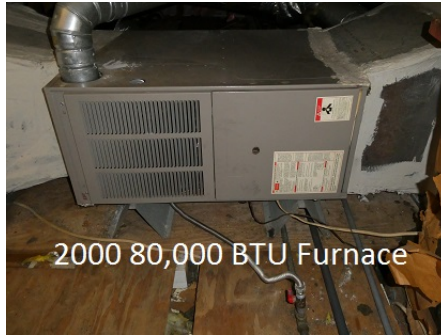
**CENTRAL HEATING SYSTEM**

2000 80,000 BTU Furnace

The furnace is older but was found to working properly at the time of the inspection. It is difficult to predict the useful remaining life of this unit.

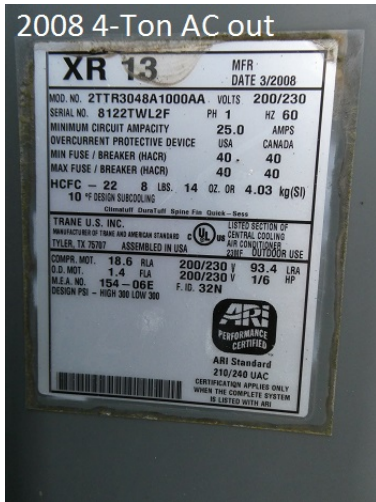
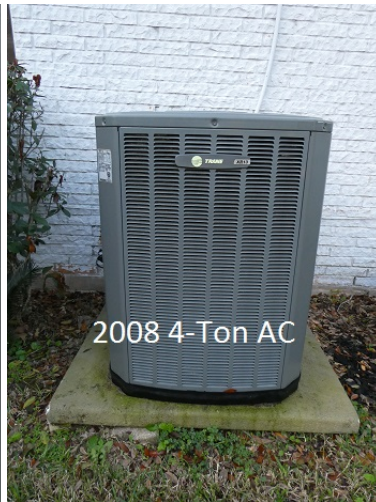
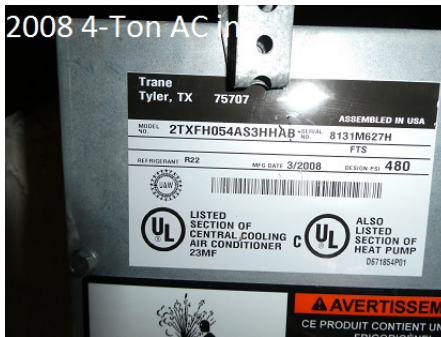
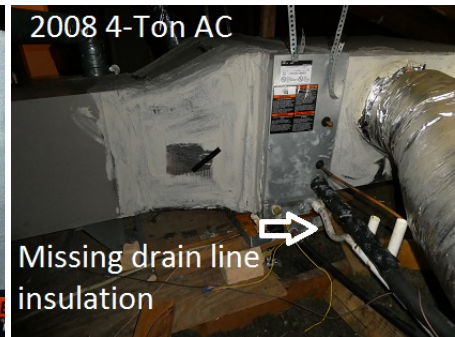
**CENTRAL AIR CONDITIONING**

A minimum of the first ten feet of the primary condensate drain line should be insulated to prevent line sweating and dripping.

The exposed wiring at the exterior wall for the outdoor unit of the central air conditioning unit should be installed in conduit.

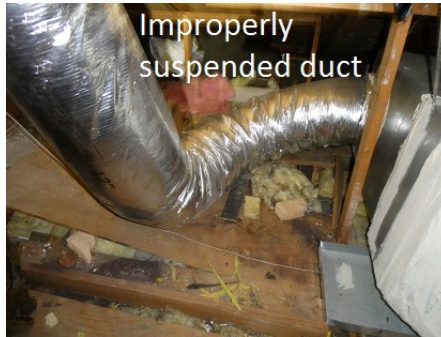
touching ducts or the ducts should be separated by re-configuration of the current ductwork suspension. The ducts should also be suspended every 4' – 5' with no more than 1/2" of sag per foot.

There is not a duct drop in the walk in master closet or half bathroom.

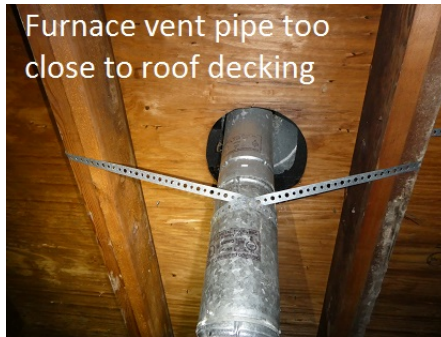
#### FURNACE VENT PIPE

The furnace vent pipe should have a minimum clearance of one inch from combustible roof decking materials.

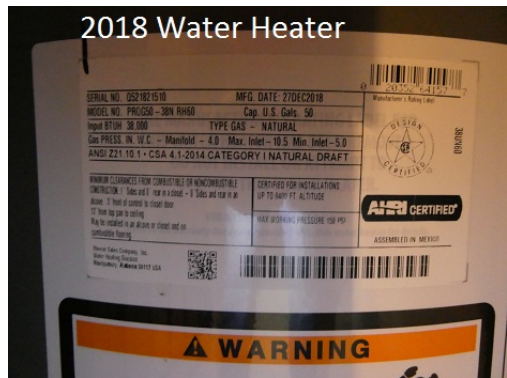
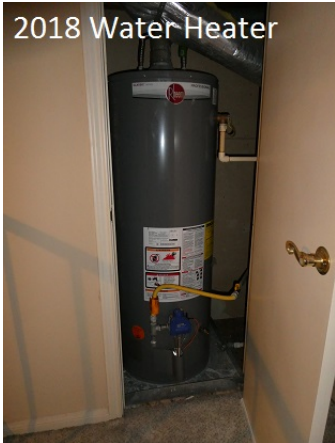
**WATER HEATER**

The water heater vent pipe should have a minimum clearance of one inch from combustible roof decking materials.

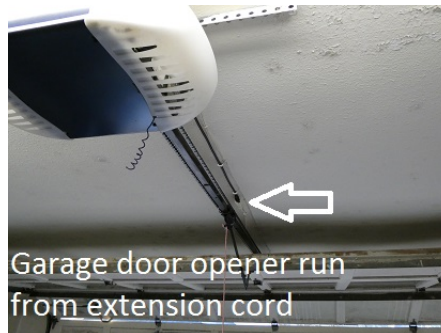
GARAGE DOOR OPENER

The garage door opener is supplied from an extension cord. An outlet should be installed in the garage ceiling within 3 feet of the opener.
