## MECHANICAL INSPECTION

1634A Park St  
Houston, TX 77019

# PROPERTY INSPECTION REPORT

Concerning: 1634A Park St, Houston, TX 77019

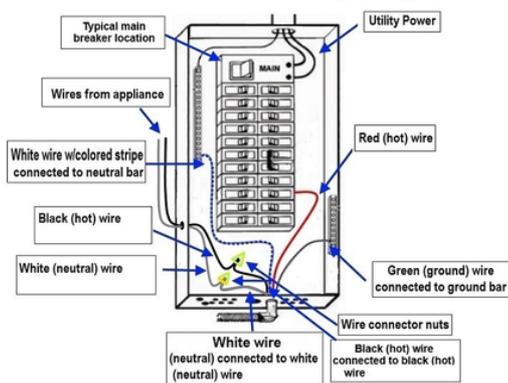
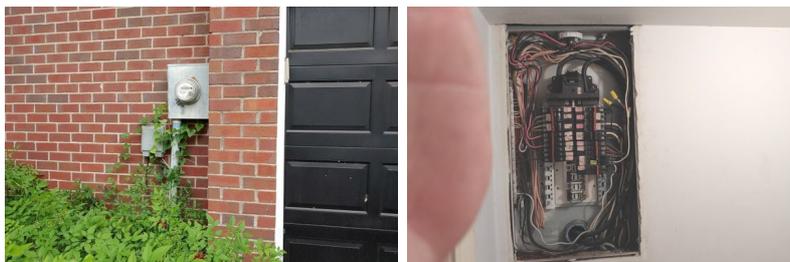
<u>Location</u>	<u>Manufacturer</u>	<u>Rating</u>
Garage	Federal Pacific	200-amperes

Seller claims breaker panel was replaced in May of 2022.

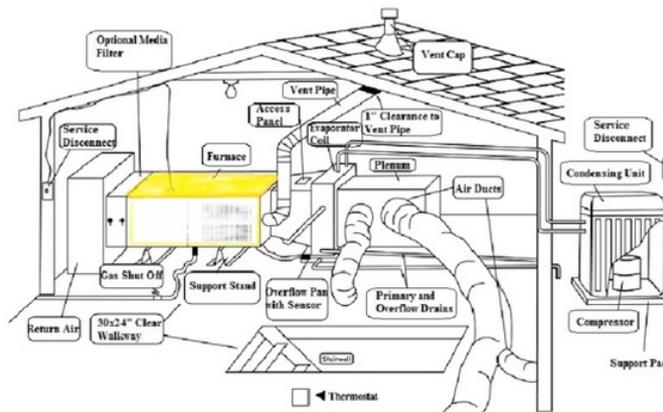
<u>ZONE</u>	<u>BRAND</u>	<u>BTU</u>	<u>DATE</u>	<u>LOCATION</u>
House	Carrier	66K	2017	Attic

The heating equipment was observed to be operating and functional at the time of the inspection. The heating equipment responded to the thermostat and the equipment appeared to be heating the air adequately.

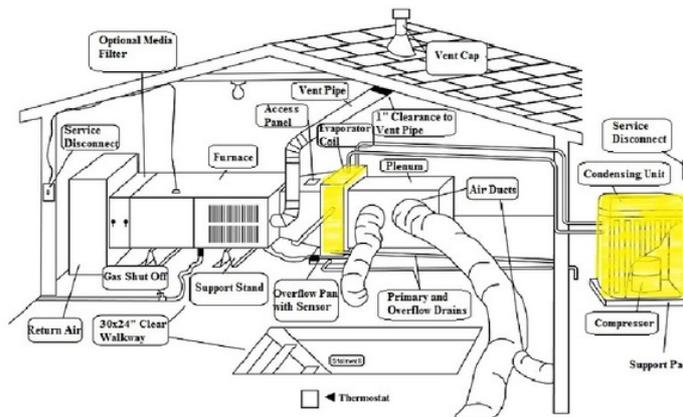
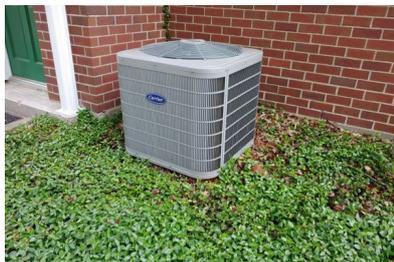
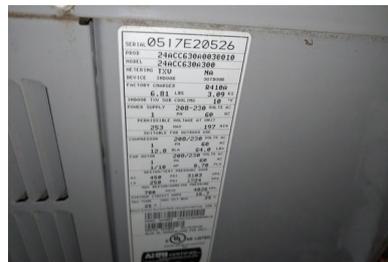
Zone	Brand	Size/Age Condenser	Size/Age Coil	Temp Drop Degrees
House	Carrier	3-ton 2017	3-ton 2016	15 Degrees

The condensing unit equipment was functional at the time of the inspection. The equipment responded to the corresponding thermostat, and the compressor components and fan motor components were operating.

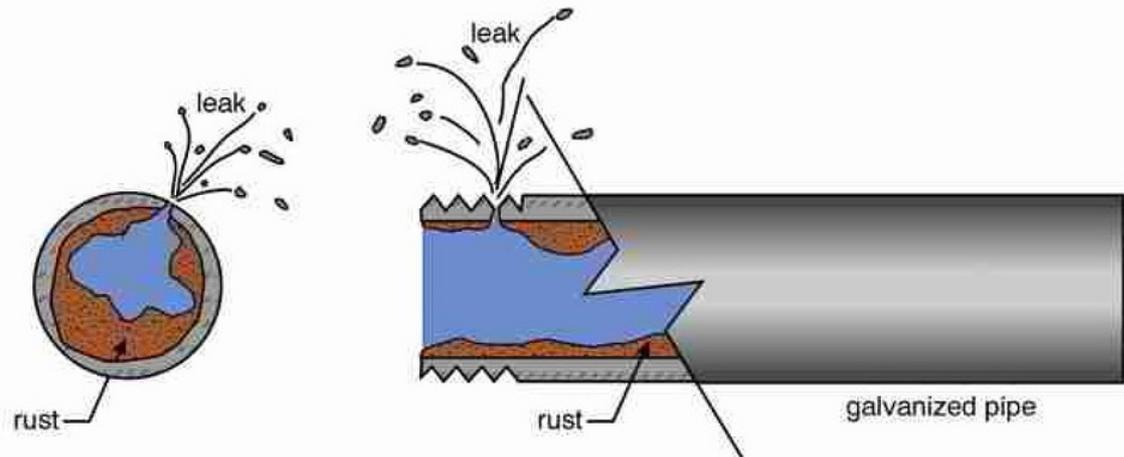
rusting of galvanized pipe can greatly reduce water pressure and will eventually cause leaks as rust creates holes in the pipe walls

problems are likely to occur soonest on pipes carrying hot water, horizontal pipes and at threaded (thinner) sections

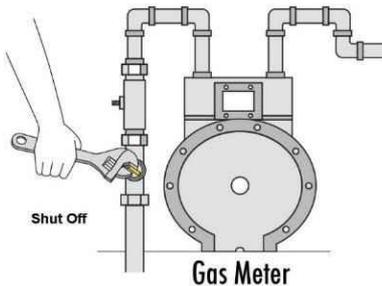
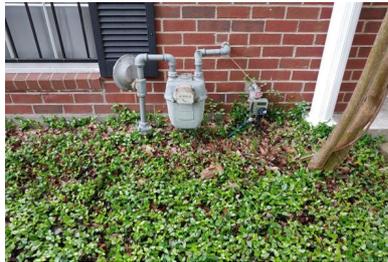
Front of house

The main gas shut off valve was located at the inlet side of the gas service meter.

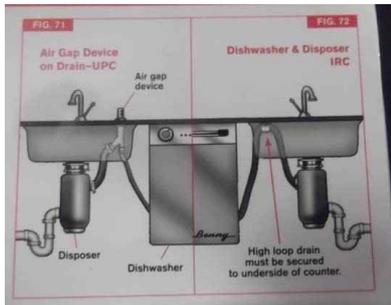
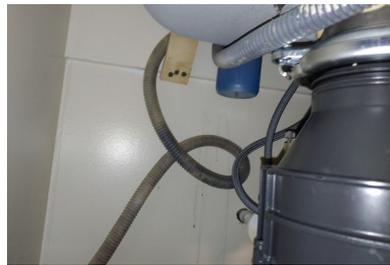
The drain line under the sink was looped up so that the top of the loop was higher than the point where the drain line connected to the disposal. This will help to prevent garbage from running down the drain line into the dishwasher.
