## STRUCTURAL INSPECTION

1634A Park St  
Houston, TX 77019

APRIL 15, 2021

REF: CONDITION OF PROPERTY SURVEY

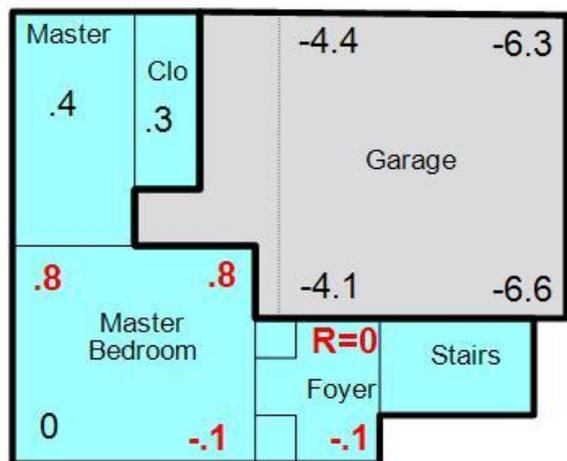
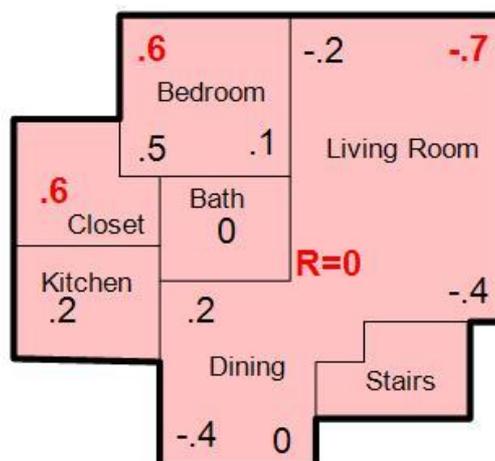
The floors were checked with an electronic level, and were observed to be acceptably level throughout the house. The difference in elevation between the high point and low point was 0.9 inch on the first floor; and 1.3 inches on the second floor. The high point was located at the rear of the master bedroom, and the low point was located at the foyer. The unlevelness takes place over a horizontal distance of approximately 15 feet.

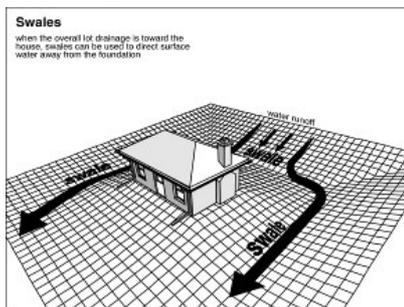
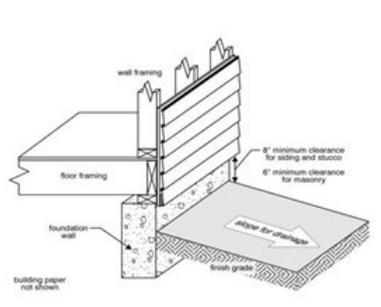
The perimeter drainage around the property appeared to generally be adequate. It could not be determined with certainty if water would pool at any localized low areas around the property. Further investigation with the homeowner is recommended to determine if there are any drainage problems or water that ponds on the property after a rain.

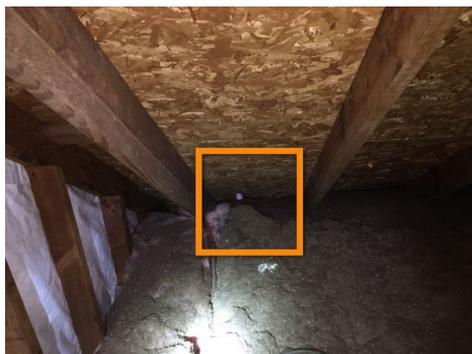
Sewer vent at the northwest corner of the attic

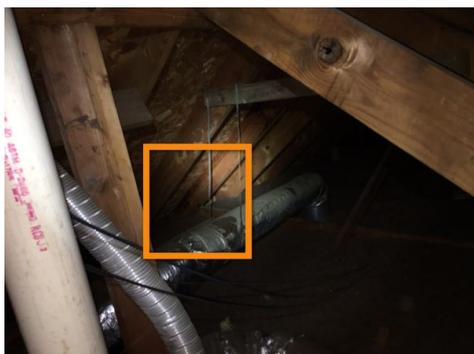
Near the chimney

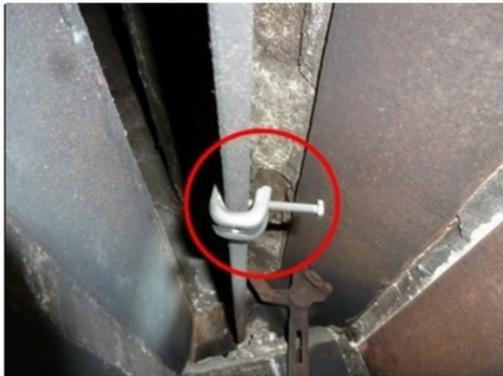
HEI file photo showing c-clamp in masonry fireplace

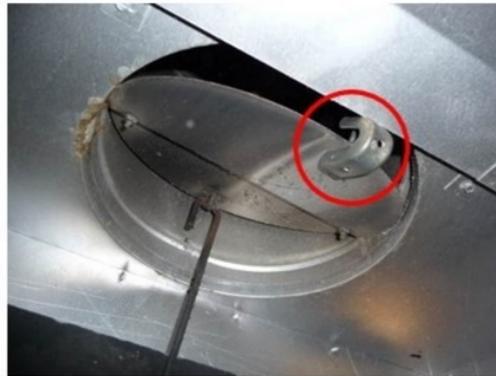
HEI file photo showing c-clamp in metal fireplace

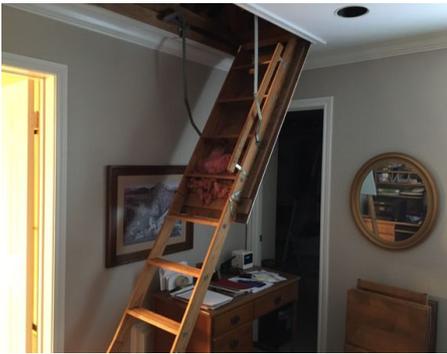
The access ladder into the attic appeared to be the original installation ladder, and the ladder was not labeled to indicate the rated capacity of the ladder. The ladder does not meet current code requirements for ladders into attics. Consideration should be given to replacing the ladder with a ladder that meets current code requirements.

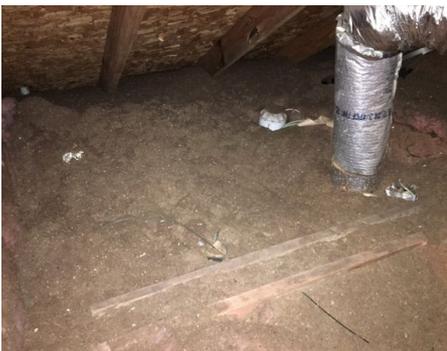
The insulation in the attic varied in thickness from approximately 4-5 inches to approximately 9-10 inches. It is pointed out that the normal amount of insulation for new houses in this area is currently an R38 energy rating, or approximately 14 inches of blown in fiberglass insulation.

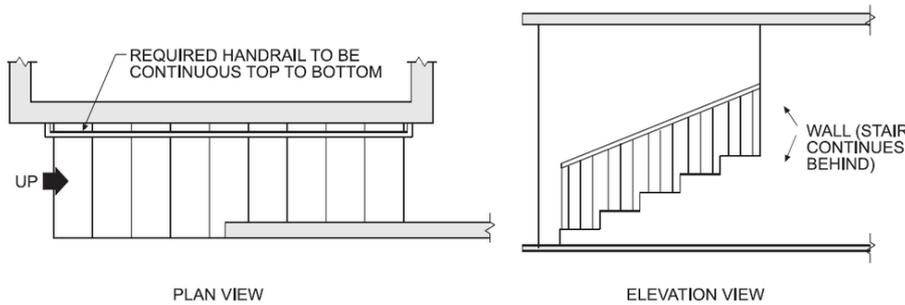
Figure R311.7.8.2 HANDRAILS

The handrails for the stairway were not constructed according to the current building code standards, which is expected given the age of the house. Therefore, the ends of the handrails do not terminate into the wall, which could allow loose clothing or a purse or bag to catch on the open end, causing tripping and/or falling down the stairs.
