Property Inspection Report

2005 39th St, Galveston, TX, 77550

Inspection Date: 10/26/2022

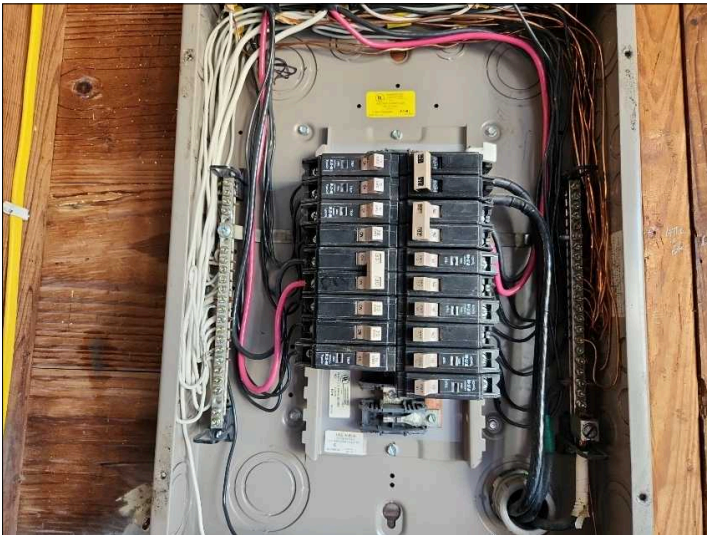
A.3. -The latch on the electric panel door is broken, recommend repairs to help prevent unwanted entry and possible electrical shock.

Overview of main electrical panel

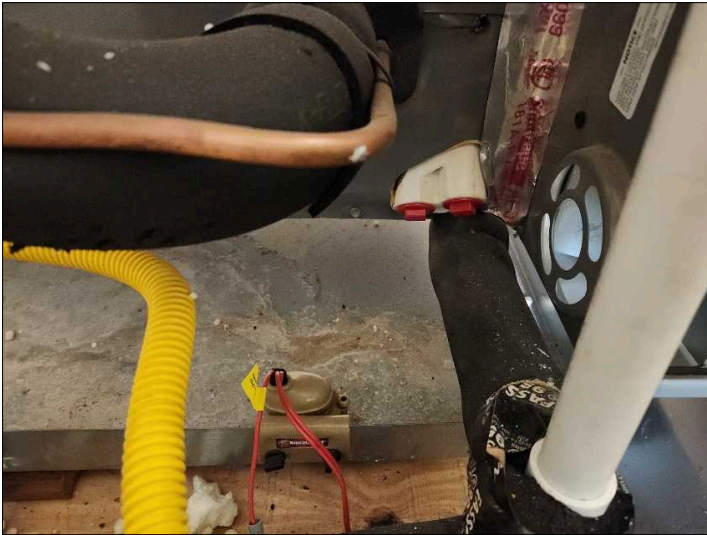
Manufacturers Tag

- The evaporator is missing the secondary drain line to the exterior or to the pan incase main condensation line becomes clogged, recommend adding a secondary drain or high water shutoff to drain line to help prevent water damage to ceilings.

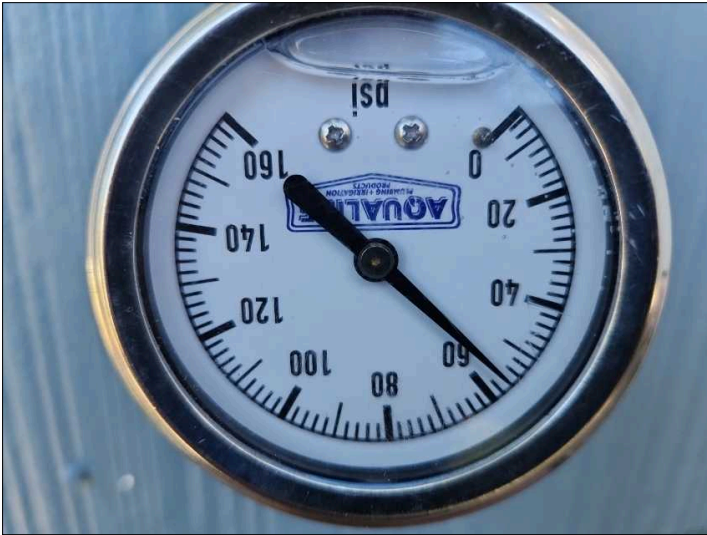
Water Pressure for home

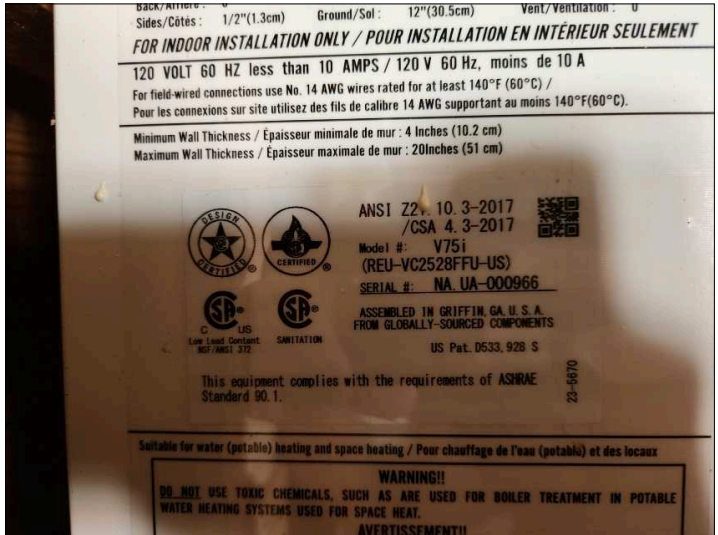
Manufacturers Tag

- The water heater pan drain or T&P (Pop-Off) valve drain line does not have a properly installed 90 elbow to safely direct the high-pressure discharge from the valve where it exits the exterior.

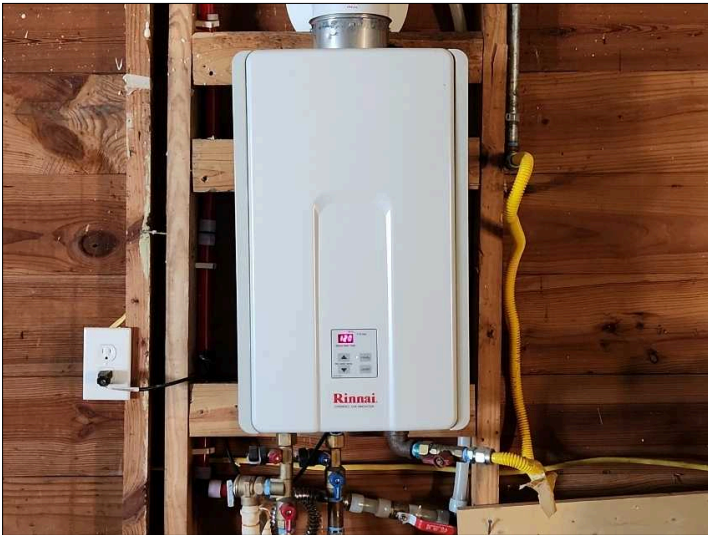
- No drip leg or sediment trap for gas line on water heater. This helps prevent trash from clogging jets.

Overview of water heater(s)

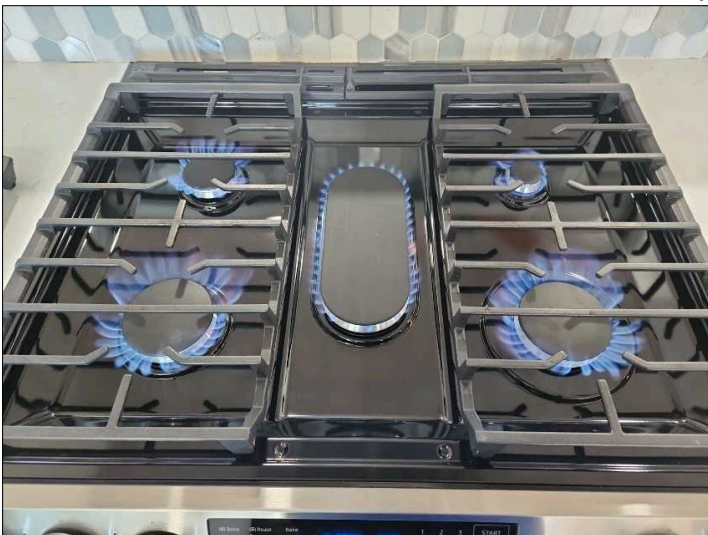
D.2. -Oven Thermostat to Temperature Reading: 350F / 365-370F

Overview of range

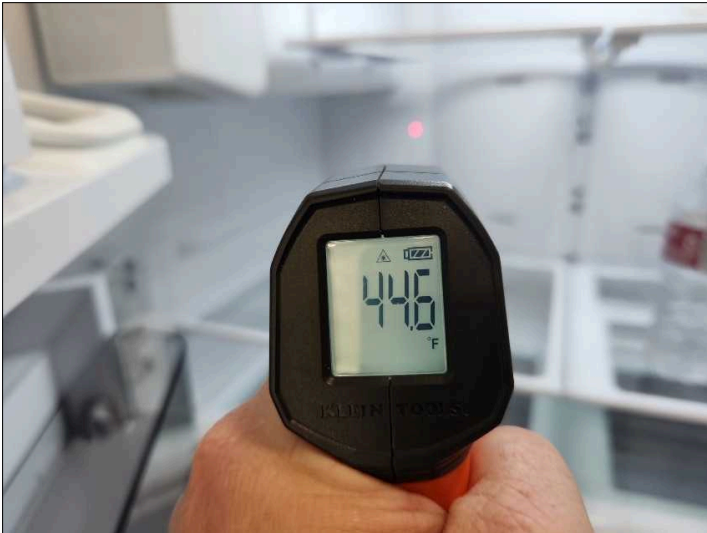
- The refrigerator is operating as intended.

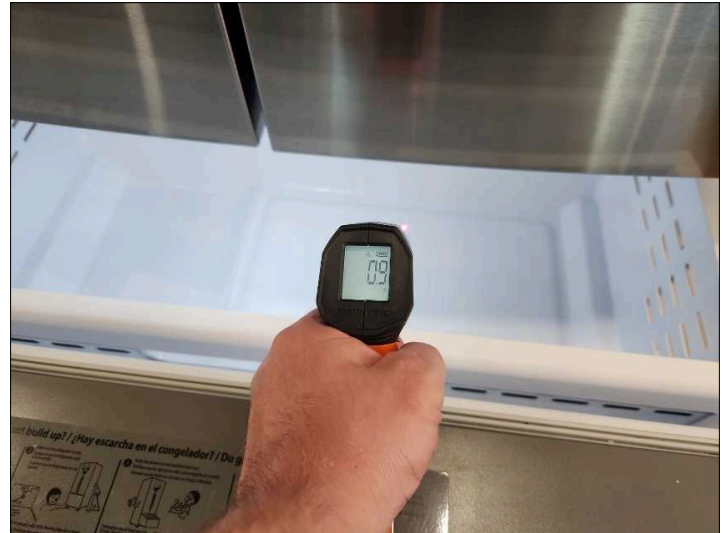
- The freezer is operating as intended.
