Property Inspection Report

3616 1/2 Avenue M, Galveston, TX 77550
Inspection prepared for: Victor Orellana
Date of Inspection: 4/28/2023 Time: 9:00 AM
Age of Home: 1975 Size: 1544
Weather: Sunny 78 Degrees
Property Vacant

Inspector: Travis Morrow
TREC 22042
P.O. Box 6816, Katy, TX 77491
Phone: 2817796431
Email: travis@morrowinspections.com
www.morrowinspections.com

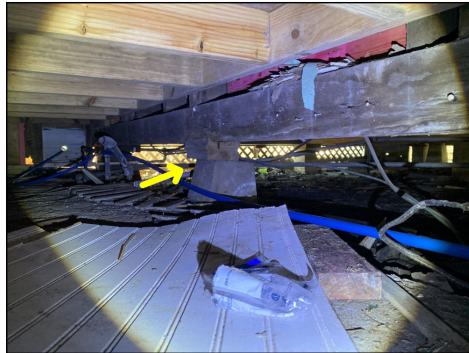
Beams not centered on piers.

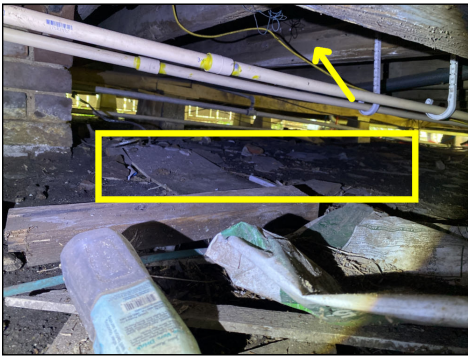
No vapor barrier/floor insulation.

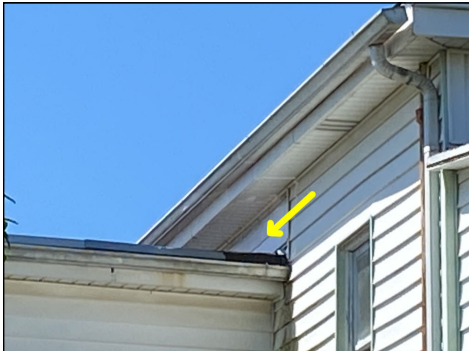
B.7. At the time of inspection gutter(s) were observed to have what appears to be improper pitch, or are not draining properly. Gutter(s) that do not properly drain are prone to over spill which can lead to moisture intrusion. A qualified gutter contractor should be engaged for repair.

Gutter not draining.

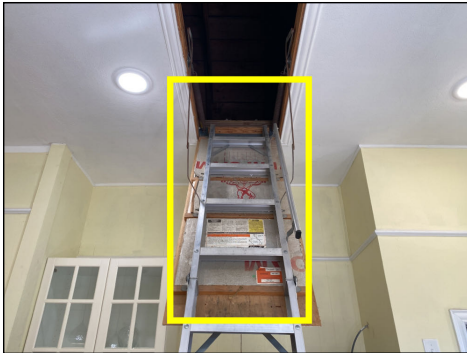
Insulate/weatherstrip attic access ladder.

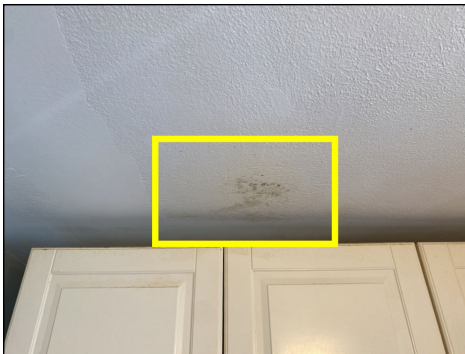
Organic like growth first floor kitchen.

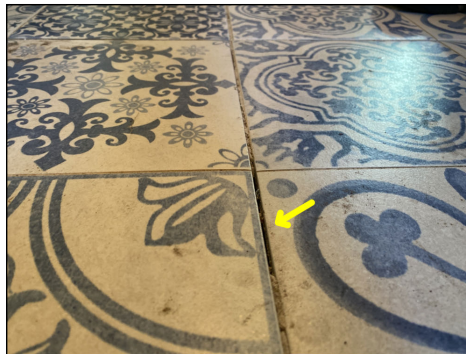
Crumbled grout first floor bathroom.

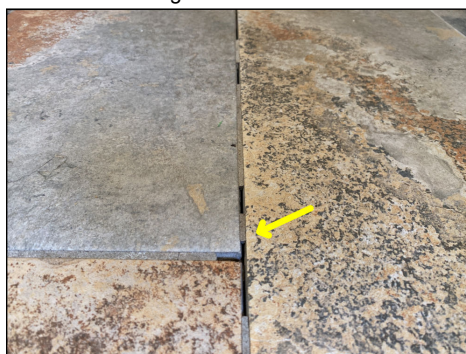
Crumbled grout second floor kitchen.

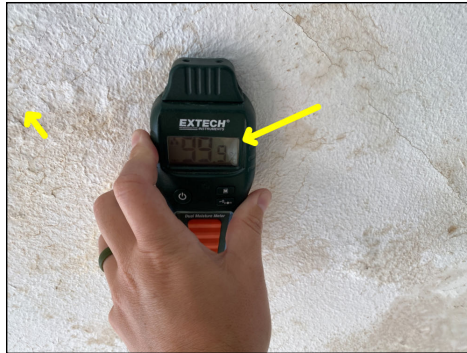
Active leakage laundry room.

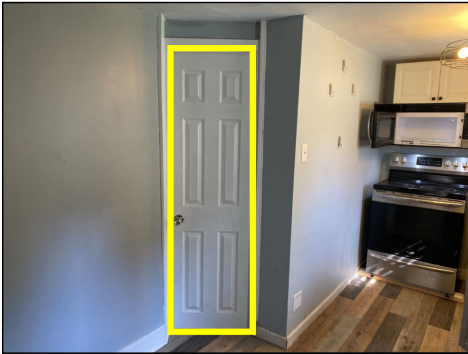
Door sticks first floor bathroom/kitchen.

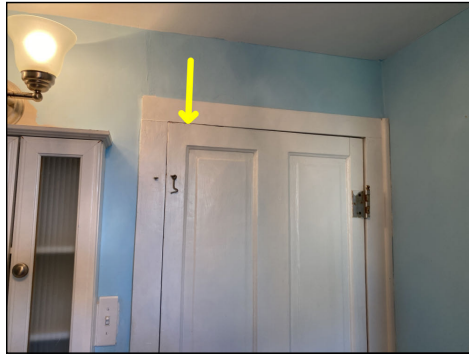
Door sticks first floor bathroom/bedroom.

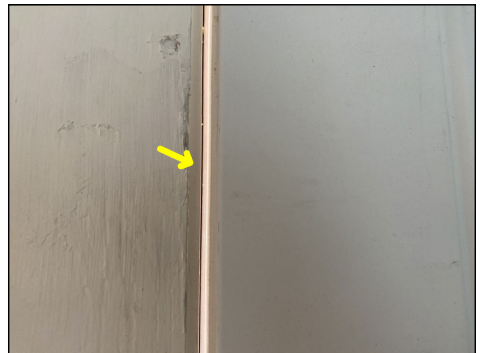
Weatherstripping front first floor door.

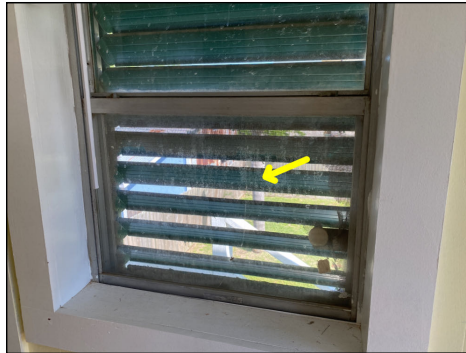
Damaged window laundry room.

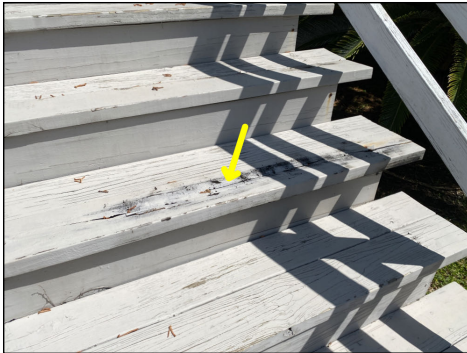
Rot/deterioration front stair treads.

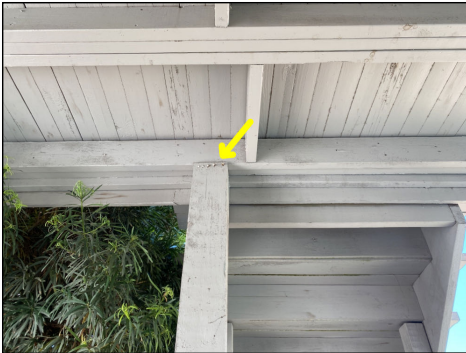
No structural strapping front deck.

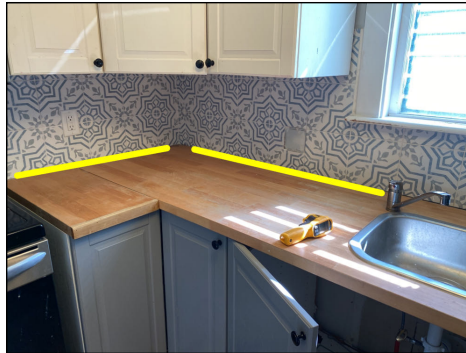
Unsealed countertop edge first floor kitchen.

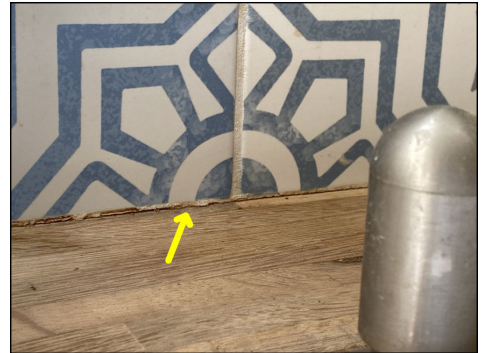
Unsealed countertop edge second floor kitchen.

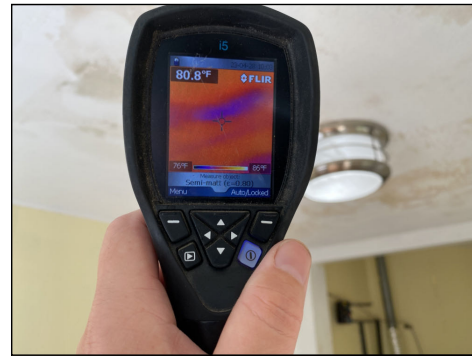
Thermal anomalies laundry room.

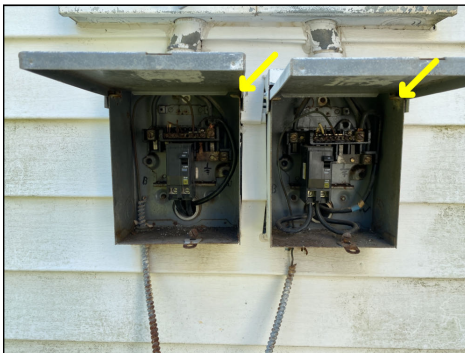
Missing dead fronts exterior disconnects.

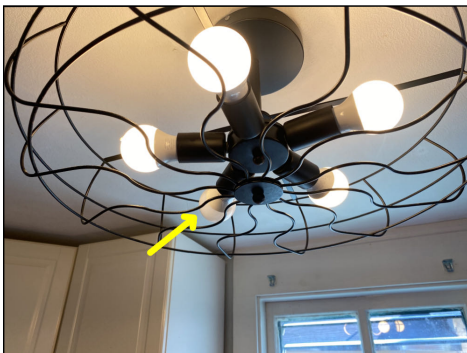
B.6. Lights were found to be inoperative. If the bulbs are not blown, the circuit should be investigated.

Inoperative light first floor kitchen.

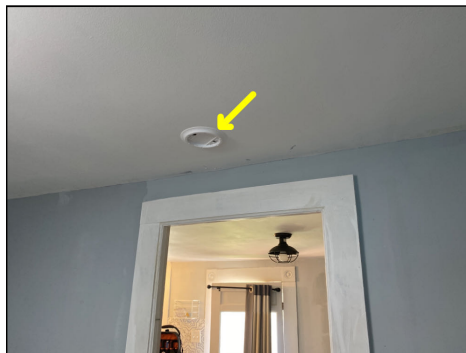
Missing bedroom smoke detectors example.

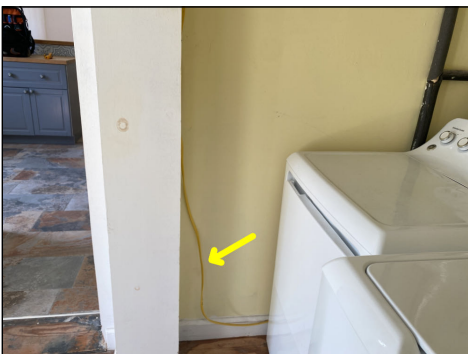
Wiring exposed on interior laundry room.

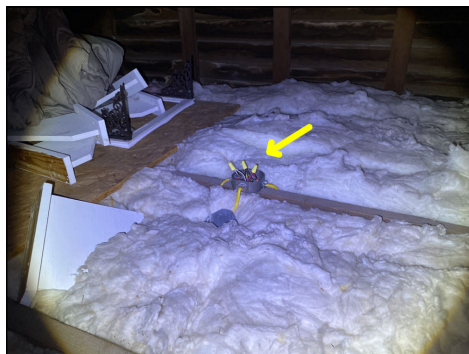
Open junction boxes attic (multiple).

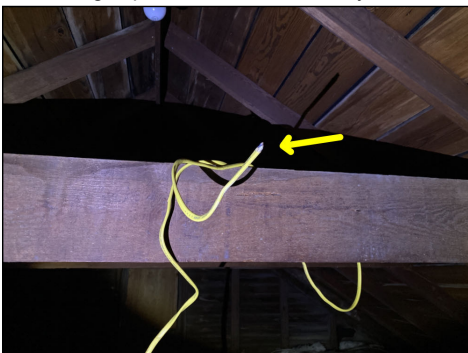
B.18. Abandoned/energized wiring should be replaced or appropriately terminated. Recommend consulting a qualified contractor to this regard. (attic)

Energized exposed wiring attic.

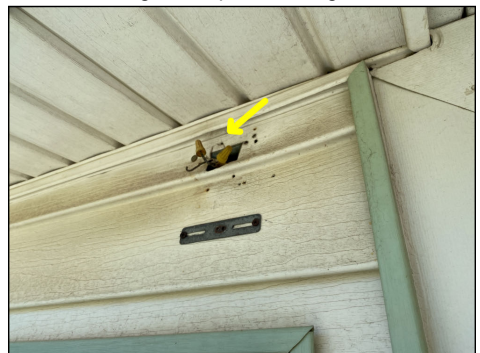
Abandoned wiring rear of home.

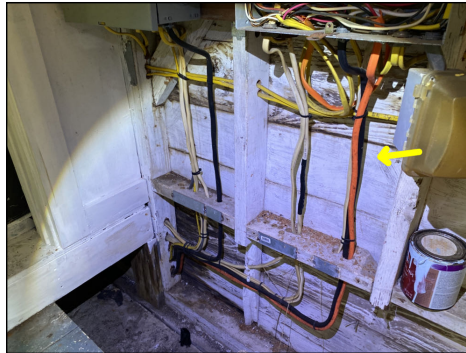
Wiring exposed on interior exterior closet.

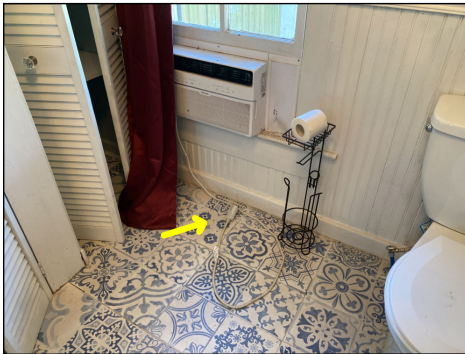
B.2. No outlet was available to test first floor bathroom unit at time of inspection.

No outlet for unit first floor bathroom.

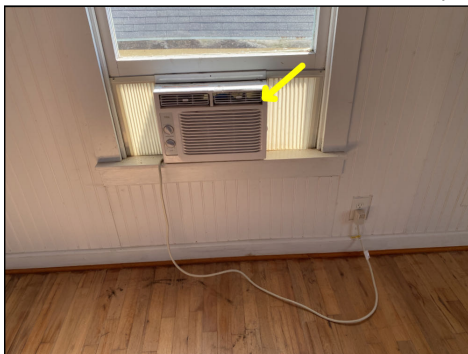
B.3. The system was inoperative and requires further evaluation/repair by a qualified HVAC contractor. (first floor rear bedroom, second floor bedroom)

Inoperative unit second floor bedroom.

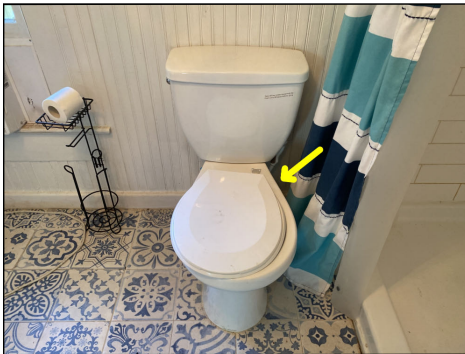
A.9. Commode seat(s) observed to be loose. Recommend re-securing seat(s) to prevent future damage. (first floor bathroom)

Loose commode seat first floor bathroom.

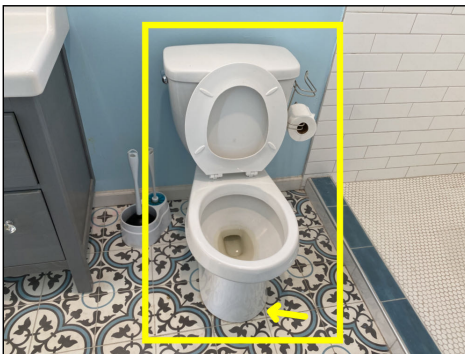
A.16. The commode is loose and should be re-secured / re-seated to help prevent potential leaks from occurring. (second floor bathroom)

Loose commode/not sealed to floor second floor bathroom.

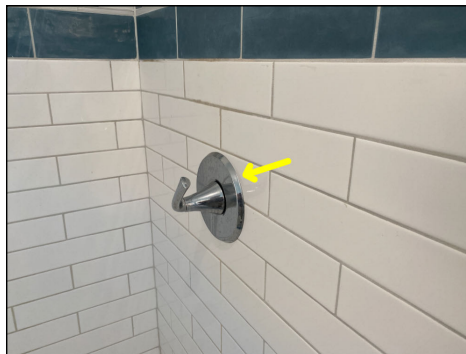
A.7. Cracked, deteriorated and/or missing tub/shower grout and/or caulk, and/or cracked tub/shower tiles should be replaced to help prevent potential moisture related issues. (second floor bathroom shower)

Caulk second floor bathroom shower stall.

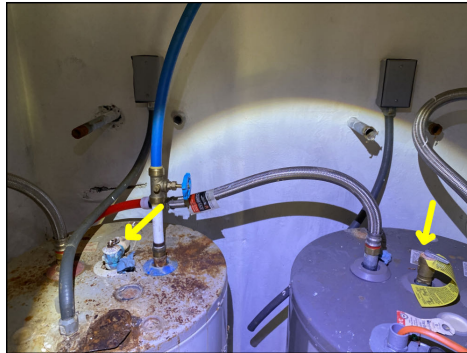
C.7. Missing TPR drain line was observed and should be properly installed. Recommend consulting a qualified plumber for repairs. (both units)

No TPR drain lines.

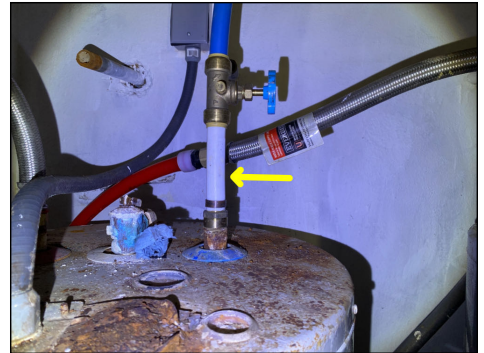
PEX connected direct to unit GE.
