BPG Inspection, LLC

**34 North Swanwick Place
Tomball TX 77375**

Client(s): Bump
Inspection Date: 3/10/2021
Inspector: Murray Campbell , TREC #22455

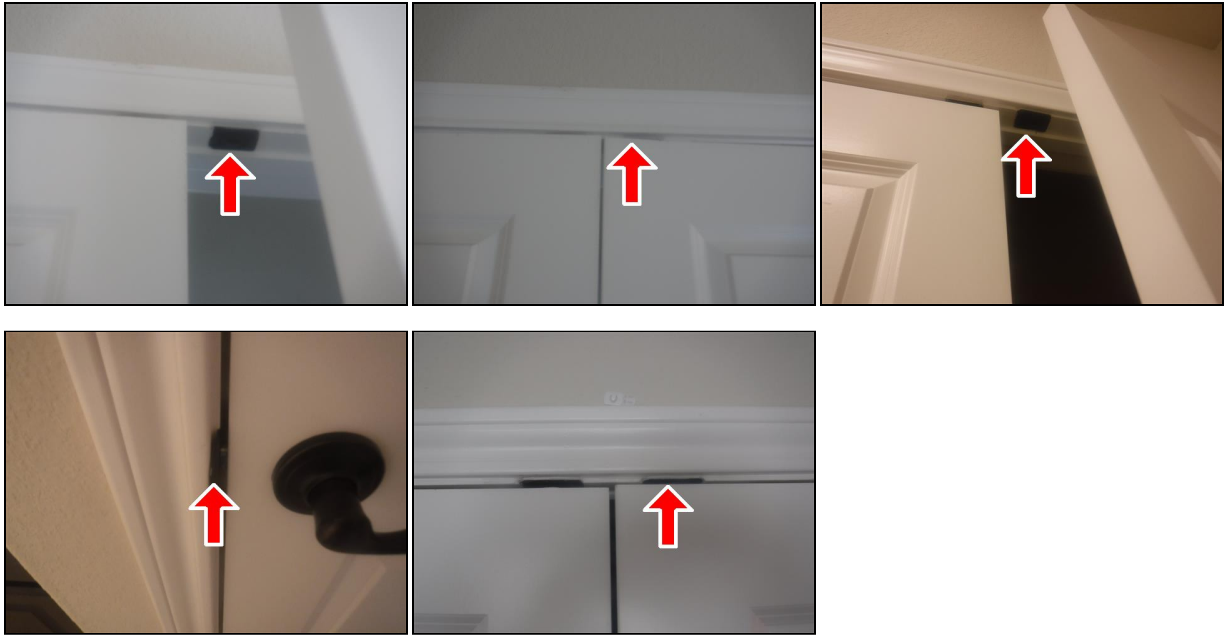
Master bedroom door functions as intended but is damaged. Repair as needed.

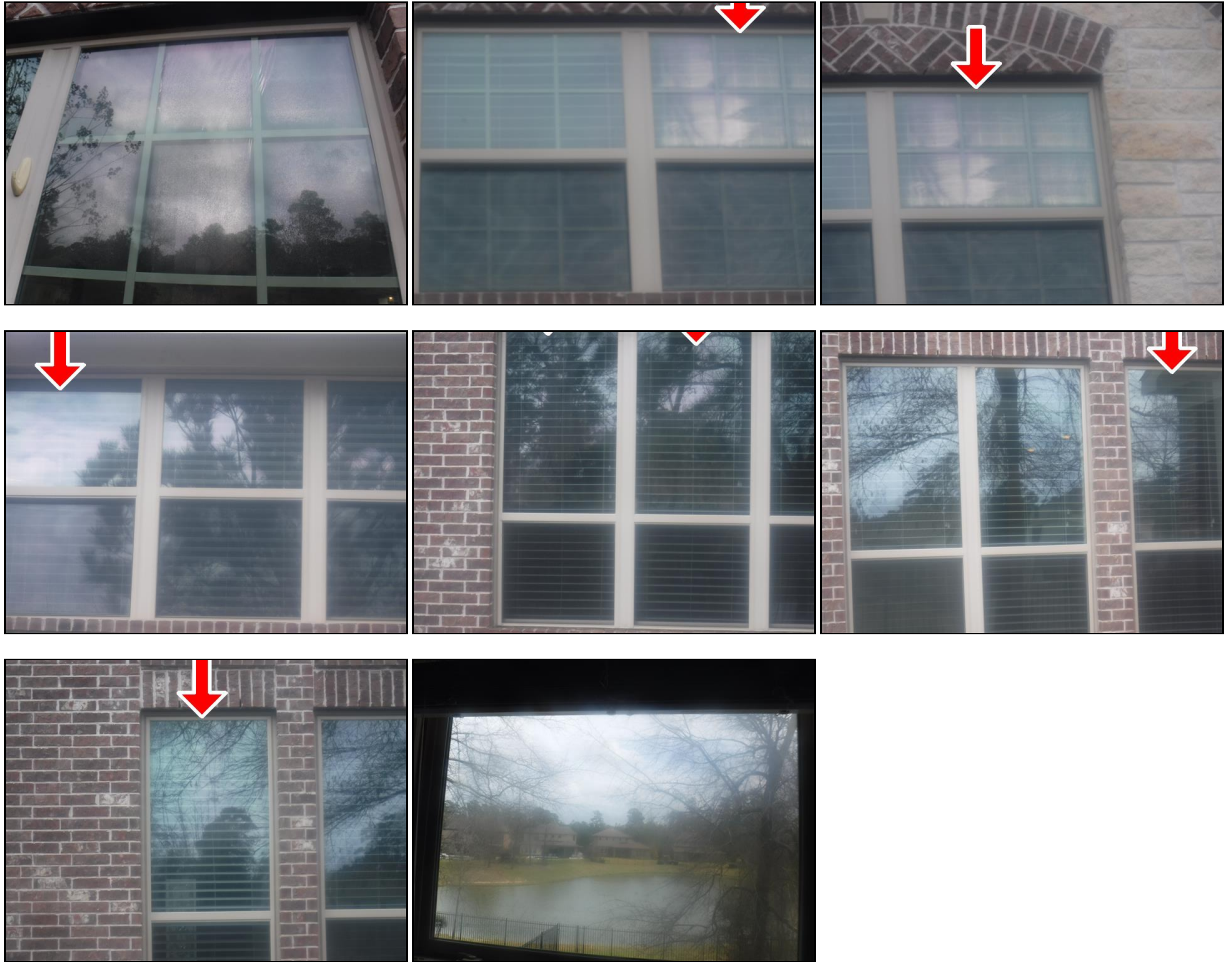
Noted one or more windows on 2nd floor that have a potential fall hazard present for small children due to their low height above floor. In dwelling units, where the opening of an operable window is located more than 72 inches above finished grade or exterior surface, the lowest part of the clear opening of the window shall be

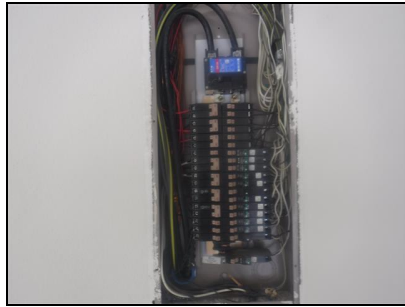
Grounding cable is loose from ground electrode. Repair needed.

The aluminium service wires should be coated with anti-oxidation grease where they are stripped back to be connected to the mains, main or branch circuit breakers.

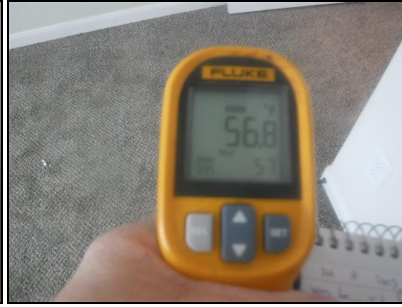
Upstairs supply a/c vent.

⚠ There is no emergency float electrical cutoff switch installed as called for by today's standards. These devices prevent condensate from overflowing into the interior house structure, and turn the unit off until service is performed to the unit. I recommend updating to current standards to prevent water incursion.

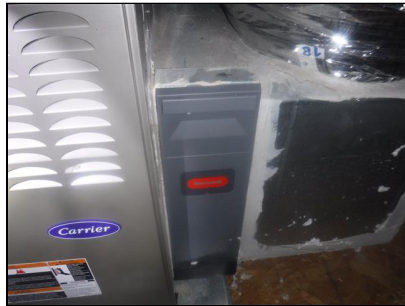
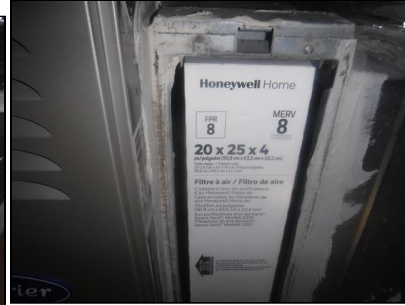
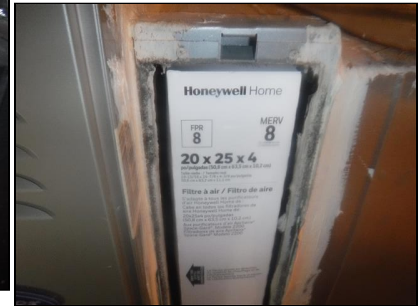
Filter size 20X25X4

The temperature differentials were off by more than 5 degrees when measured at random vents. This may be corrected by balancing ducts and will provide a more even temperature distribution throughout the house.

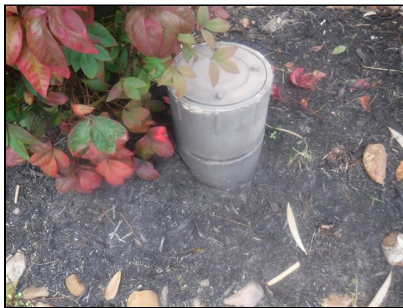
Cleanout located front of residence.

Have all missing/not functional drain stops repaired/replaced.

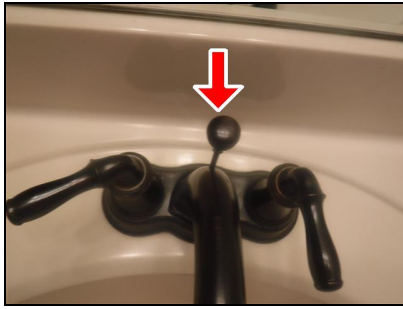
The guest bath master bath sink does not have an over-flow drain and there is a drain stopper present. Client should ensure that the sink is never left unattended during filling. Suggested recommendation is to remove stopper assembly from sink.

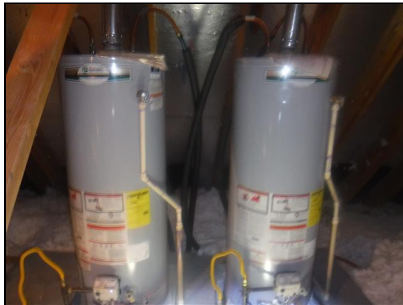
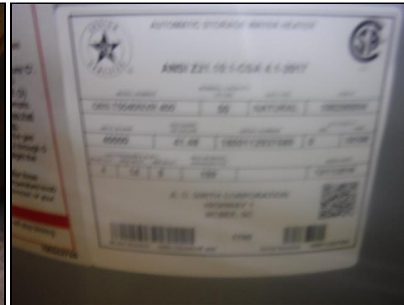
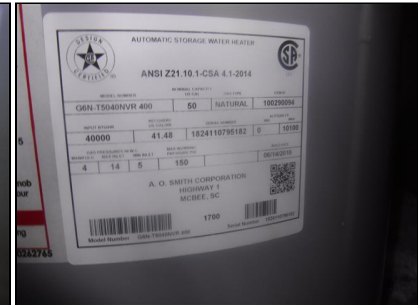
The water heater(s) functioned normally at time of inspection.

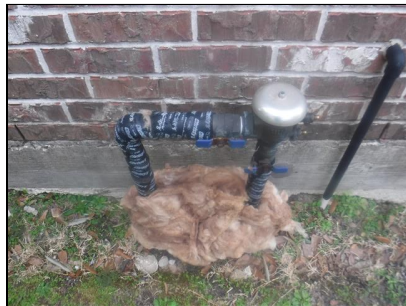
Irrigation back flow preventer located left side of residence.

Tested and operated all zones of sprinkler system with no concerns noted. System operated from controller in garage.

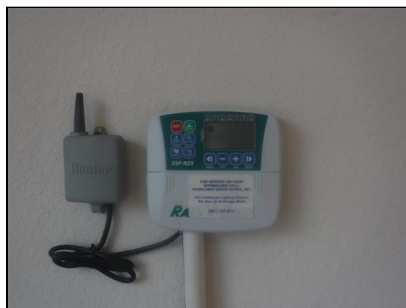
There is a damaged sprinkler head at front, rear and sides of home. The system is in need of further review and repair by a licensed irrigator.
