**NOTICE CONCERNING HAZARDOUS CONDITIONS, DEFICIENCIES, AND CONTRACTUAL AGREEMENTS**

**ADDITIONAL INFORMATION PROVIDED BY INSPECTOR**

### I. STRUCTURAL SYSTEMS

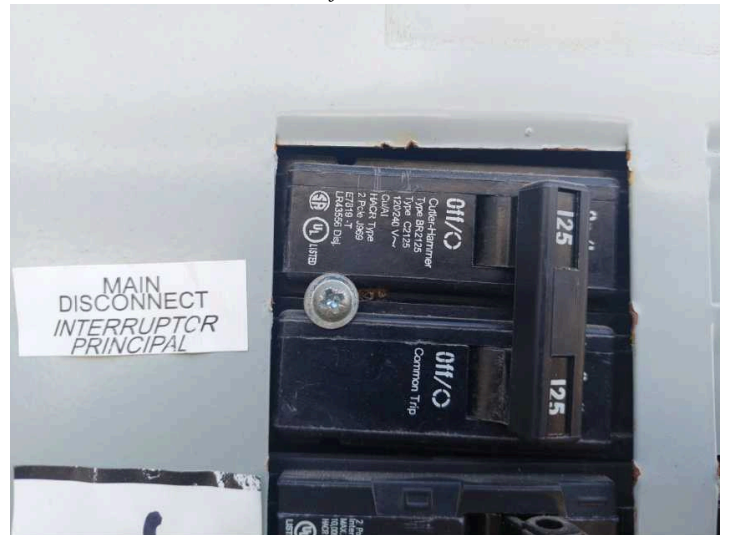
Main breaker (125A)

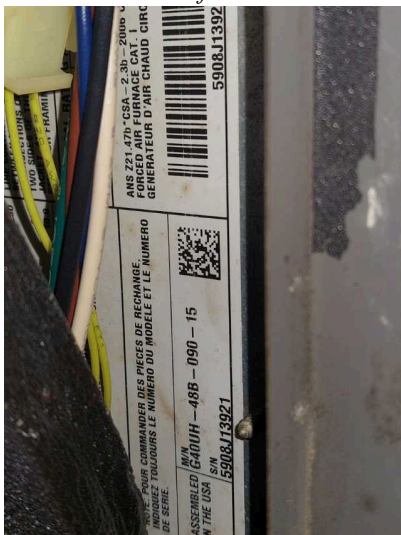
Furnace Data Tag (2008)

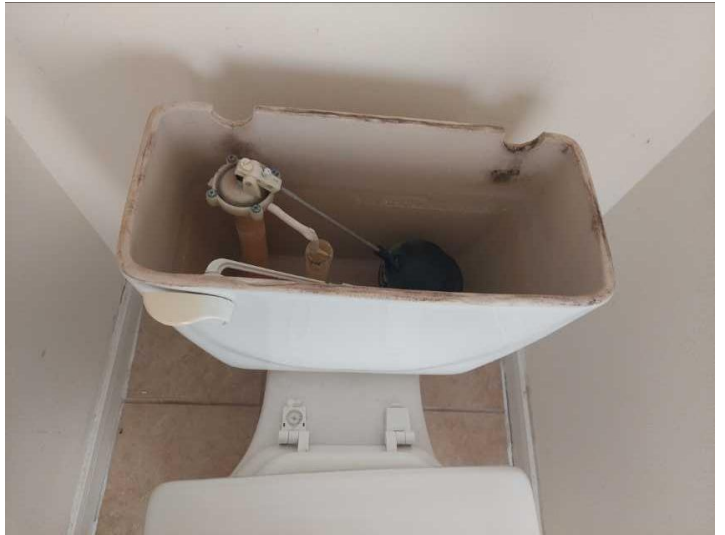
- Type of Supply Piping Material: Copper
- Static Water Pressure Reading: psi. Unable to attach water pressure gauge due to covered hose bibs.
- The kitchen sink faucet was leaking water at base.
- One or more toilets did not flush at time of inspection.
- Water appeared to be leaking from the shower pan to the adjacent areas in Master Bathroom and should be evaluated by a qualified plumber.
- Damaged caulking was noted at the downstairs hall bathroom sink.

*Master bathroom toilet does not flush*

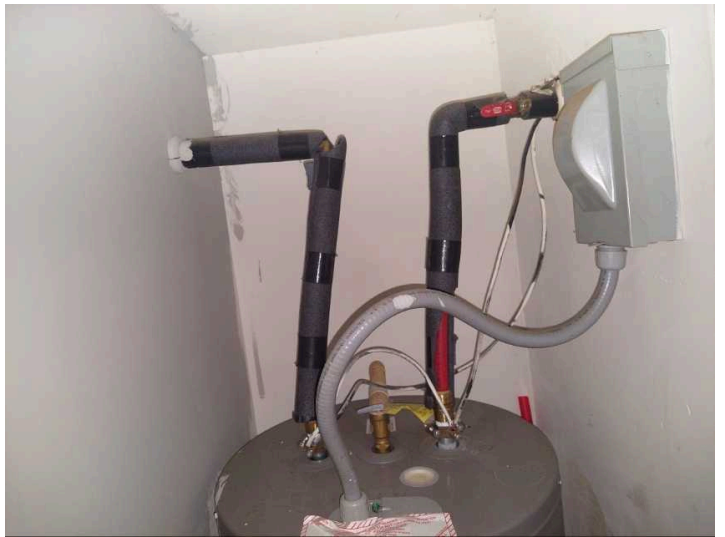
WH connections, with proper electrical disconnect

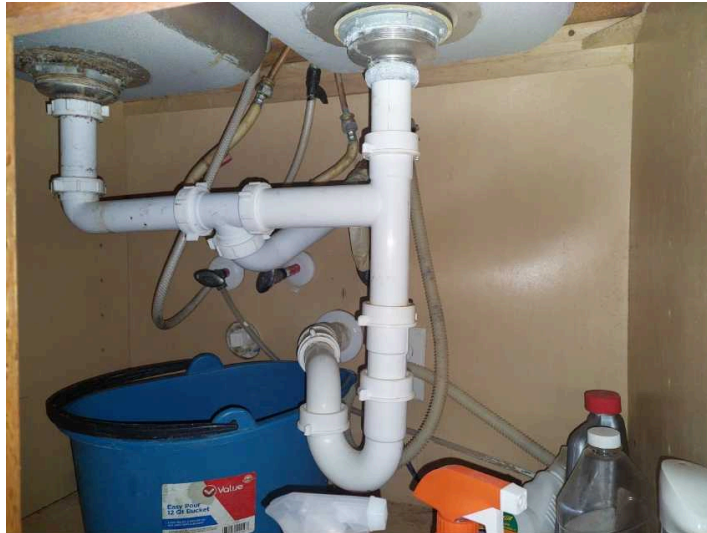
*Food Waste Disposer not installed*
