PROPERTY INSPECTION REPORT

Concerning: 1611 W 24th St A, Houston, TX 77008
(Address or Other Identification of Inspected Property)

By: Michael Garcia, Lic #20817 06/10/2019
(Name and License Number of Inspector) (Date)

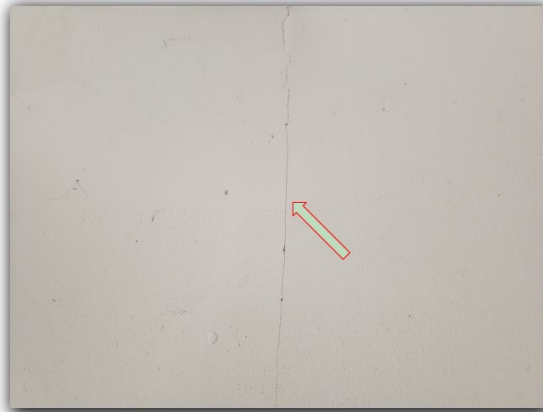
Some of the walls appear to have been recently painted. This may hide some stains, mildew, or other damage that may exist.

Repair is recommended.

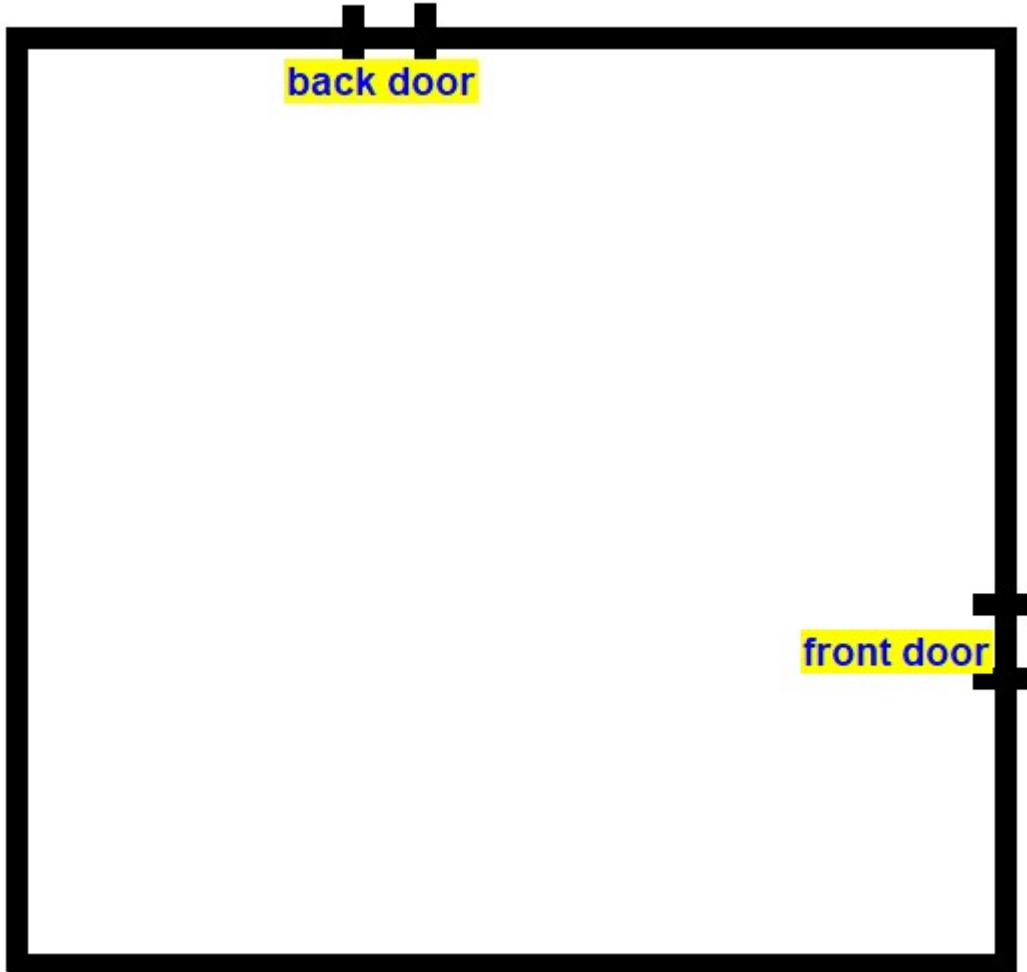
Diagram of Structure(s) Inspected

Additional Comments No active termite activity was observed at the home.
