Lone Star Stucco, LLC

Moisture Assessment Report

1843 Sul Ross St

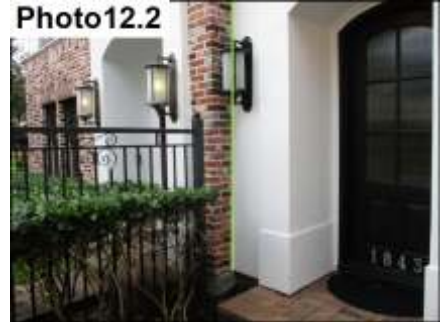
Photo12.2

- Brick and stucco sealants are present at this location. The inspector states that this is a positive detail and suggests maintaining these sealants in an effort to prevent moisture intrusion. Please refer to photos #12.2, #12.3, #12.4, #12.5 and #12.6 for more detail.

Brick/Stucco Termination / Maintain

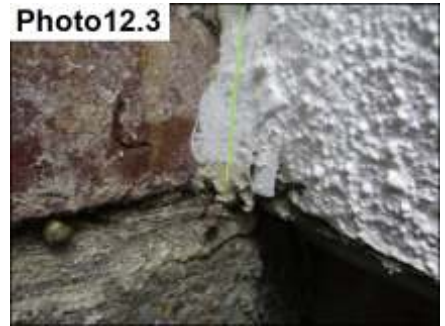
Photo12.3

Brick/Stucco Termination / Maintain

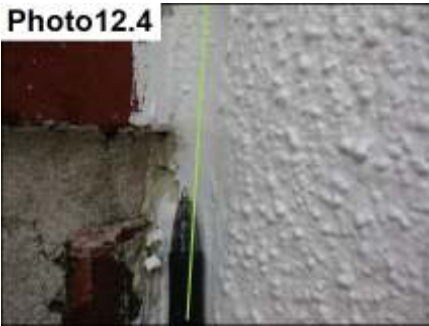
Photo12.4

Brick/Stucco Termination / Maintain

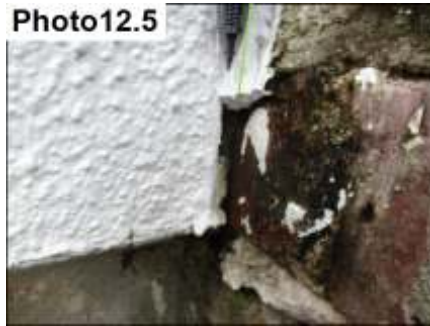
Photo12.5

Brick/Stucco Termination / Maintain

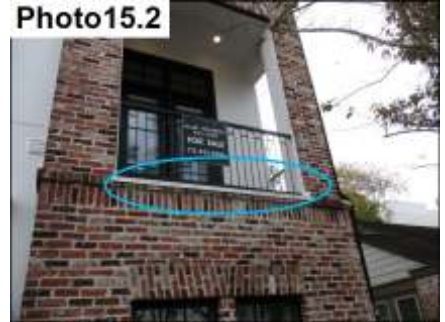
Photo15.2

- The balcony flashing sealants are aged and separated at this location. The inspector suggests to have a qualified waterproofing contractor further assess and seal this area with a low modulus sealant in an effort to prevent moisture intrusion. These types of sealants are of high quality and compatible with stucco and other termination points. Please refer to photos #15.2, #15.3, #15.4, #15.5 and #15.6 for more detail.

Balcony Flashing / Seal

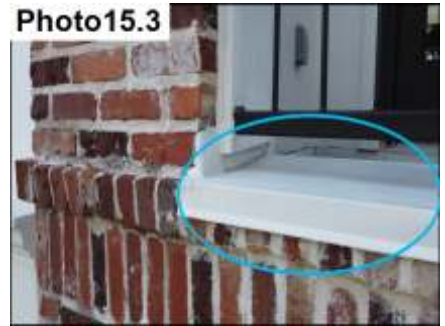
Photo15.3

Balcony Flashing / Seal

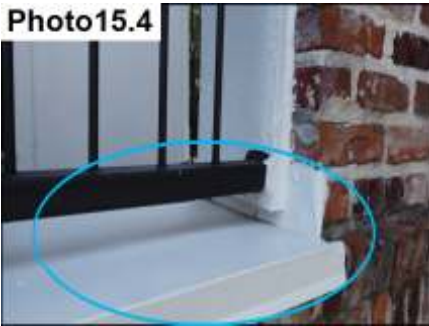
Photo15.4

Balcony Flashing / Seal

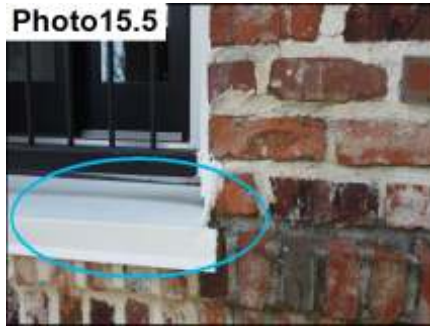
Photo15.5

Balcony Flashing / Seal

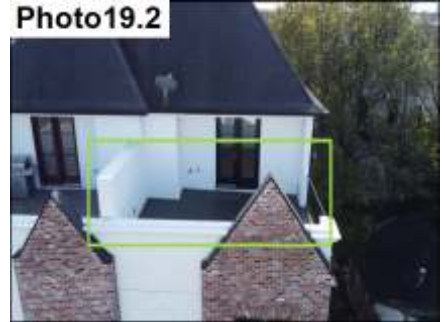
Photo19.2

Rooftop Parapet Cap / Seal

Grid Location	Item Description	Moisture Readings	Substrate Condition	Observations
Green Boxes	Flashing			The rooftop parapet cap flashing sealants are aged and separated at this location. The inspector suggests to have a qualified waterproofing contractor further assess and seal this area with a low modulus sealant in an effort to prevent moisture intrusion. These types of sealants are of high quality and compatible with stucco and other termination points. Please refer to photos #19.2, #19.3, #19.4, #19.5 and #19.6 for more detail.

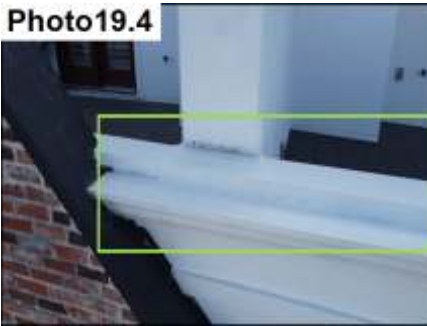
Photo19.4

Rooftop Parapet Cap / Seal

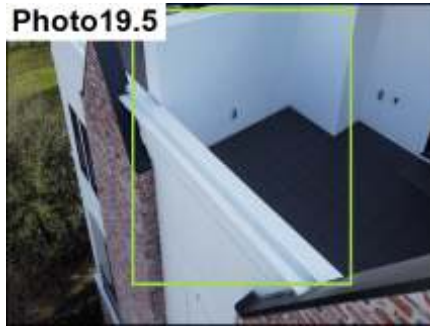
Photo19.5

Rooftop Parapet Cap / Seal

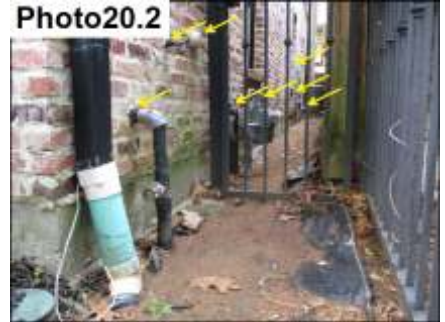
Photo20.2

Penetration Sealants / Seal

Grid Location	Item Description	Moisture Readings	Substrate Condition	Observations
Yellow Arrows	Penetrations			The penetration sealants are aged. The inspector suggests to have a qualified waterproofing contractor seal this area with a low modulus sealant in an effort to prevent moisture intrusion. These types of sealants are of high quality and compatible with stucco and other termination points. Please refer to photos #20.2, #20.3, #20.4, #20.5 and #20.6 for more detail.

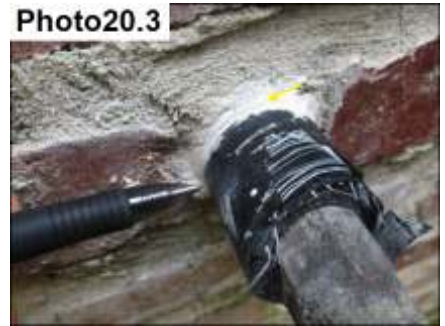
Photo20.3

Penetration Sealants / Seal

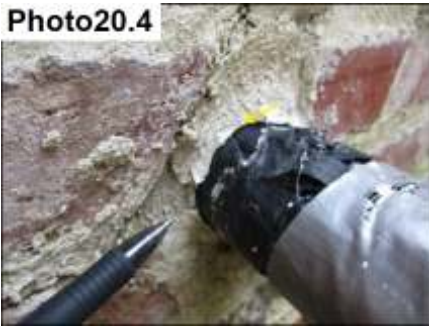
Photo20.4

Penetration Sealants / Seal

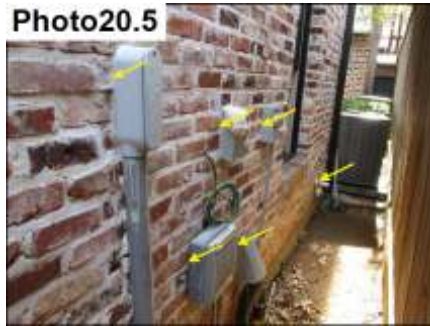
Photo20.5

Penetration Sealants / Seal

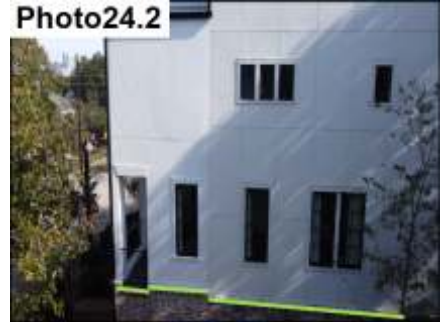
Photo24.2

Brick/Stucco Termination / Maintain

Grid Location	Item Description	Moisture Readings	Substrate Condition	Observations
Green Lines	Stucco Termination			Brick and stucco sealants are present at this location. The inspector states that this is a positive detail and suggests maintaining these sealants in an effort to prevent moisture intrusion. Please refer to photos #24.2, #24.3, #24.4 and #24.5 for more detail.

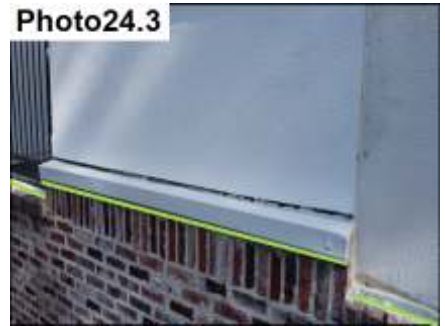
Photo24.3

Brick/Stucco Termination / Maintain

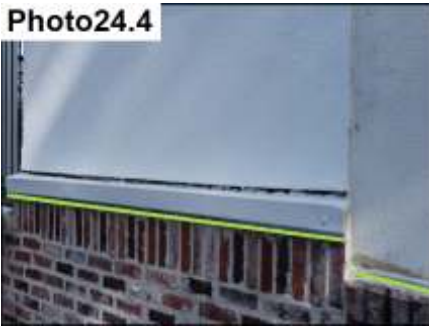
Photo24.4

Brick/Stucco Termination / Maintain

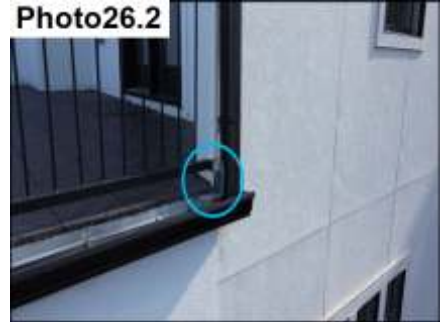
Photo26.2

Balcony Flashing / Seal

Grid Location	Item Description	Moisture Readings	Substrate Condition	Observations
Blue Circles	Flashing			The balcony flashing sealants are aged at this location. The inspector suggests to have a qualified waterproofing contractor further assess and seal this area with a low modulus sealant in an effort to prevent moisture intrusion. These types of sealants are of high quality and compatible with stucco and other termination points. Please refer to photos #26.2, #26.3, #26.4 and #26.5 for more detail.

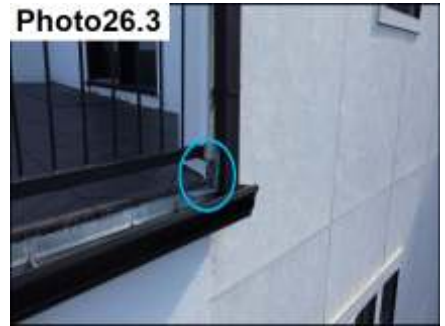
Photo26.3

Balcony Flashing / Seal

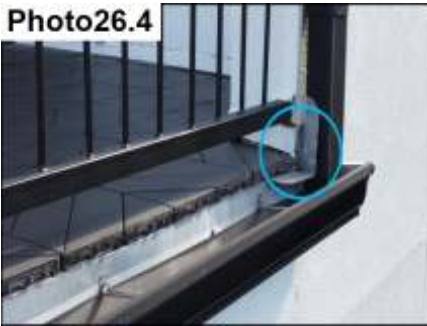
Photo26.4

Balcony Flashing / Seal

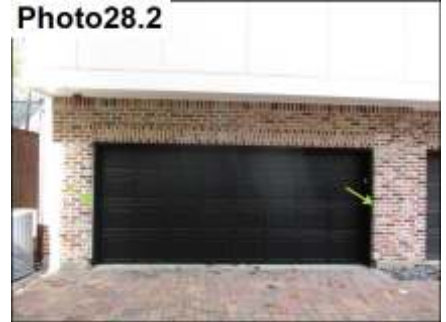
Photo28.2

- The door trim sealants are aged and separated. The inspector suggests to have a qualified waterproofing contractor seal this area with a low modulus sealant in an effort to prevent moisture intrusion. These types of sealants are of high quality and compatible with stucco and other termination points. Please refer to photos #28.2, #28.3, #28.4, #28.5 and #28.6 for more detail.

Door Sealant Separation / Seal

Grid Location	Item Description	Moisture Readings	Substrate Condition	Observations
Green Arrows	Doors			The door trim sealants are aged and separated. The inspector suggests to have a qualified waterproofing contractor seal this area with a low modulus sealant in an effort to prevent moisture intrusion. These types of sealants are of high quality and compatible with stucco and other termination points. Please refer to photos #28.2, #28.3, #28.4, #28.5 and #28.6 for more detail.

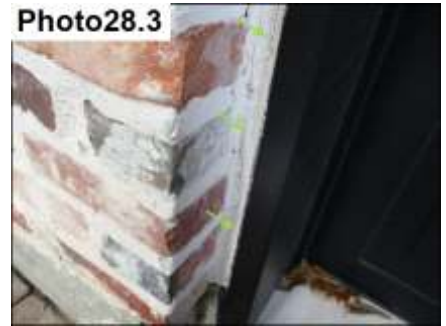
Photo28.3

Door Sealant Separation / Seal

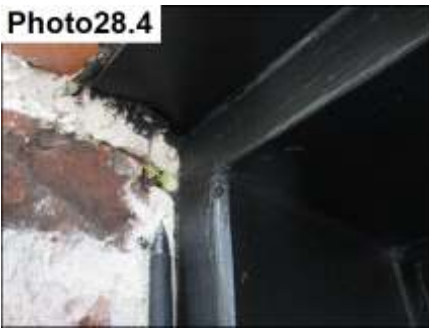
Photo28.4

Door Sealant Separation / Seal

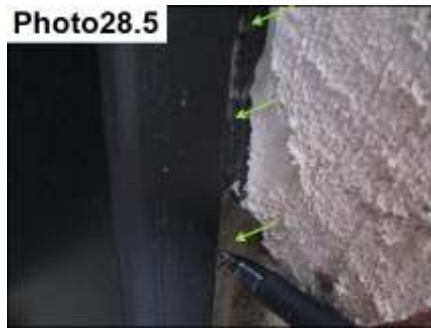
Photo28.5

Door Sealant Separation / Seal

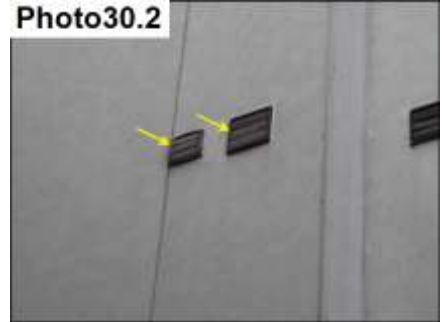
Photo30.2

- The penetration sealants are aged and separated. The inspector suggests to have a qualified waterproofing contractor seal this area with a low modulus sealant in an effort to prevent moisture intrusion. These types of sealants are of high quality and compatible with stucco and other termination points. Please refer to photos #30.2, #30.3 and #30.4 for more detail.

Penetration Sealants / Seal

Grid Location	Item Description	Moisture Readings	Substrate Condition	Observations
Yellow Arrows	Penetrations			The penetration sealants are aged and separated. The inspector suggests to have a qualified waterproofing contractor seal this area with a low modulus sealant in an effort to prevent moisture intrusion. These types of sealants are of high quality and compatible with stucco and other termination points. Please refer to photos #30.2, #30.3 and #30.4 for more detail.

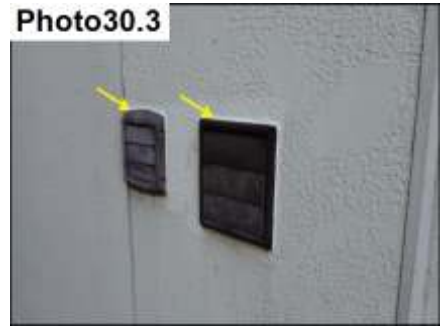
Photo30.3

Penetration Sealants / Seal

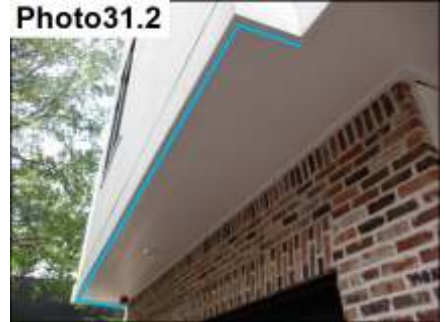
Photo31.2

- Although a relief is present at this location, excess sealant was applied to the drainage plane obstructing proper moisture evacuation of the system. The inspector recommends having a qualified waterproofing contractor further assess, clean out excess material and verify the house back wrap has been cut. This will provide the proper functioning of the system at this location. Please refer to photos #31.2, #31.3, #31.4, #31.5 and #31.6 for more detail.

Relief Present / Clean Out Excess Sealant

Grid Location	Item Description	Moisture Readings	Substrate Condition	Observations
Blue Lines	Relief			Although a relief is present at this location, excess sealant was applied to the drainage plane obstructing proper moisture evacuation of the system. The inspector recommends having a qualified waterproofing contractor further assess, clean out excess material and verify the house back wrap has been cut. This will provide the proper functioning of the system at this location. Please refer to photos #31.2, #31.3, #31.4, #31.5 and #31.6 for more detail.

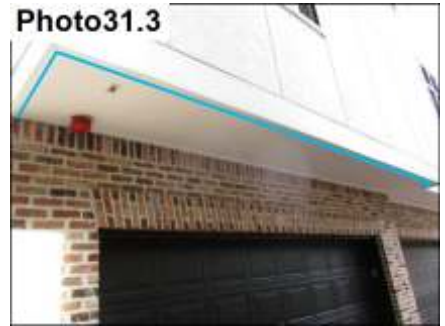
Photo31.3

Relief Present / Clean Out Excess Sealant

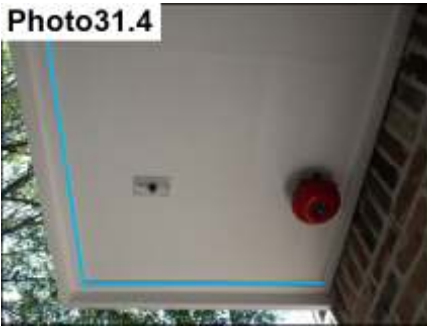
Photo31.4

Relief Present / Clean Out Excess Sealant
