PROPERTY INSPECTION REPORT

Concerning: 21114 Barker Canyon Lane, Katy, TX 77450

Report Identification: 21114 Barker Canyon Lane, Katy , TX 77450 - July 5, 2021

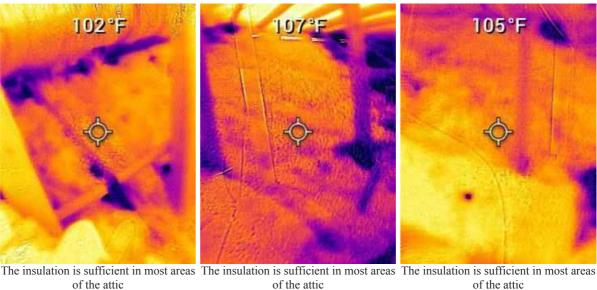
The components of the truss assemblies, roof decking, and ventilation appear to be performing as intended at the time of the inspection. The insulation is sufficient in most areas of the attic

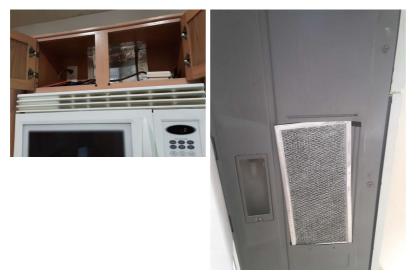
The exhaust fan system is functioning as intended at the time of the inspection. This exhaust fan is of the recirculating type, using the microwave

1: Light inoperable

Recommendation

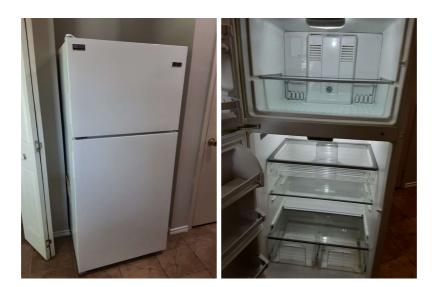
The refrigerator is functioning as intended at the time of the inspection. There was no manufacturer's plate to indicate the model and serial numbers.
