MECHANICAL INSPECTION

902 Rolling Mill Dr
Sugar Land, TX 77498

PROPERTY INSPECTION REPORT FORM

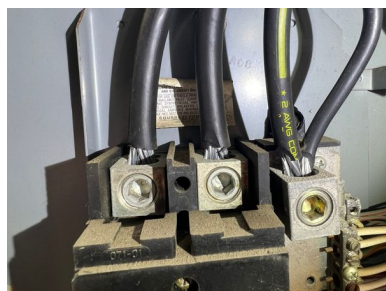
The aluminum conductors were not coated with an anti-oxidation solution. Per the standards set forth by the Texas Real Estate Commission, we are required to recommend that the wires should be coated with an anti-oxidation solution, however this is not required by the current building codes.

Obtain cost estimate

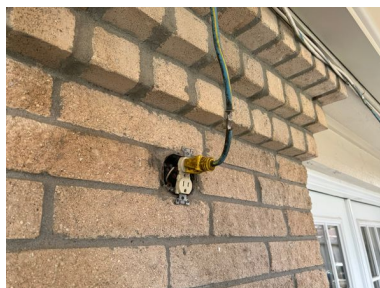
8: Cover Plate - Missing screw

Wet Bar, Hall Bath

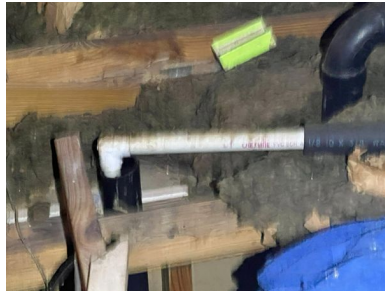
The primary condensate drain line for the unit terminated into a plumbing vent pipe in the attic. This can allow sewer gases to backup into the living space, which is a hazard. It is recommended that the primary drain line be rerouted and terminated in an approved manner.

Obtain Cost Estimate

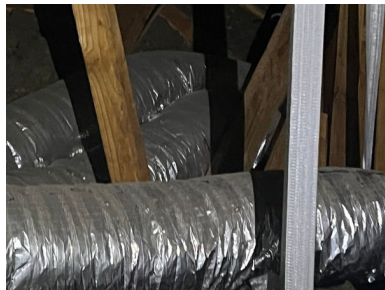
We observed that some of the air ducts in the attic were in contact with each other, which can cause condensation to form on the outside of the ductwork. It is recommended that the ducts that are touching be separated. Typically, this is done by inserting a piece of fiberglass batt insulation or duct board between the ducts.

Obtain Cost Estimate

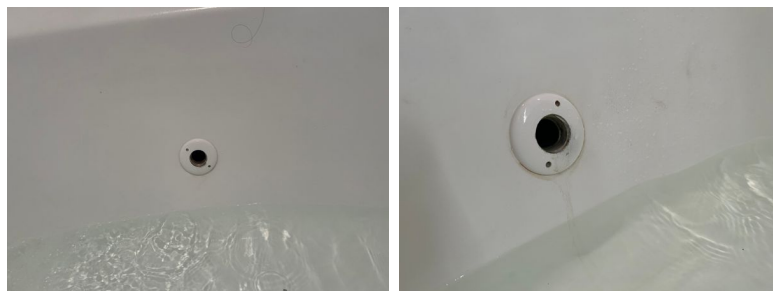
2: No GFCI protection

The whirlpool tub was not protected by a Ground Fault Circuit Interrupt device.

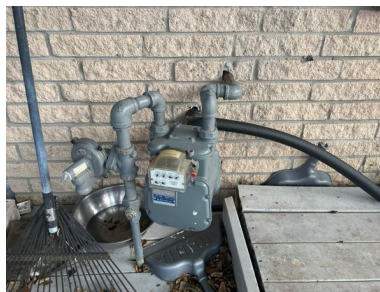
Gas Piping - Slight Rust:

The visible gas piping at the meter was observed to be slightly rusted at the joints and/or piping. The degree of the rust was not such that repairs are recommended, but if this condition concerns you, contact a plumber to remove the rust and paint the gas piping to prevent further deterioration.

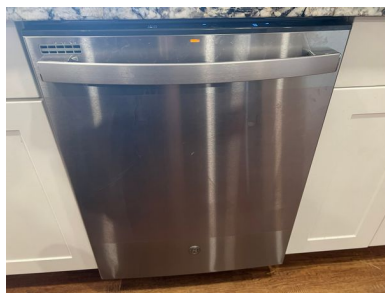
1: No Anti-Siphon

The drain line under the sink was not equipped with an anti-siphon device, nor was it looped up so that the top of the loop is at least six inches above the entrance of the drain line into the disposal. It is recommended at least that the drain line be looped to prevent the water from the garbage disposal from siphoning back into the dishwasher, or an anti-siphon device installed.

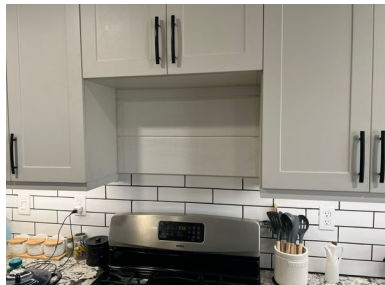
The range vent hood was not present at the time of the inspection.

Contact Builder

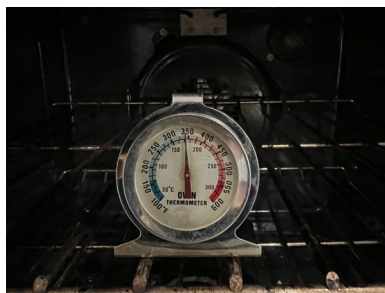
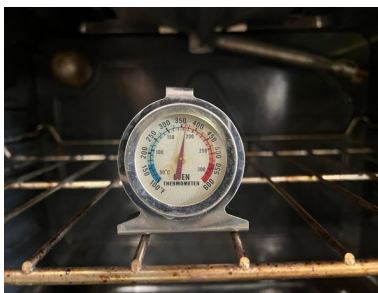
Ovens - Left/Right calibrated properly:

Both oven thermostats were checked and were properly calibrated. The thermostats were set at 350 degrees, and the ovens heated to within the allowable ± 25 degrees. The ovens were checked with an oven thermometer and found to heat to 340 degrees for the left oven, and 360 degrees for the right oven.

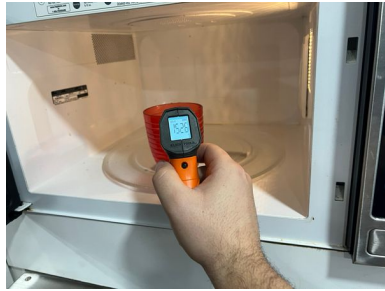
Functional:

No items requiring repair were visible at the time of the inspection for the heating operation of the microwave. A cup of water was placed in the unit, and the microwave heated the water adequately. It is pointed out that the unit was not checked for microwave leakage.

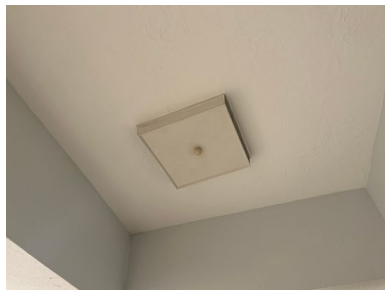
The exhaust fan was nonfunctional.

Obtain Cost Estimate

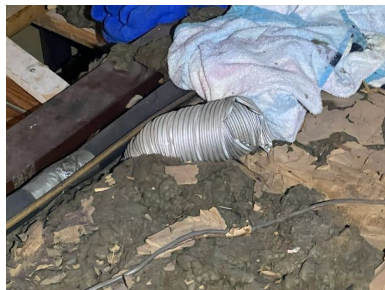
2: Vents - Not terminated outside

We observed one or more bath vent fans that were not terminated outside. The most current building code requires the vent fan to be vented to the outside of the house, and it is recommended that the vent be extended to the outside of the house.

Obtain Cost Estimate

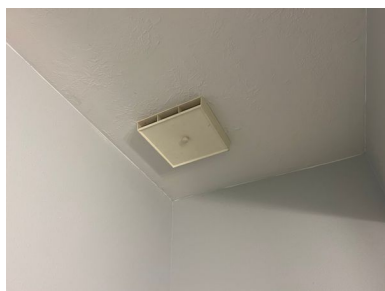
3: Exhaust Fan - Noisy

Half Bath

The exhaust fan was excessively noisy and should be repaired/replaced.

Obtain Cost Estimate

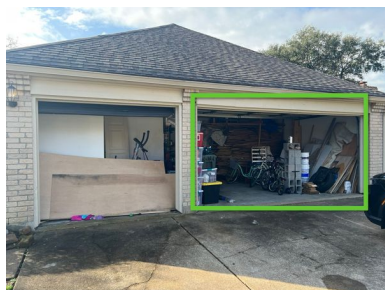
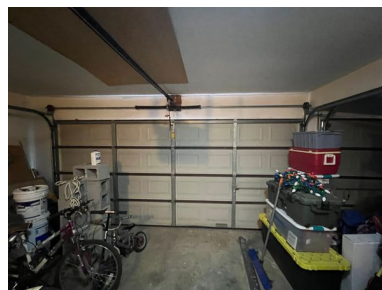
Functional - Autoreverse and sensors:

The garage door opener equipment was functional at the time of the inspection and opened/closed when the controls were operated. The auto-reverse mechanism was operational, and the sensitivity setting on the mechanism was adequate. Also, the infrared auto reverse mechanism was functional.

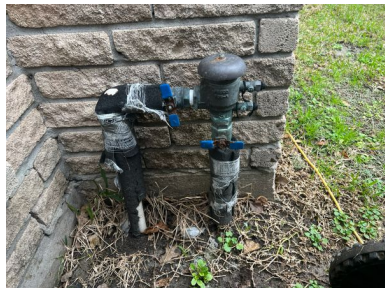
Backflow Prevention Device - present:

A backflow prevention device was present and was equipped with the two water shut off valves on the water supply line to the sprinkler system.

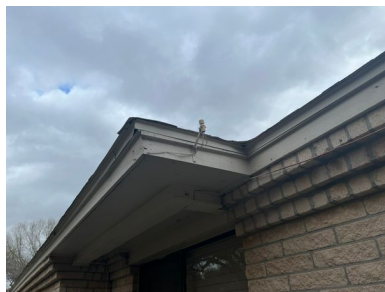
Rain Sensor: Rain Sensor - Present -

It is currently required for automatic sprinkler systems to be equipped with a rain sensor device that will prevent the sprinkler system from operating during and shortly after a significant rain.
